GEORGIA  
DEPARTMENT OF TRANSPORTATION

GDOT RESEARCH PROJECT NO. 7703

FINAL REPORT

WRONG-WAY TRAFFIC  
MOVEMENTS ON  
FREEWAY RAMPS

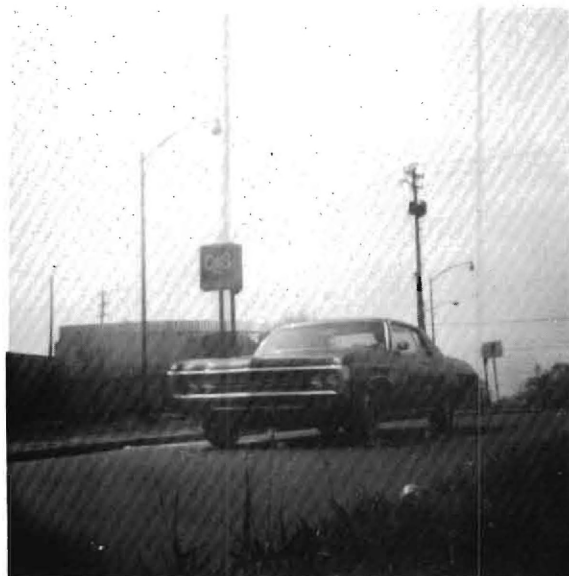
Figure 6. Daylight wrong-way movement

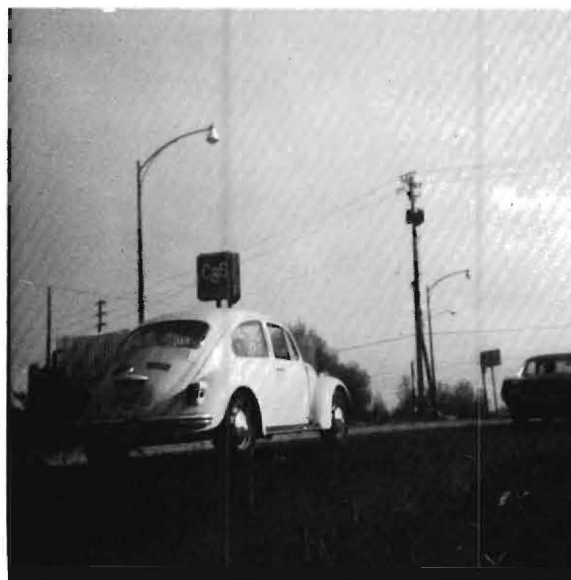
Figure 7. False actuation caused by vehicle roll-back

Therefore it is important that the equipment include a camera, not just a digital counter. Of the 57 photos obtained at I-75 and Central Avenue, five were of cars rolling back.

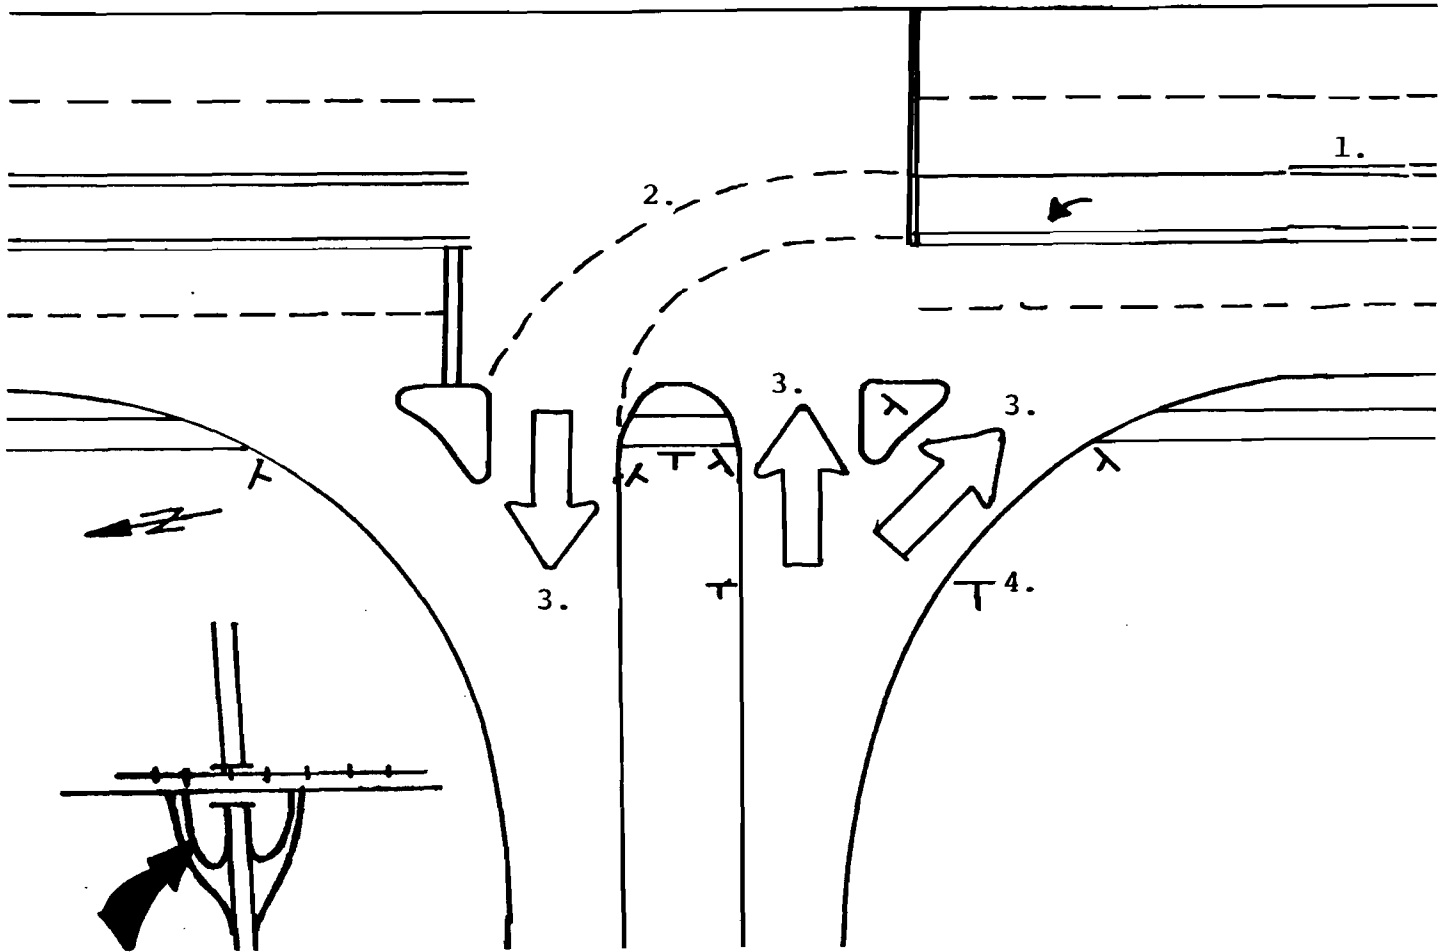
## PARCLO AB LOOP RAMP

1. Short dotted "elephant tracks" to guide left-turning traffic into the correct ramp (there is an exclusive left-turn lane here);
2. Large pavement arrows;
3. Replace missing DO NOT ENTER sign, and replace a length of striping on Ga. 54 that was removed by a patching operation.

1. STRIPE GAP AT PATCH ON JONESBORO RD.
2. ADD "ELEPHANT TRACKS" TO GUIDE LEFT-TURNING TRAFFIC
3. ADD LARGE PAVEMENT ARROWS
4. REPLACE MISSING "DO NOT ENTER" SIGN (POST IS STILL IN PLACE)
