# VLF/AC Withstand Testing at NEETRAC

Jorge Altamirano, Tim Andrews, Nigel Hampton

## **Voltage Withstand Test Program**

Utilized 12 lengths of 1973 vintage, 15 kV, XLPE cables from Exelon

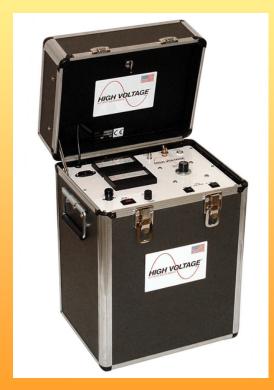
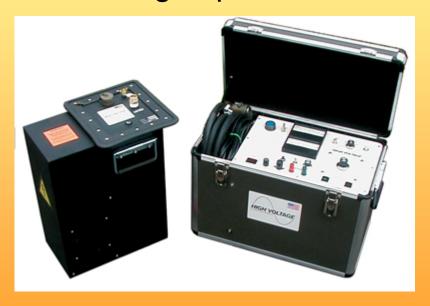
# **Elevated Voltage Test Equipment**

Voltage up to to 26 kV

Voltage up to 40kV

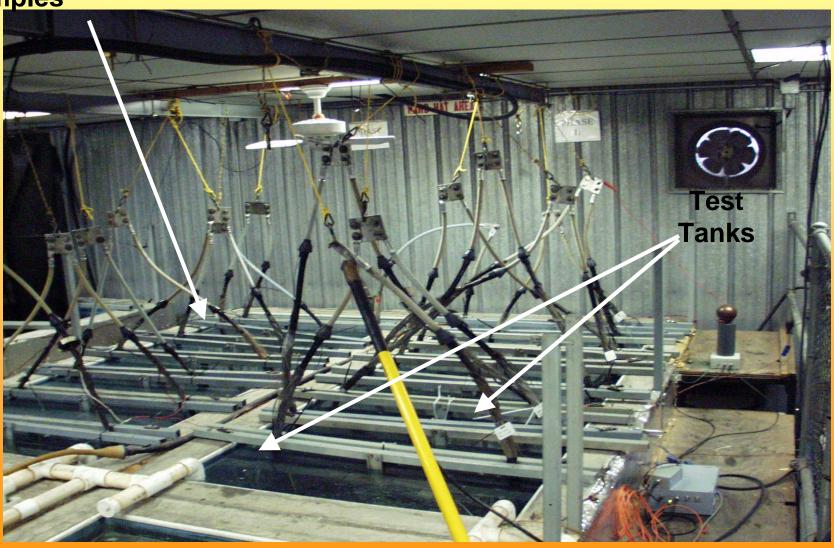
# **Test Underway**

Samples
