**EVALUATION OF ROADSIDE COLLISIONS WITH UTILITY POLES  
AND TREES AT INTERSECTION LOCATIONS**

In Partial Fulfillment  
of the Requirements for the Degree  
Masters of Science in the  
School of Civil Engineering

Georgia Institute of Technology  
December 2007

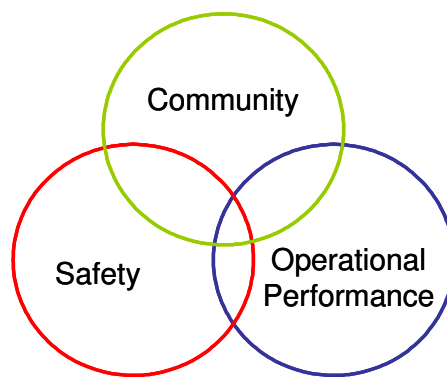
**Figure 1.1 The three dimensions of context-sensitive solutions.**

NCHRP Project 16-04 was developed to address the relationship between a transportation network and its surrounding environment. The project's working plan states that "A major challenge for the transportation profession is to enhance the current practices and guidelines to simultaneously increase the mobility, accessibility, and safety of the transportation while simultaneously preserving the scenic, aesthetic and community values of the area in which they are located" [4]. The project examined several urban arterial corridors in four states –Georgia, California, Illinois, and Oregon– to determine the effect of the

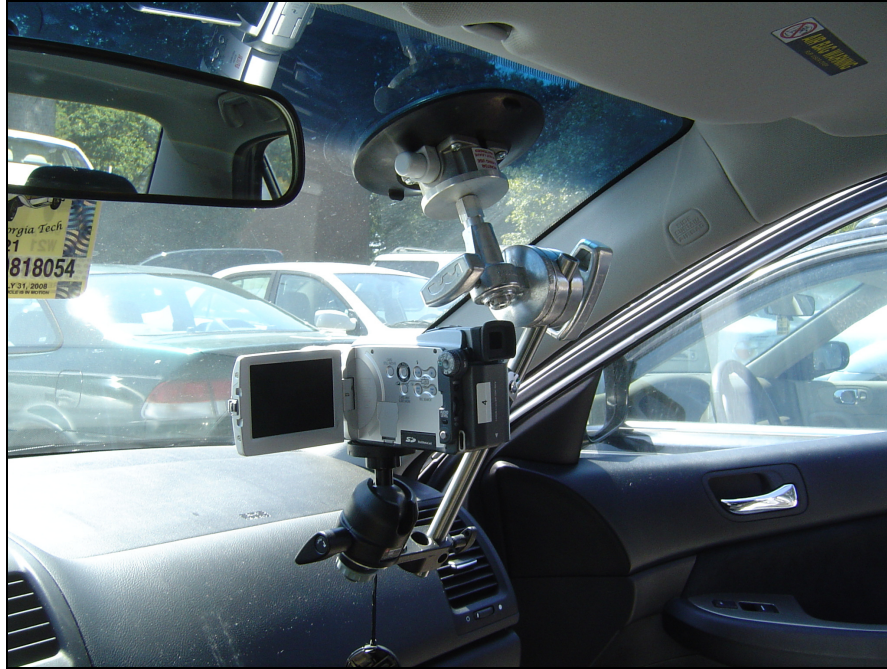
**Figure 3.3 Photograph of video camera with windshield mount.**

In order to have a visual image of each study corridor, the corridor roadsides were video recorded. To accomplish this task, a camera was mounted to the windshield inside of the vehicle on the front passenger side as shown in Figure 3.3. A Canon Optura Xi Digital Video Camcorder was focused to capture the edge of pavement and the right-of-way and any obstructions or features that were present. A DC power cable was used to ensure sufficient battery life during the collection period.

While driving on the study corridors, the driver of the vehicle would remain in the far right travel lane so as to capture the clearest image of the corridor's roadside. In some cases, it was impossible to remain in the far right line due to on-street parking and right turn lanes. To increase the video quality, the investigators attempted not to exceed 35 miles per hour, but often found this impossible for safety reasons. While driving the corridors, street names and other roadside information was reported verbally to aid with the video analysis.

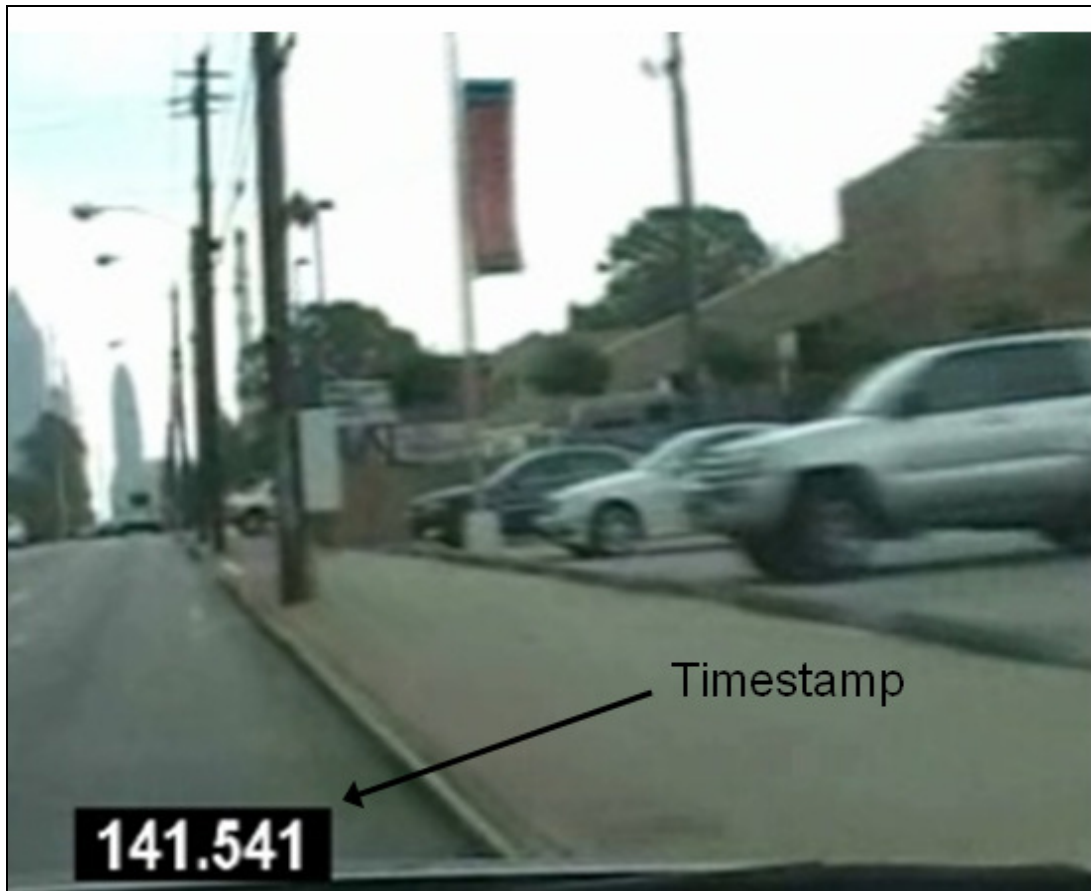
**Figure 3.5 Image from video of 14<sup>th</sup> Street**

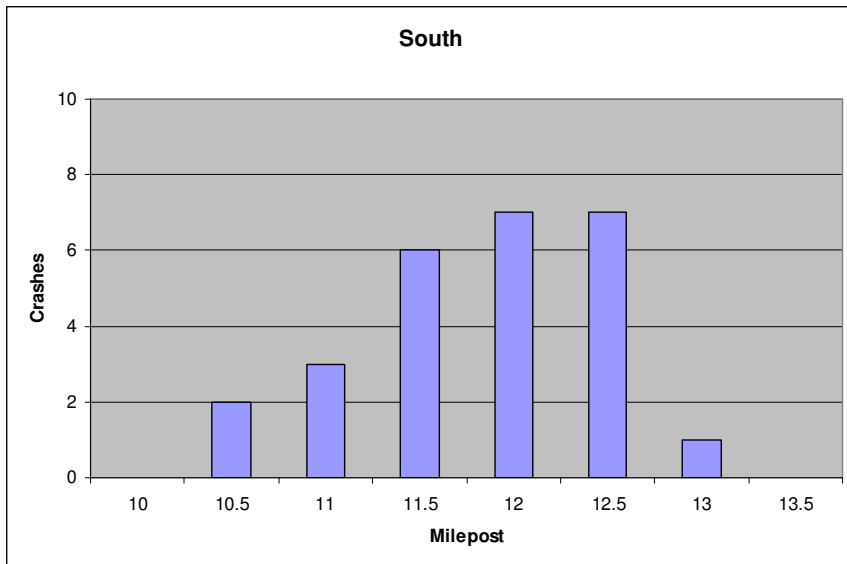
Figure 3.6 Histogram of off-road fixed object collisions for the southbound portion of Roswell Road (1) corridor.

The resulting crashes were grouped by corridor and exported into nine separate spreadsheets. In order to quantify the locations of crashes along the corridors, histograms were created using a macro written using Visual Basic. An example of the resulting

histograms can be seen in Figure 3.6. This histogram illustrates the number of crashes in 0.5 mile increments along a corridor. Additionally, line graphs were used to display the same information with a 0.1 mile interval. An example is pictured in Figure 3.7. The histograms for each of the study corridors can be found in Appendix B. This information was beneficial when comparing general roadside conditions found from the video analysis with off-road fixed object crash histories.

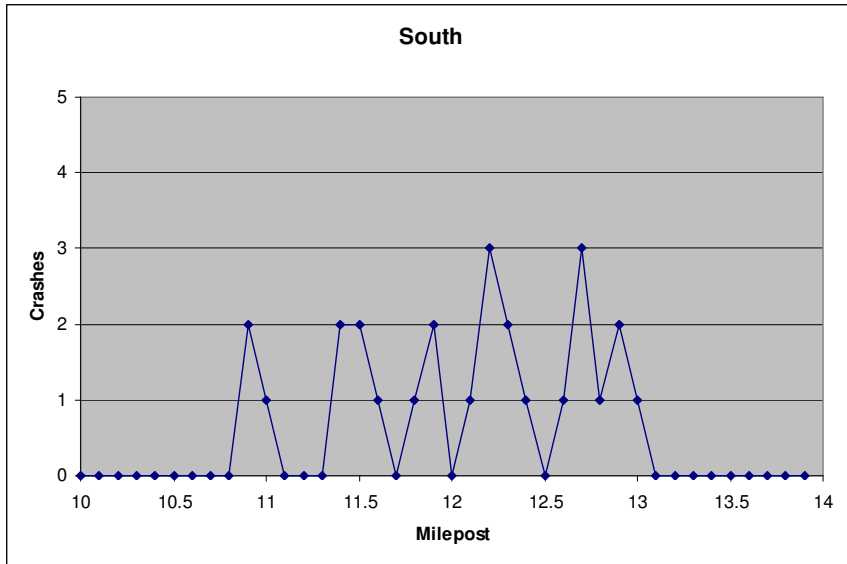
Figure 3.7 Graph displaying off-road fixed object collisions for the southbound portion of Roswell Road (1) corridor.

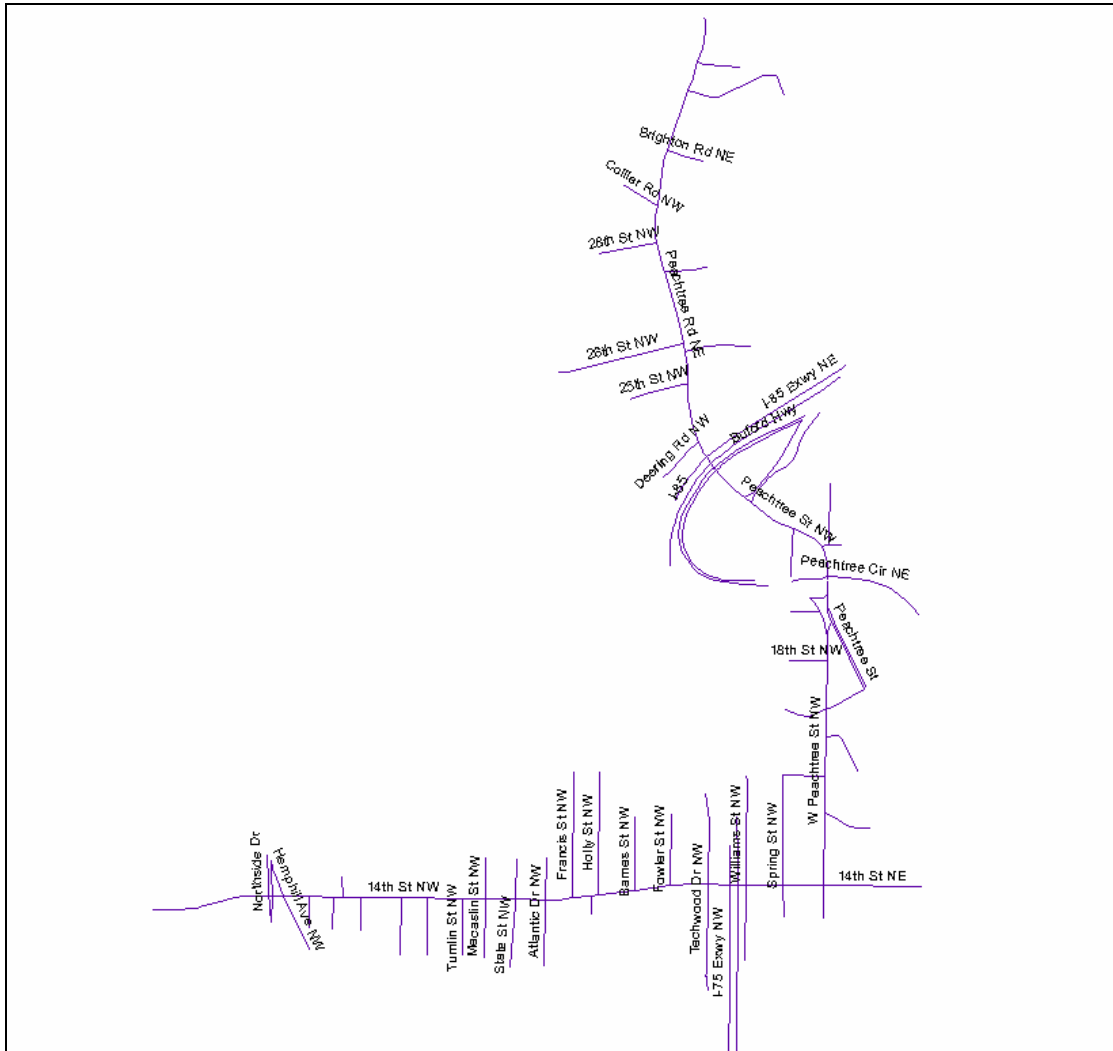
**Figure A.1 GIS Image of 14<sup>th</sup> Street / Peachtree Street Corridor (Length of 3.0 Miles).**

Additional tables and figures that are not included in the body of this report can be found in the appendices. Appendix A includes geographic information system (GIS) maps of the study corridors examined in the report. Appendix B contains tables and graphs with data specific to each of the study corridors.

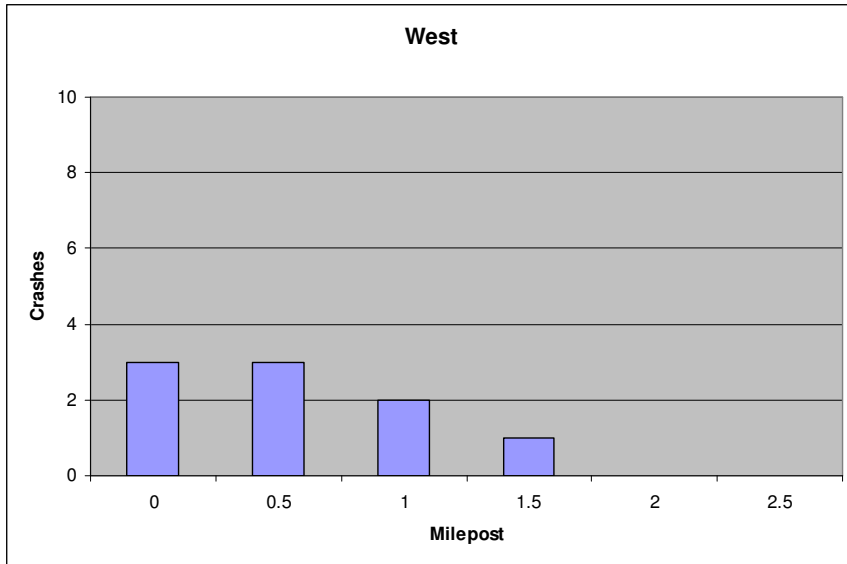
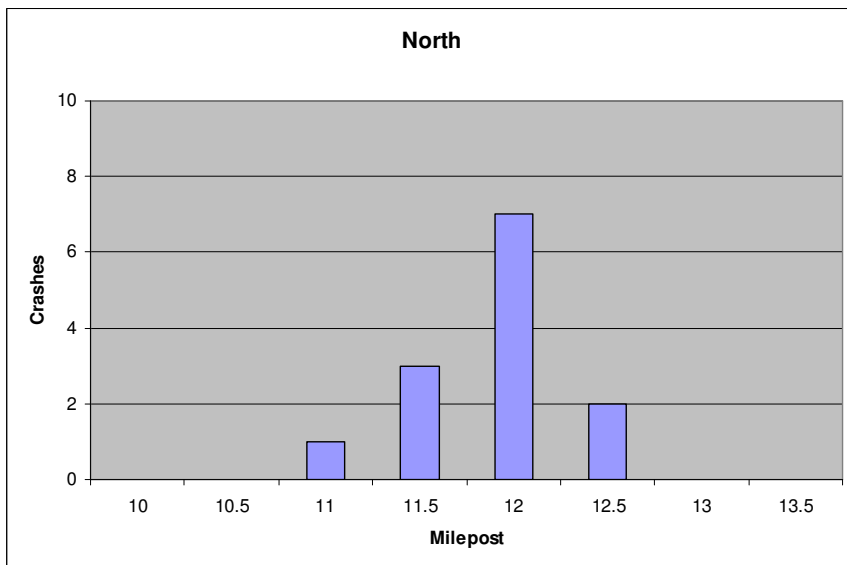
**Figure B.1 Histogram of off-road fixed object collisions for the eastbound portion of 14<sup>th</sup> / Peachtree Street corridor.**

**Figure B.2 Histogram of off-road fixed object collisions for the westbound portion of 14<sup>th</sup> / Peachtree Street corridor.**

**Figure B.3 Histogram of off-road fixed object collisions for the northbound portion of 14<sup>th</sup> / Peachtree Street corridor.**

**Figure B.4 Histogram of off-road fixed object collisions for the southbound portion of 14<sup>th</sup> / Peachtree Street corridor.**

**Figure B.5 Histogram of off-road fixed object collisions for the northbound portion Roswell Road (1) corridor.**

**Figure B.6 Histogram of off-road fixed object collisions for the southbound portion Roswell Road (1) corridor.**
