Title: Transformer Insulation Failure

Interim Summary Report

Transformer Insulation Failure

TO: W. Shakun  
FROM: J. W. Gooch  
SUBJECT: "Transformer Insulation Failure", Westinghouse Electric Company, Athens, GA

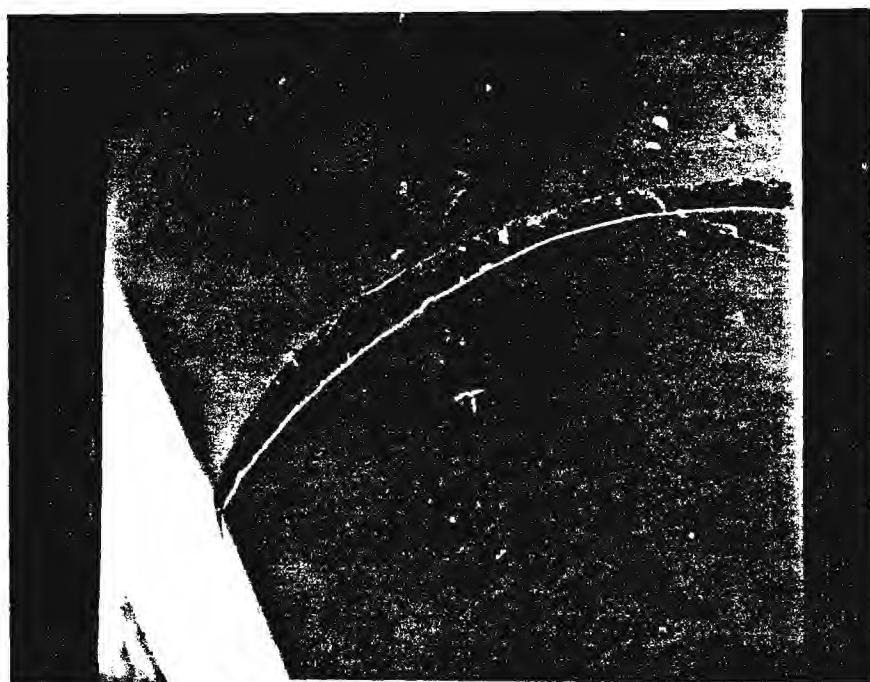
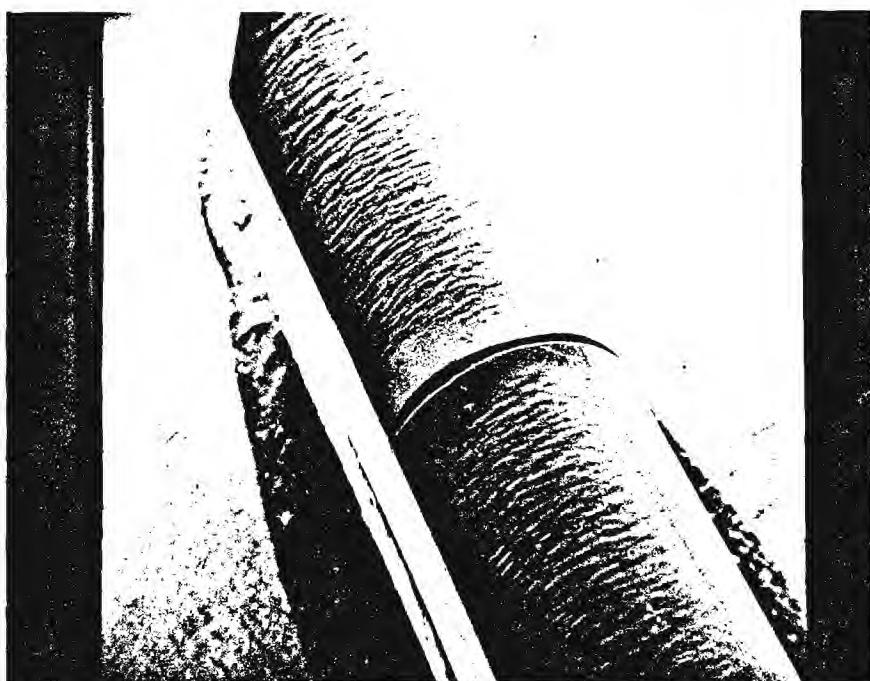
FIGURE 8

Higher mag. of crack

Ripples and cracks near  
major crack in formvar on  
Cu wire.

- c. Scanning electron microscopy of the copper wire insulation (Figure 8,9) shows ductile fracture tendrils in the formvar. Ripples and smaller cracks appear near major regions of cracking of the formvar. The cracks under high magnification indicate tendrils which may be indicative of excessive local heating.

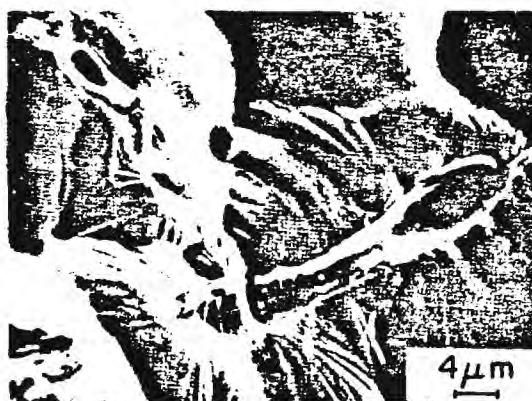
*Fig. 8: Freeze-fractured Sections through an Electrical Tree, 35 kV XLPE Cable*

Freeze fracture through an electrical tree grown in 35 kV XLPE cable insulation in the laboratory clearly shows tree channels, which vary in diameter up to about 10  $\mu\text{m}$ , Fig. 8a. The density of the tree channels depends on the applied voltage, frequency and temperature [1]. Fig. 8 also shows a permanganic acid etched specimen containing an electrical tree. The discharge channels do not follow the nodule boundaries as might be expected if the nodules were true spherulites and considering the results of Wagner for polypropylene [6]. The nodules are smaller in diameter in the region of a breakdown channel and also tend to be aligned along the tree channels, Fig. 8c.

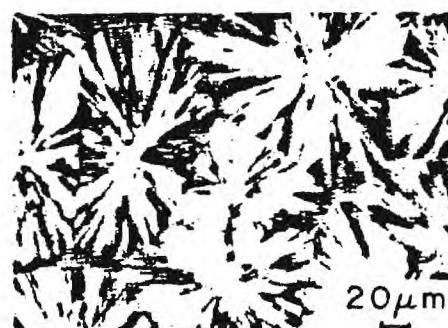
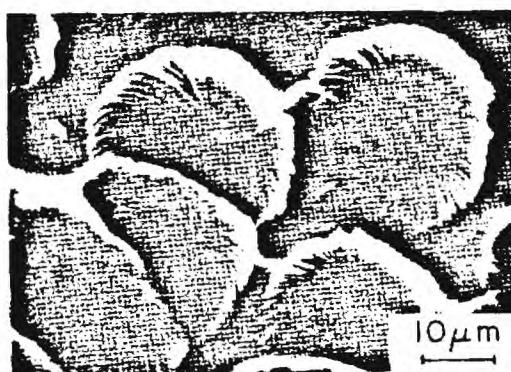
Fig. 11: Micrographs of PP and XLPE Film  
(a) PP film, polarized light, unetched  
(b) PP film, permanganic acid etched (SEM)  
(c) XLPE film, permanganic acid etched (SEM)

The tests were repeated on PP film which was cooled sufficiently slowly to produce large spherulites as shown in Fig. 11a. The etched surface, shown in Fig. 11b, contained nodules of similar size to those for XLPE film, Fig. 11c. Fig. 12 shows the distributions of the equivalent circle diameters of the spherulites, as measured by optical microscopy, and of the nodules. The mean diameters of the spherulites and nodules were 100 and 16.3  $\mu\text{m}$ , respectively, with the spherulites ranging between 37 and 210  $\mu\text{m}$  and the nodules between 5 and 31  $\mu\text{m}$ . These results confirm that the
