# **DEVELOPMENT OF AN ARTIFICIAL MENISCUS IMPLANT**

In Partial Fulfillment  
of the Requirements for the Degree  
Master of Science in the  
School of Mechanical Engineering

Georgia Institute of Technology  
May 2020

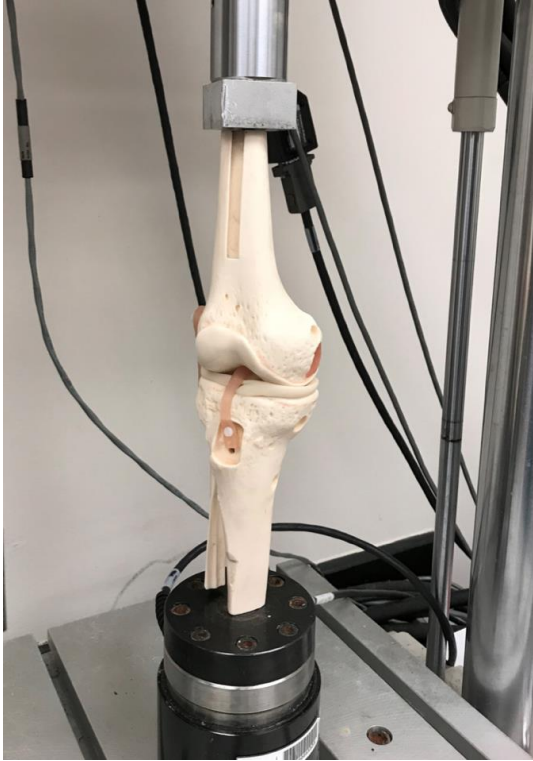
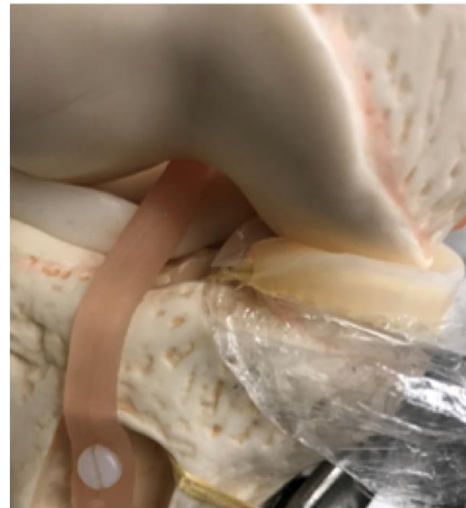
**Figure 21: Experimental compression test with anatomically accurate geometry (left) and pressure film wrapped in plastic placed at base of implant (right). [69]**

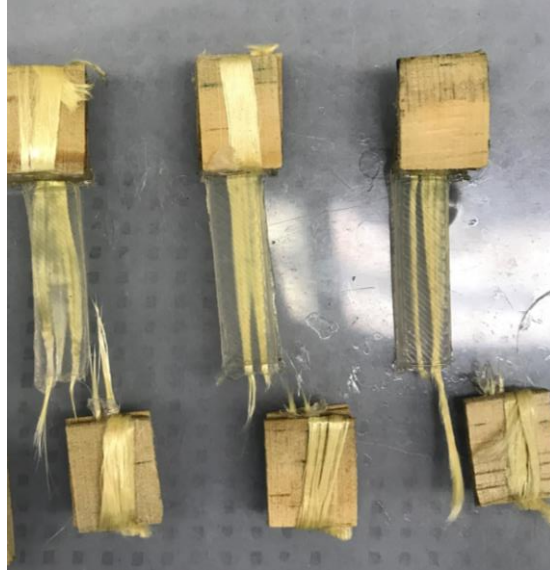
**Figure 47: Composite tensile sample failure mode. [69]**

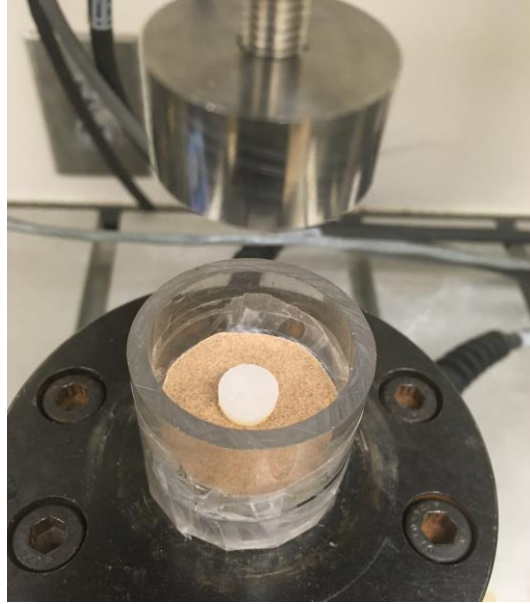
**Figure 49: Compressive modulus test setup.**

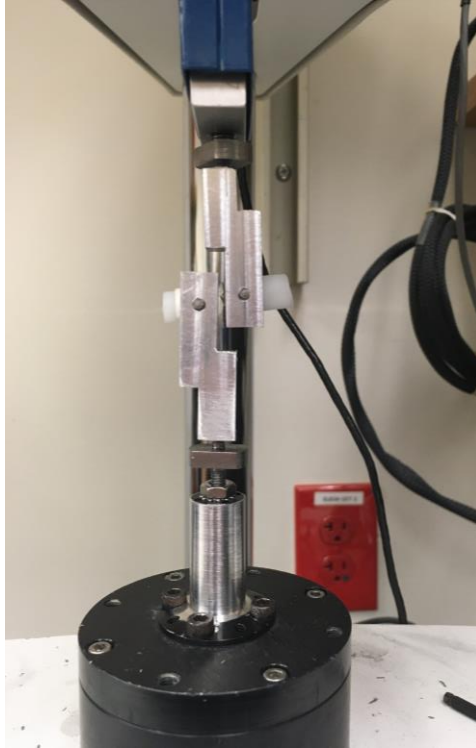
**Figure 54: Extreme and daily shear setup.**
