**Understanding the mechanisms and parameters affecting the structural  
corrosion of sheet gauge 7xxx alloys**

A Dissertation  
Presented to  
The Academic Faculty

In Partial Fulfillment  
of the Requirements for the Degree  
Doctor of Philosophy in the  
School of Materials Science and Engineering

Georgia Institute of Technology  
May 2023

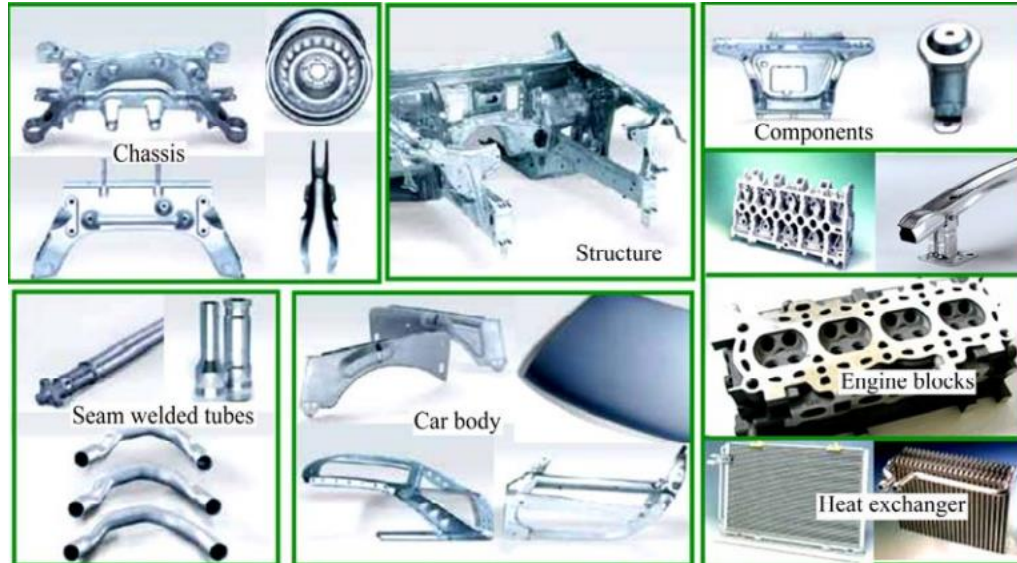
**Figure 1-5: Typical automotive components made of aluminum alloys [23].**

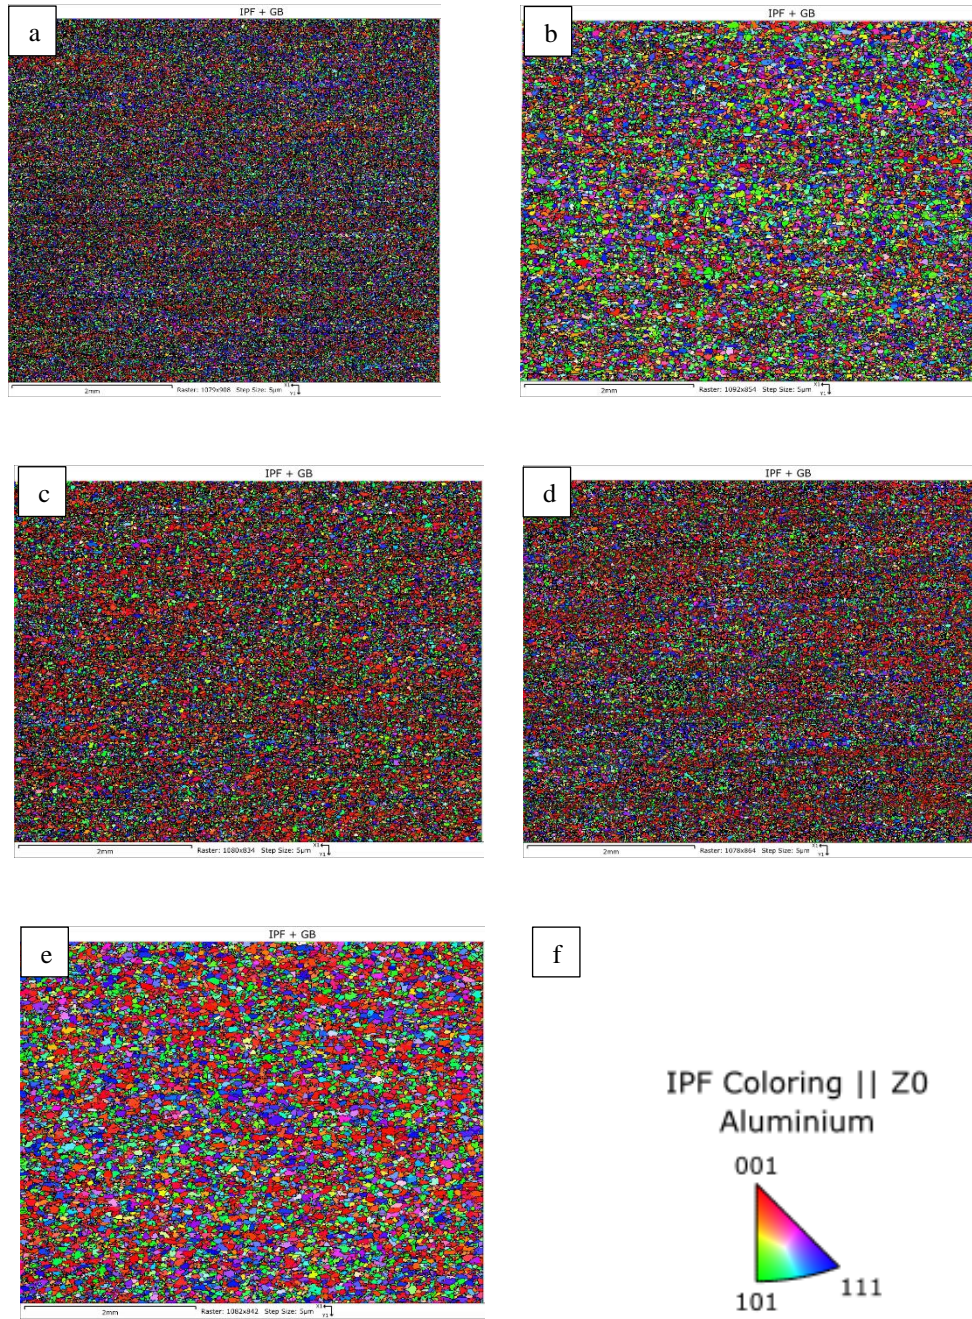
size of 51  $\mu\text{m}$  in plane view. Error! Reference source not found. shows the inverse pole figure map from EBSD analysis, apart from the grain size, qualitatively the crystallographic orientation was comparable between the 80% and 50% CR samples.

**Figure 4-3: Inverse pole figure (IPF) map from EBSD analysis of (a) 80% CR (b) 50% CR (c) 250°C RA (d) 350°C RA (e) 450°C RA (f) IPF coloring chart respectively**

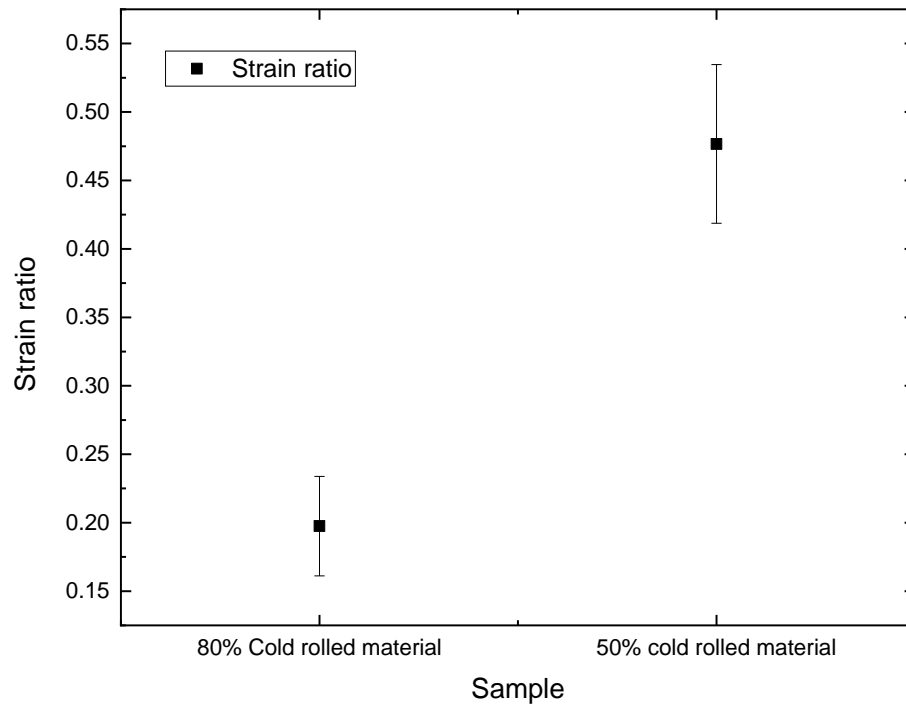
fractured when it was close to reaching the yield strength value. In contrast, the 50% cold rolling samples broke when they were nearing the maximum tensile strength. A significant difference in the grain size effect was observed in the strain ratio. As shown in **Figure 4-5**, the strain ratio value for the fine-grain 80% CR samples was 0.2, while the coarse-grain 50% CR samples exhibited a higher strain ratio of 0.5.

**Figure 4-5: Effect of cold work on strain ratio in ASTM D1384 solution + 1% H<sub>2</sub>O<sub>2</sub>**

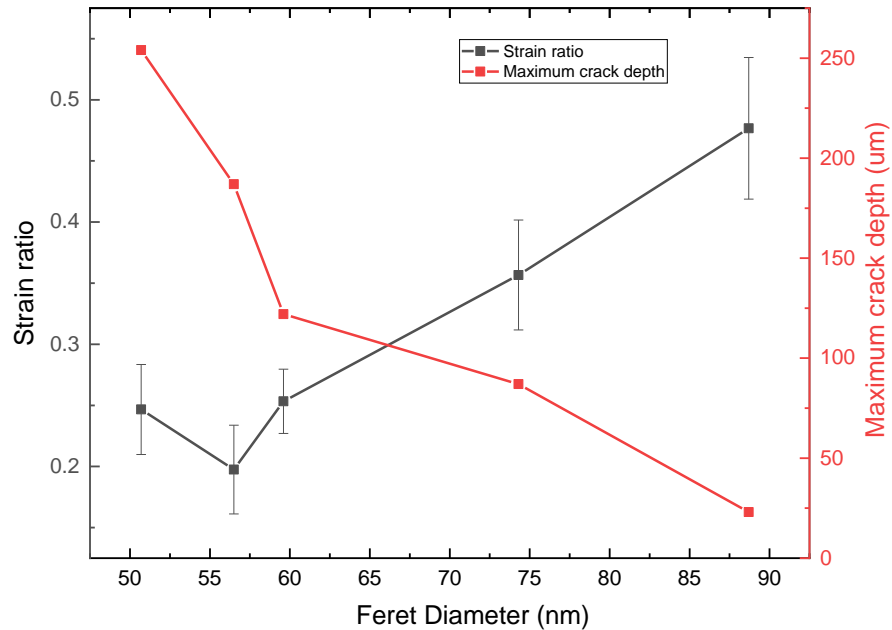
**Figure 4-14: Effect of GBP size (Feret diameter) on strain ratio and maxim crack depth.**

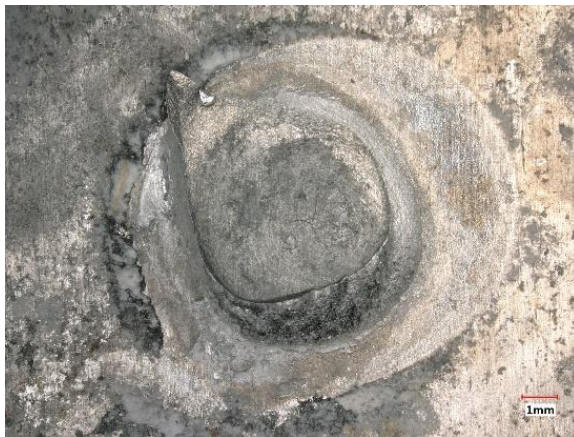
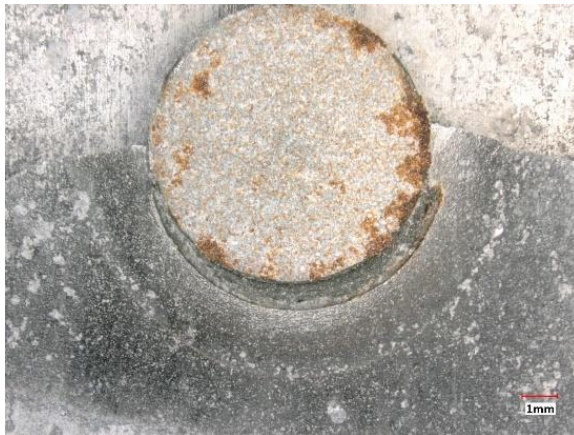
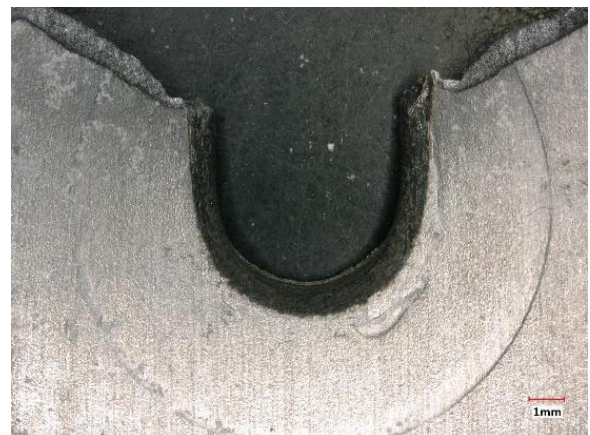
**Figure 7-22: Macro images of the joint fracture surface after 28 days ASTM G85-A2 test followed by tensile test.**

**Figure 7-22** shows the fracture morphology of the joints before and after exposure to ASTM G85-A2. The RSW preexposure sample failure locus (**Figure 7-10**) was along the weld region between the faying surfaces. The failure mode did not change after 28 days of exposure as it was still occurring along the weld region.

SPR samples exhibited similar fracture behavior as the pre-exposure samples since the 5182 around the rivet region deformed significantly. The breakup of the metal after exposure was due to the excessive mechanical force that was applied to remove 5182. The most striking result that emerged from this work was that the applied stress, 50% of joints peak strength, did not affect the joint corrosion performance. **Figure 7-23** shows the residual strength of the joints before and after corrosion exposure. The cross-section images indicated early signs of the IGC attack in the heat-affected zone of 7075. However, no such corrosion attack was observed in the 5182 section. Similarly, there was no sign of any primary or secondary cracks in the cross-section images. The fracture locus (**Figure 7-24**) after tensile testing was comparable with preexposure as both exhibited interfacial failure in RSW and deformation of the 5182 section around the rivet in SPR. Even with the applied stress, the residual strength of the joint did not decrease after 100 days of exposure. The RSW joints exhibited only a 7% decrease in strength, while the SPR samples did not show any measurable drop in strength. Similarly, macro-images also showed that there was no significant accumulation of the corrosion product after the exposure period. **Figure 7-25** shows the residual strength of the joints after 100 days of exposure in a humid environment and applied stress did not affect the final strength of the joints.
