CREVICE CORROSION IN ALUMINUM ALLOYS

A THESIS

Georgia Institute of Technology

June, 1976

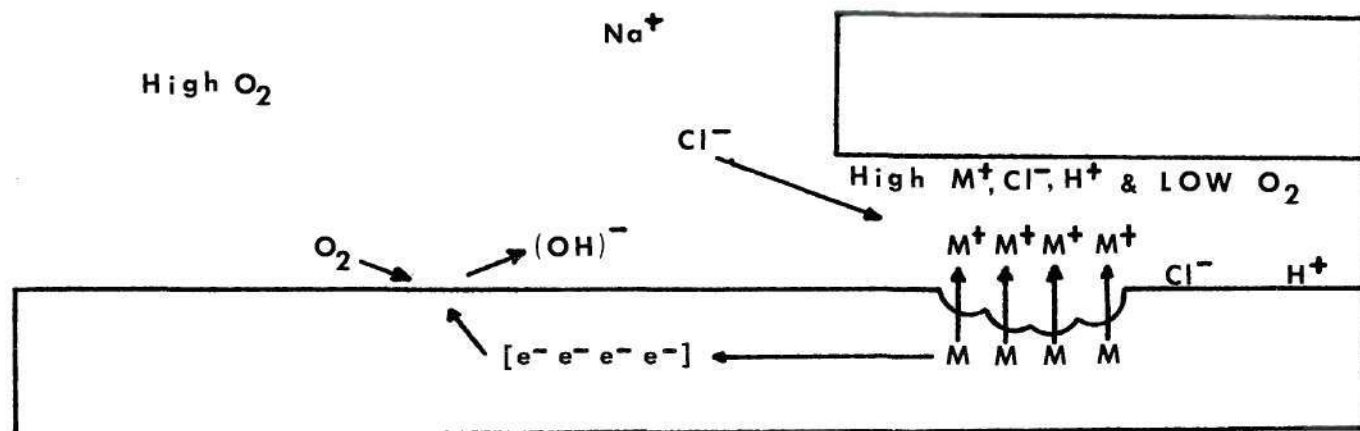
Figure 1. The Fontana and Greene Model of Crevice Corrosion.

7. Observations were in general agreement with the Fontana and Greene Model of crevice corrosion. Quantitative data were close to the results of calculations based on thermodynamical data.

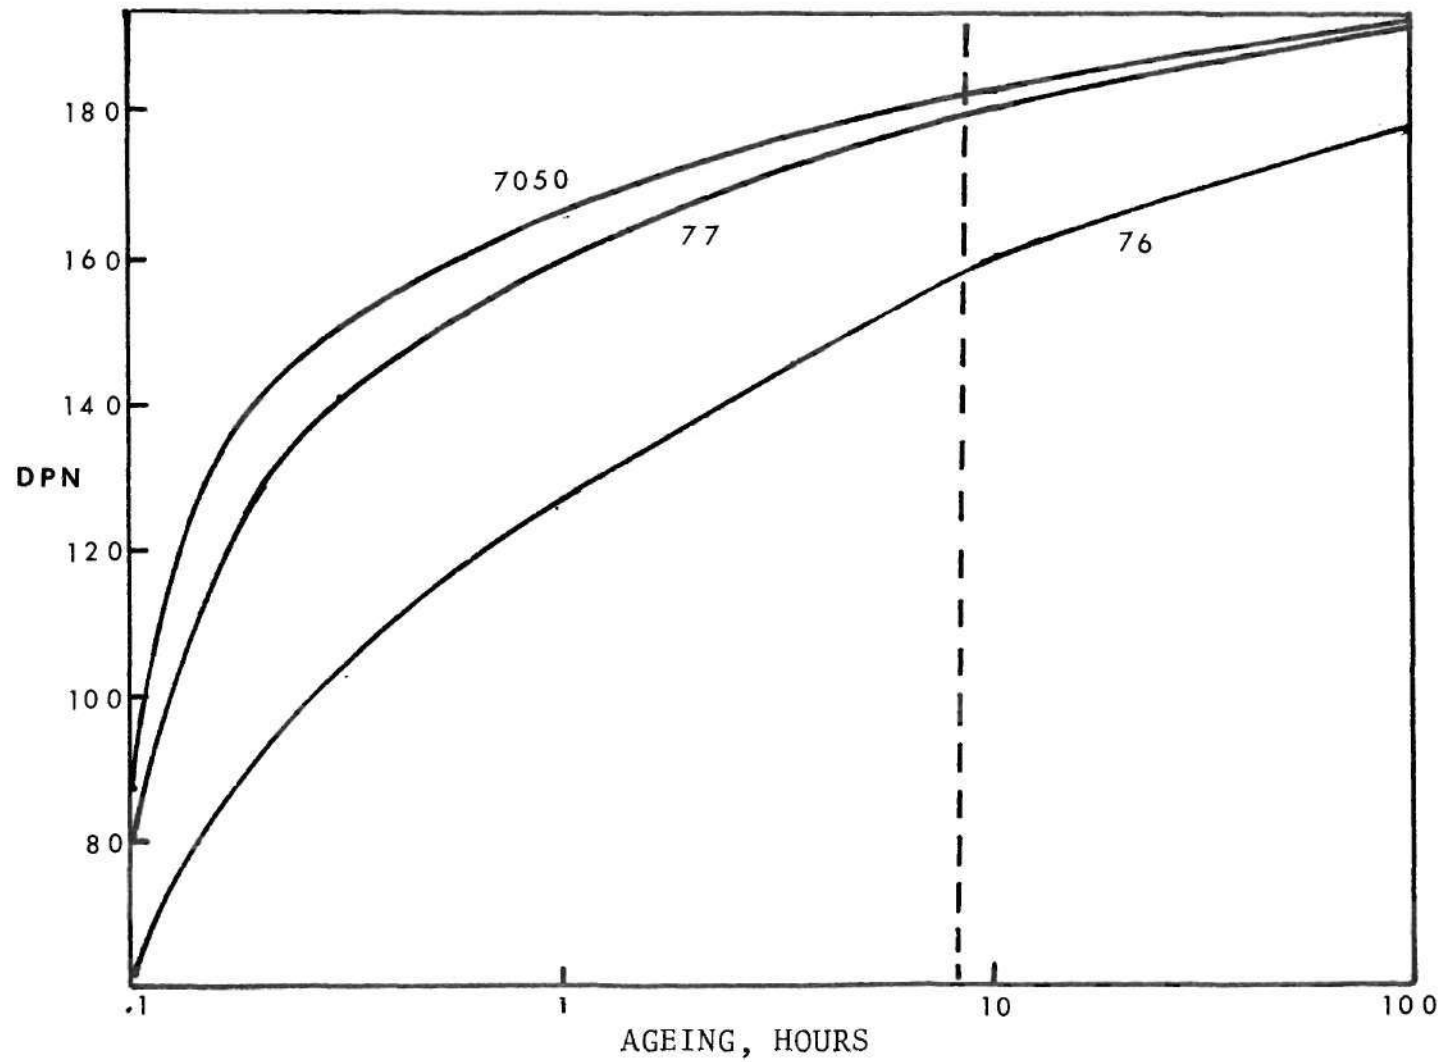
Figure 2. Hardness Curves vs. Ageing Time for Alloys 76, 77, and 7050. Ageing Temperature was 120 C. (25,26)

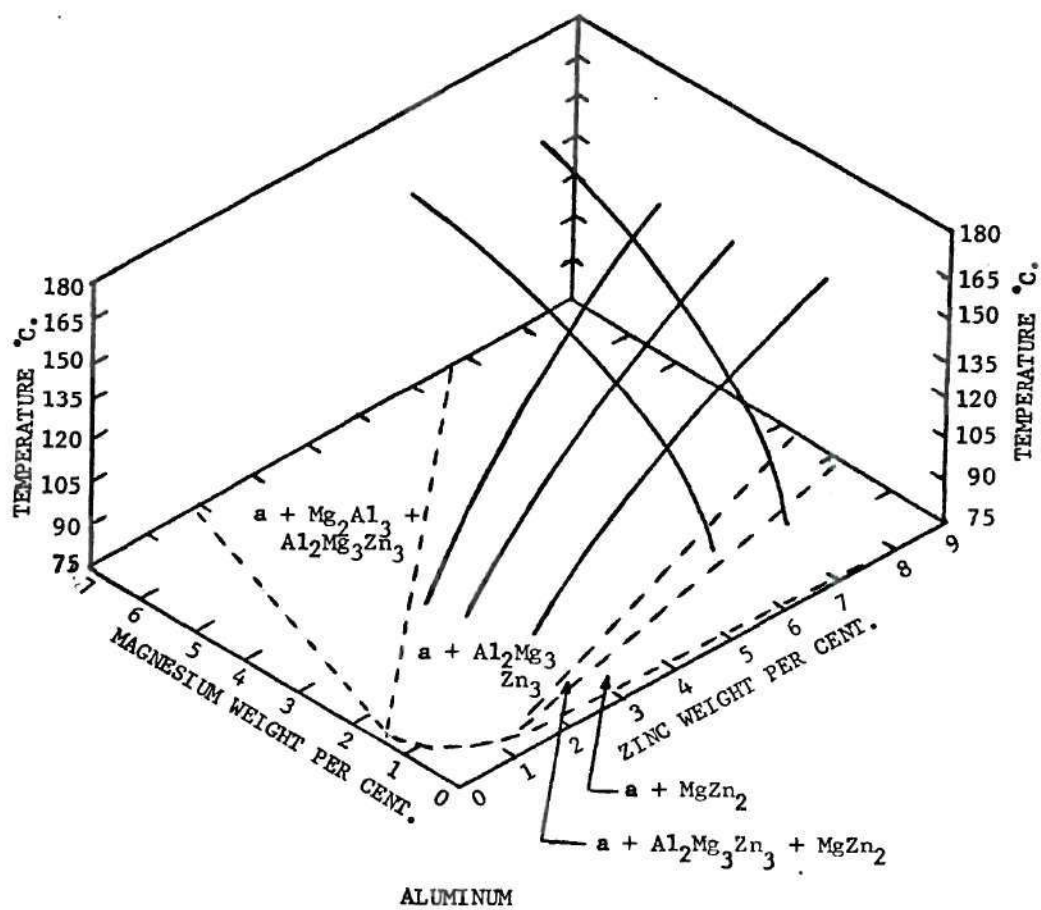
Figure 3. Upper Solvus Line for Al-Mg-Zn Alloys. (26)

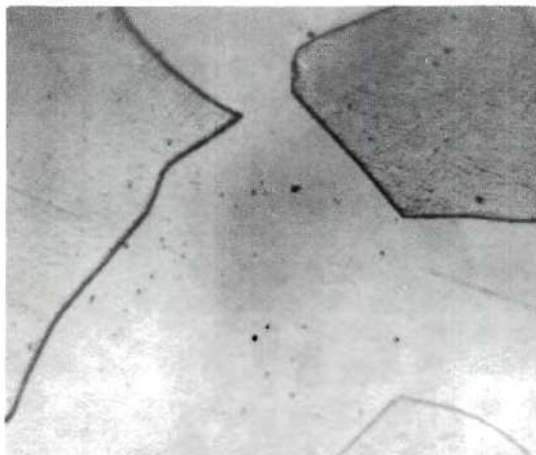
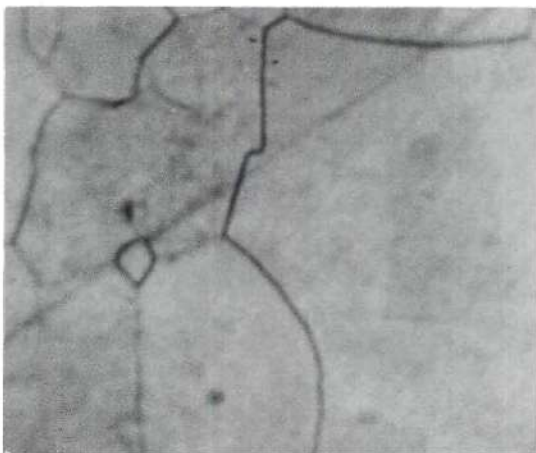
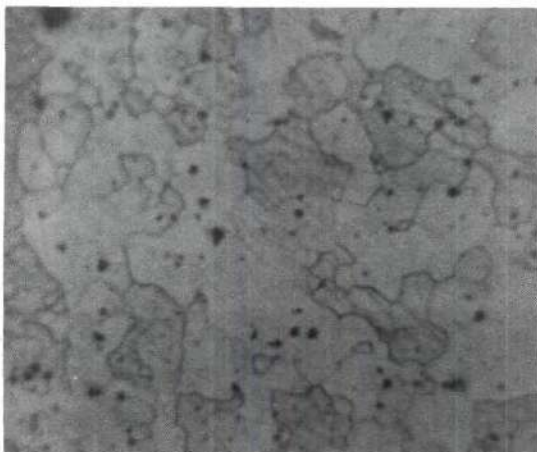
Figure 4a. Microstructure of the Longitudinal Sections of Alloys 76, 77, and 7050. (25,26)
Magnification: 100X.

alloy 7050 was substantially smaller than those of alloy 76 and 77, alloy 76 having the largest grains. Sanders⁽²⁶⁾ suggested that copper in excess of 1.5 per cent acted as a grain refiner. The microstructures of all three alloys are shown in Figure 4a, and a comparison of the estimated grain sizes is shown in Table 3.

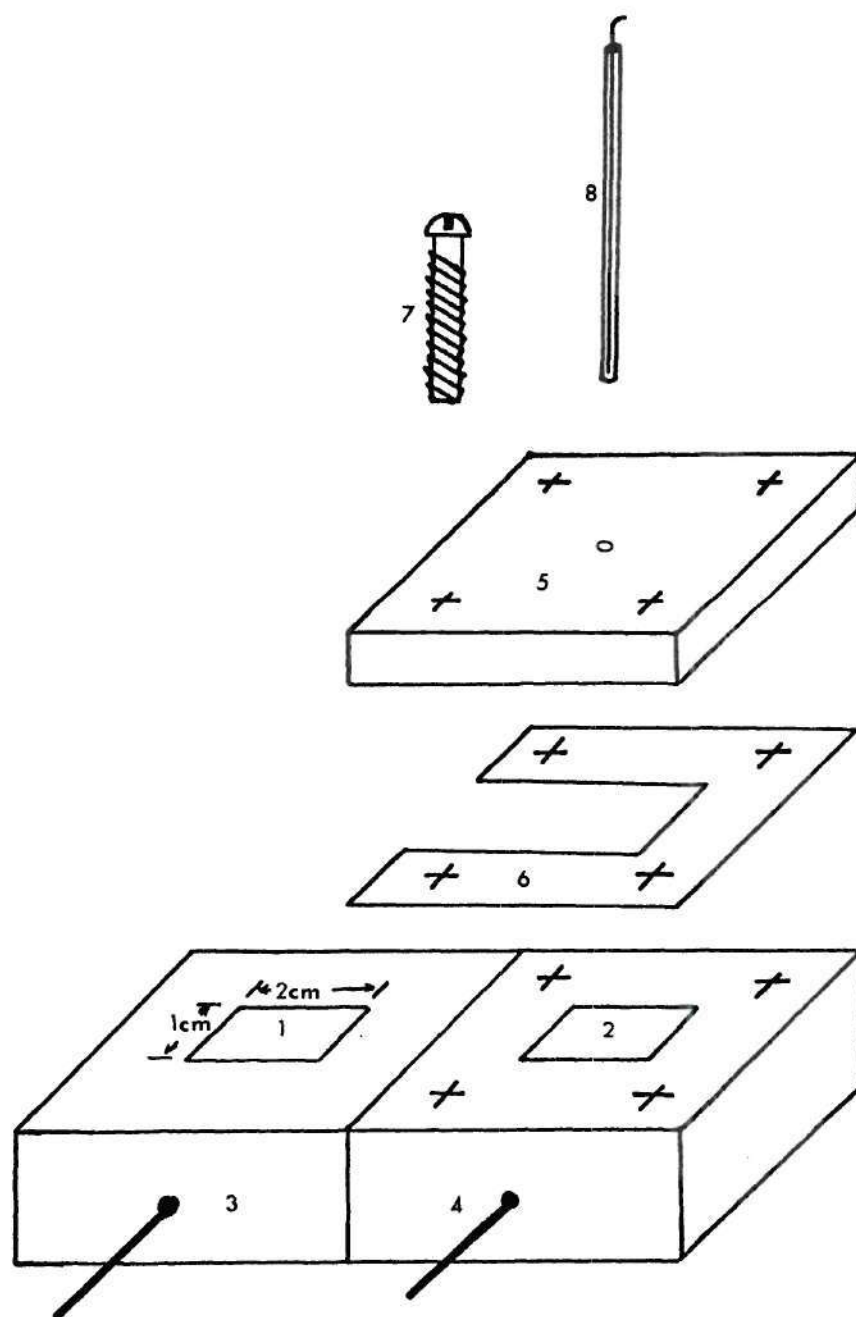
Figure 4b. Artificial Crevice Corrosion Cell. (1 and 2 - identical samples, 3 and 4 - electrical connections, 5 - PTFE or acrylic cover plate, 6 - PTFE spacer, 7 - one of four non-metallic screws, 8 - fiber plugged capillary.)

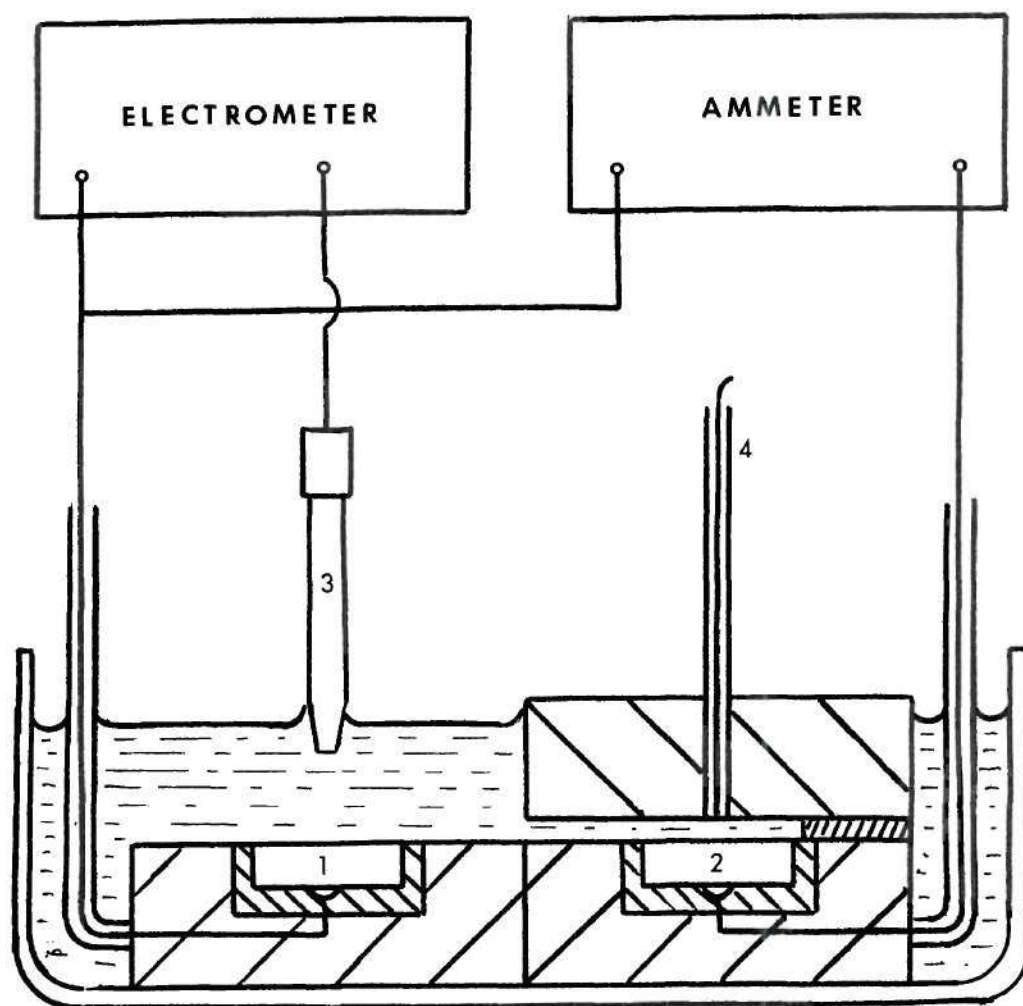
Figure 5. Schematic Set-up of a Corrosion Cell to Allow Sampling of the Crevice Solution and Measurement of the Current and Potential. (1 and 2 - identical samples, 3- reference electrode, 4 - capillary)

The samples were electrically connected, as shown in Figure 5, and the galvanic current flow between the two electrodes was measured by means of a potentiostat (PAR Model 174) adjusted for zero potential difference between the electrodes. The corrosion potentials of the electrode couple and of an uncoupled outside electrode were measured with respect to a standard saturated calomel electrode by means of an electrometer (Keithley Model 600B).

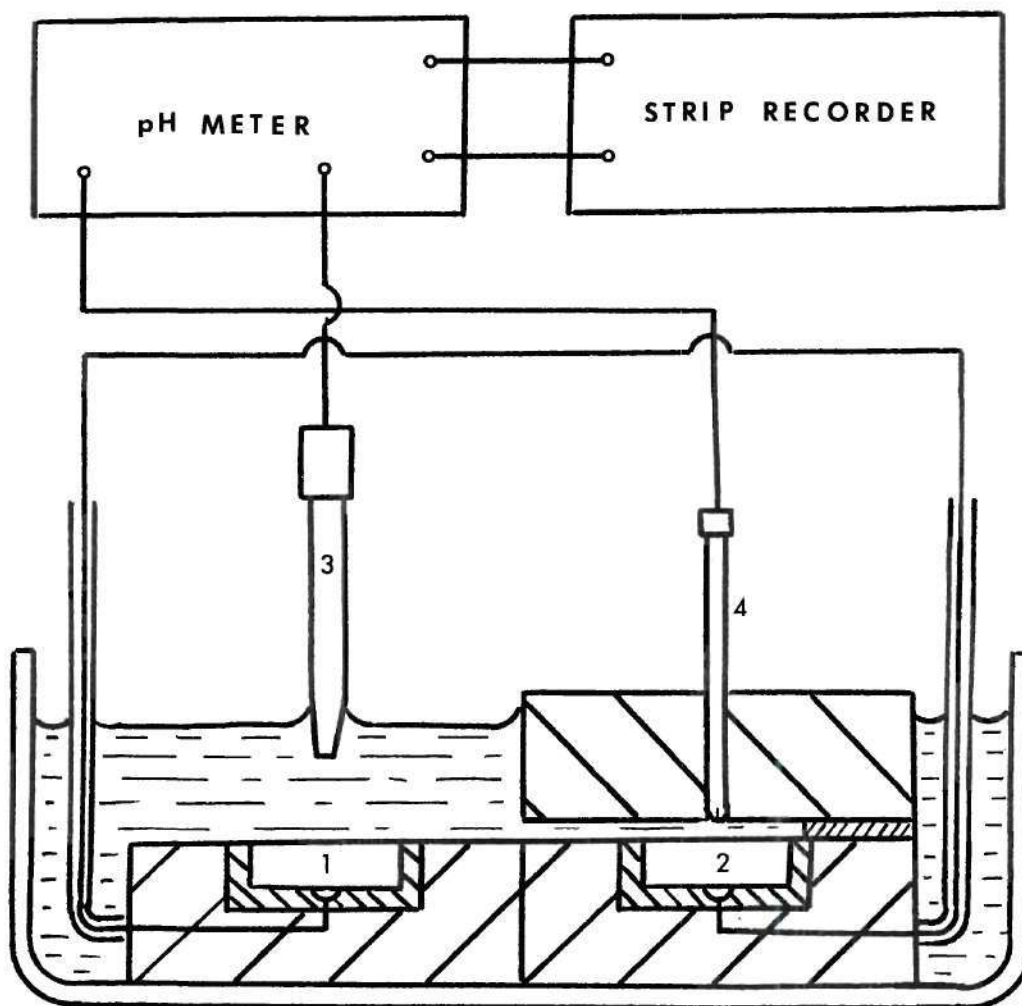
Figure 6. Schematic Set-up of the Corrosion Cell to Allow Continuous Monitoring of the pH of the Crevice Solution. (1 and 2 - identical samples, 3 - reference electrode, 4 - pH electrode)

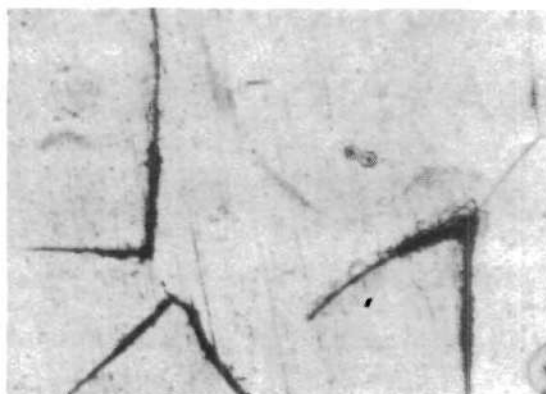
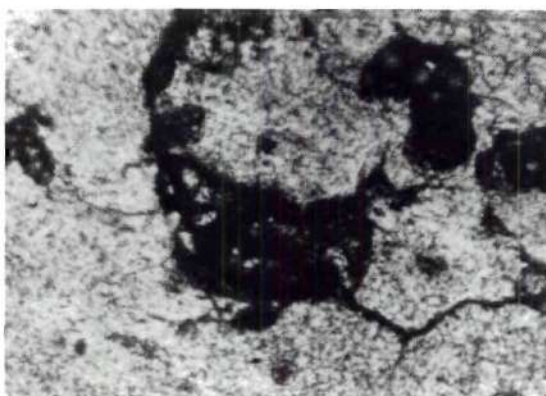
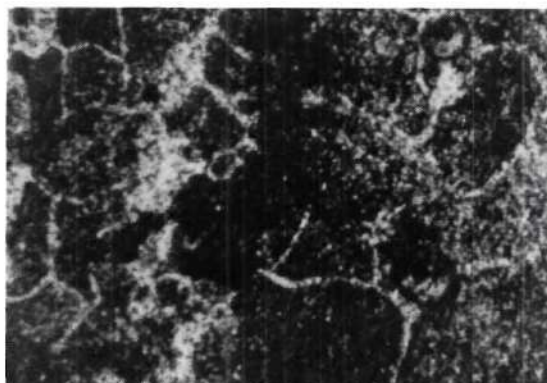
Figure 7. Micrographs of the Electrodes in Crevices after 100 Hours of Exposure (coupled). Magnification: 100X.

For all three alloys visual corrosion products were less evident on the surface of the crevice than on the outside electrode; however, pitting and grain boundary attack were observed microscopically on all three alloys. The severity of pitting increased with increasing copper content. Micrographs of the various surfaces of all three alloys,

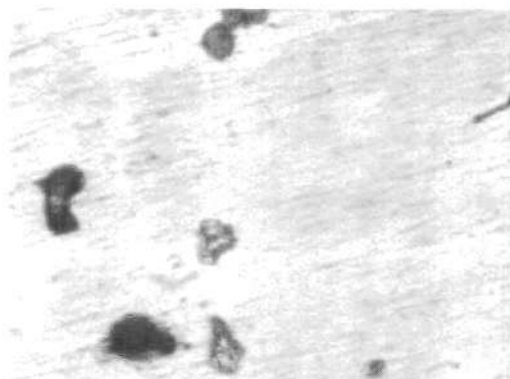
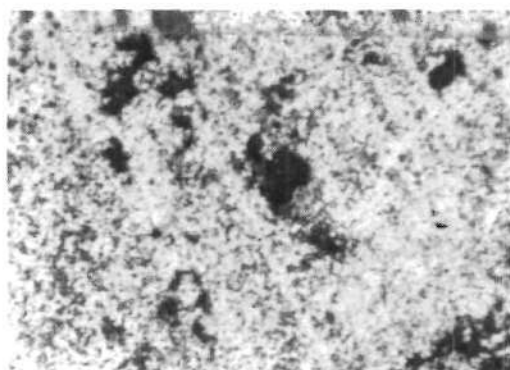
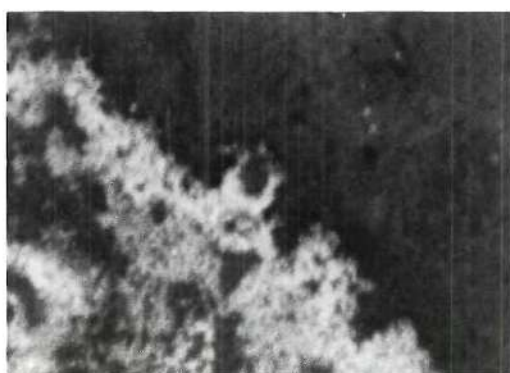
Figure 8. Micrographs of the Electrodes in the Bulk Solution, coupled with Electrodes in a Crevice, after 100 Hours of exposure. Magnification: 100X.

The surface of all three alloys which were exposed to the bulk solution showed visible corrosion damage, usually in the form of pitting. The deterioration of alloys containing copper was substantially more severe than of the alloy without copper. Surfaces of the copper-containing alloys also showed moderate to heavy accumulation of dark corrosion products, while the ternary alloy remained bright. The conditions of the surface did not seem to be substantially affected by the coupling with the electrodes placed inside the crevice.

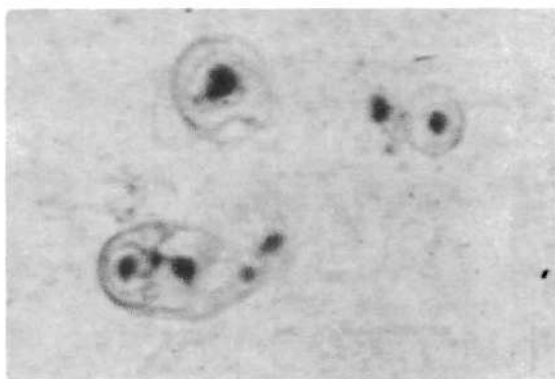
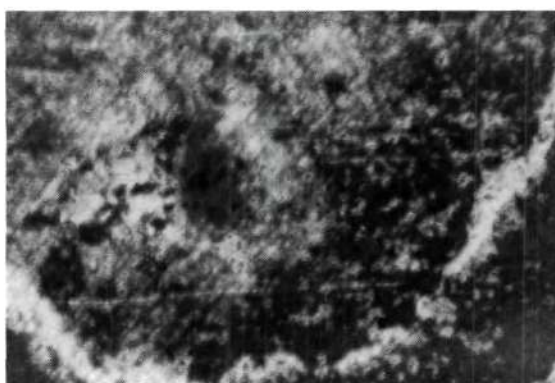
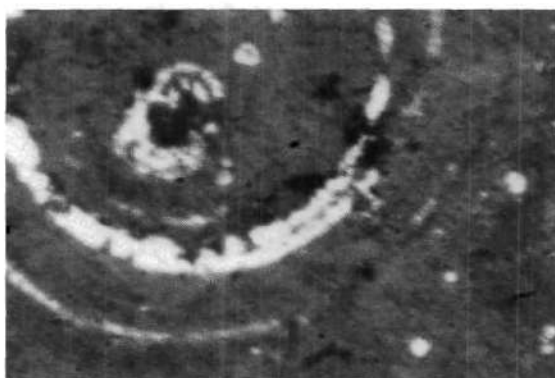
Figure 9. Micrographs of the Freely Corroding Electrodes, after 100 Hours of exposure. Magnification: 100X.

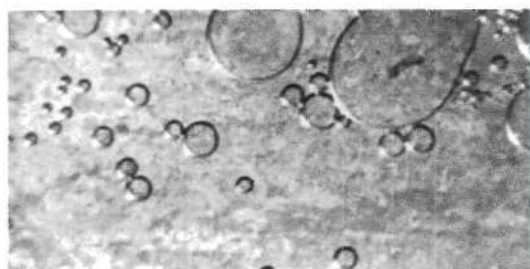
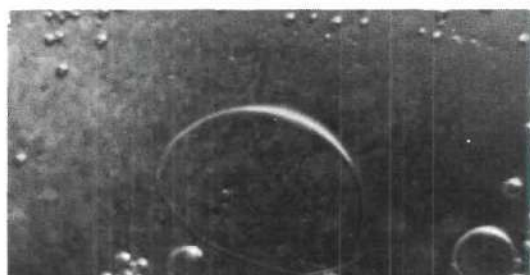
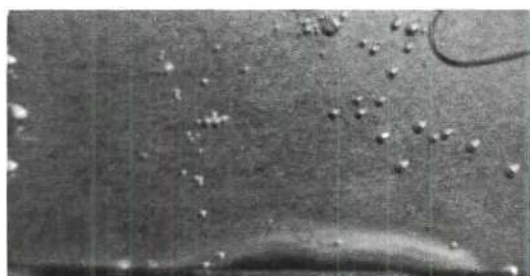
Figure 10. Corroding Crevice Electrodes after
Twelve Hours of Exposure.

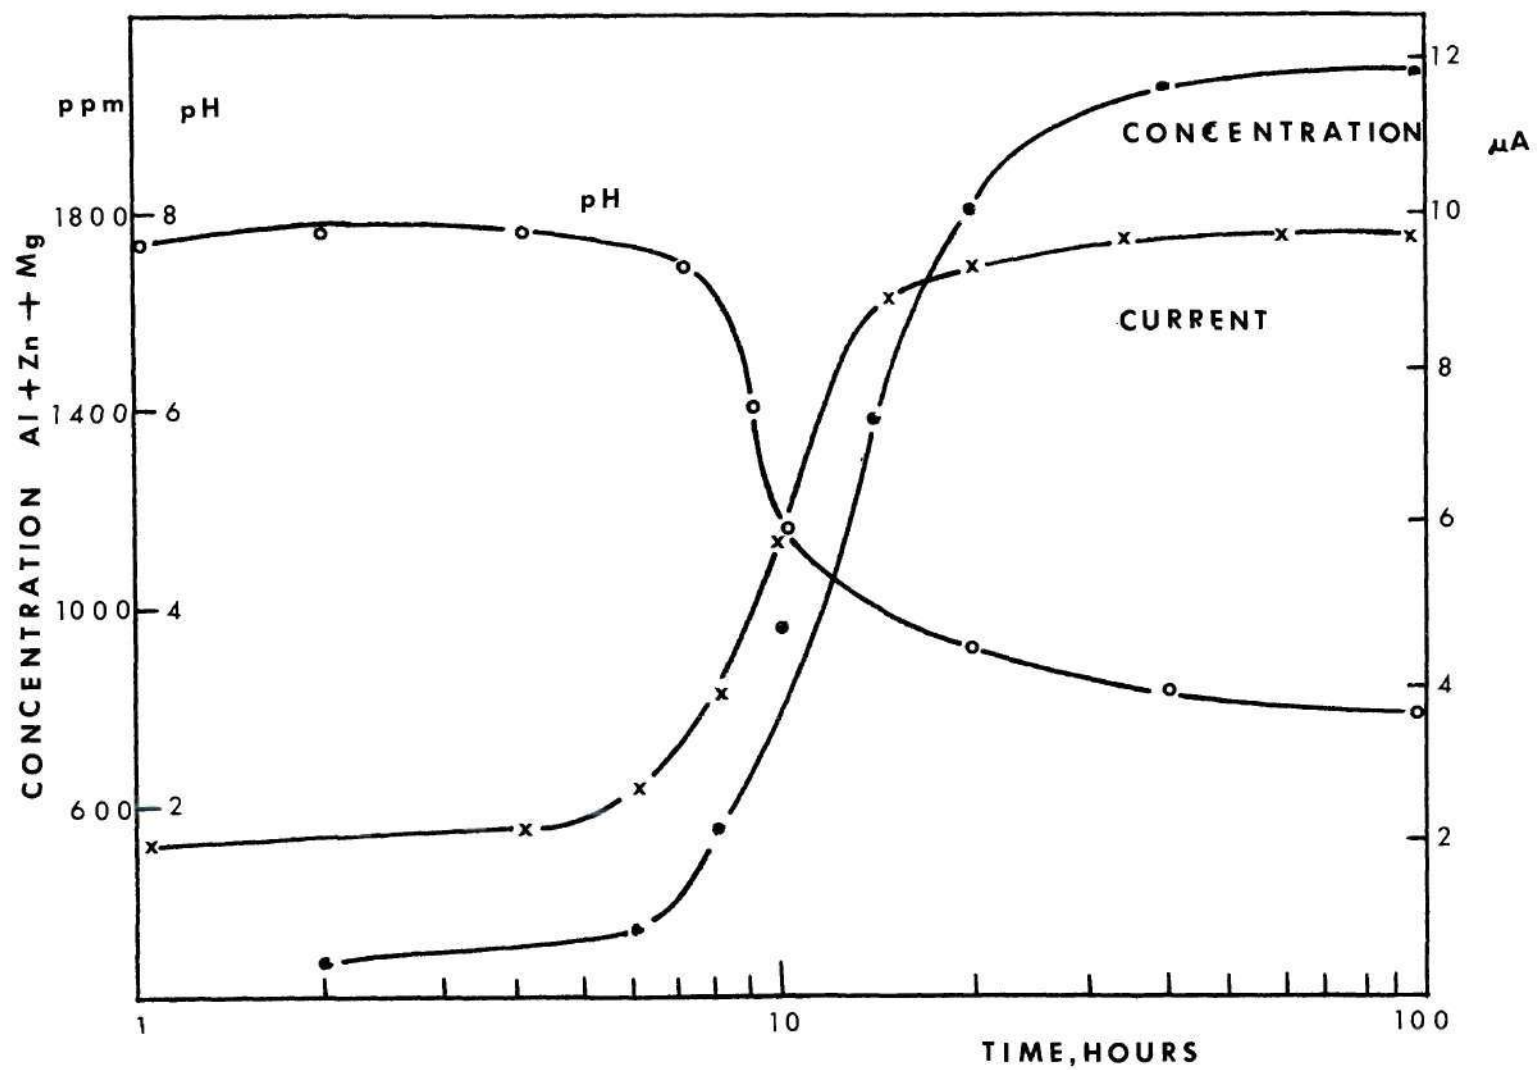
Figure 11. Results of Current and Solution Chemistry Measurements on a Crevice in Alloy 76.

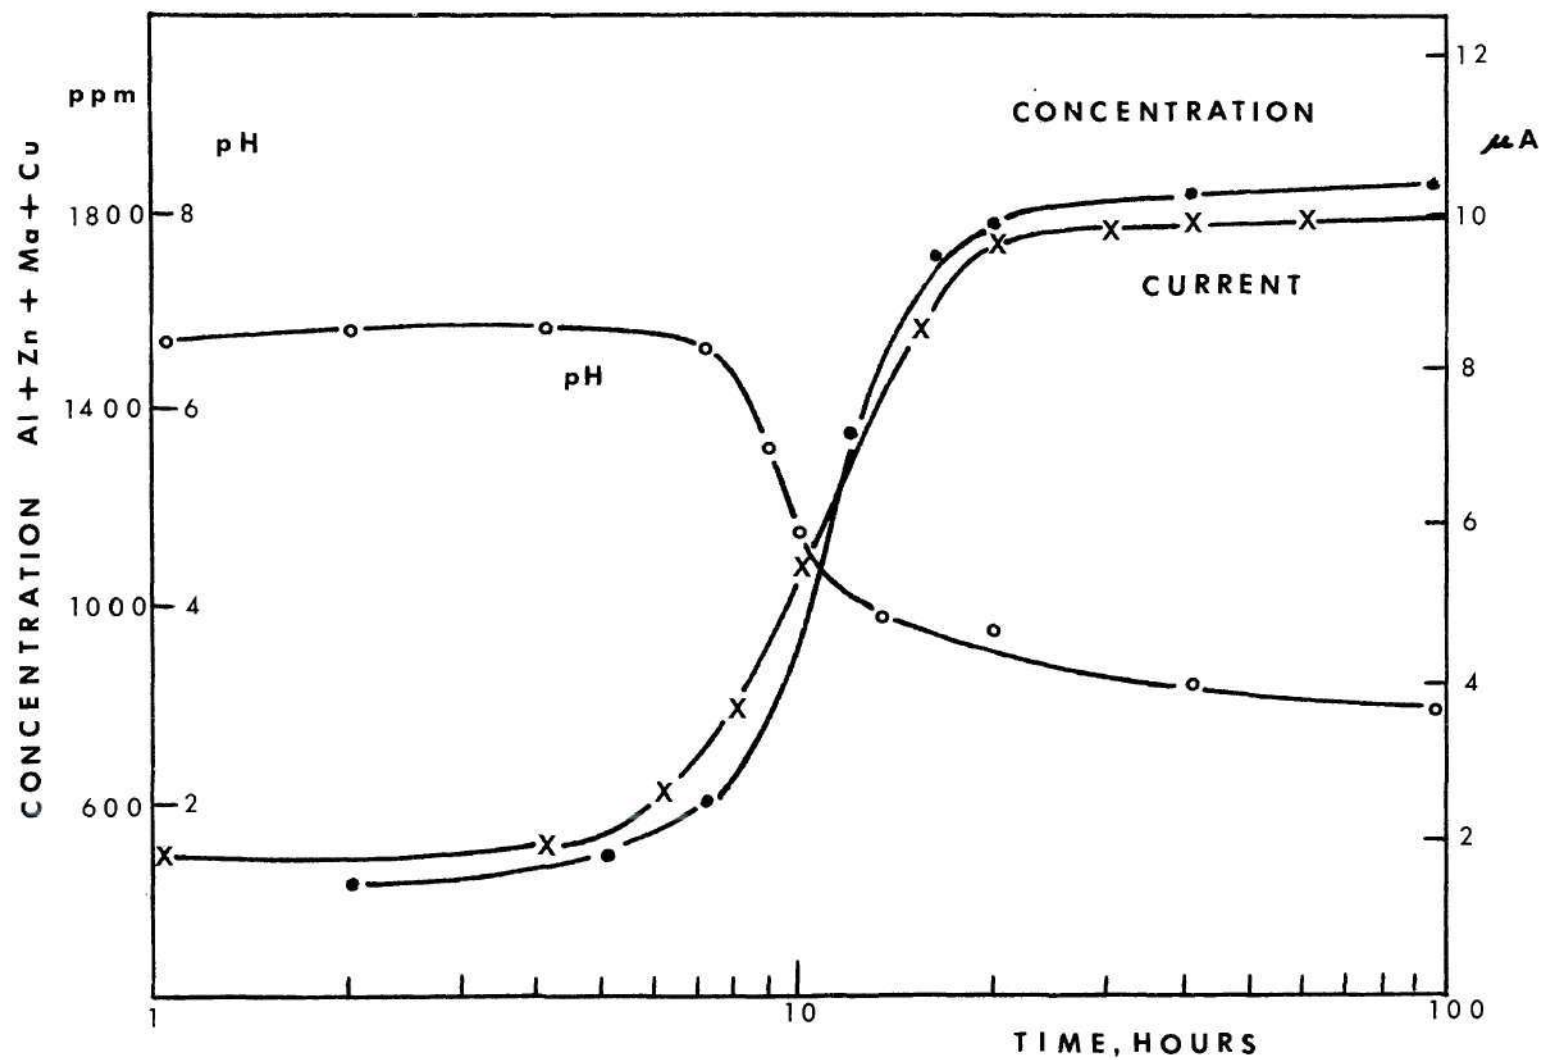
Figure 12. Results of Current and Solution Chemistry Measurements on a Crevice in Alloy 77.

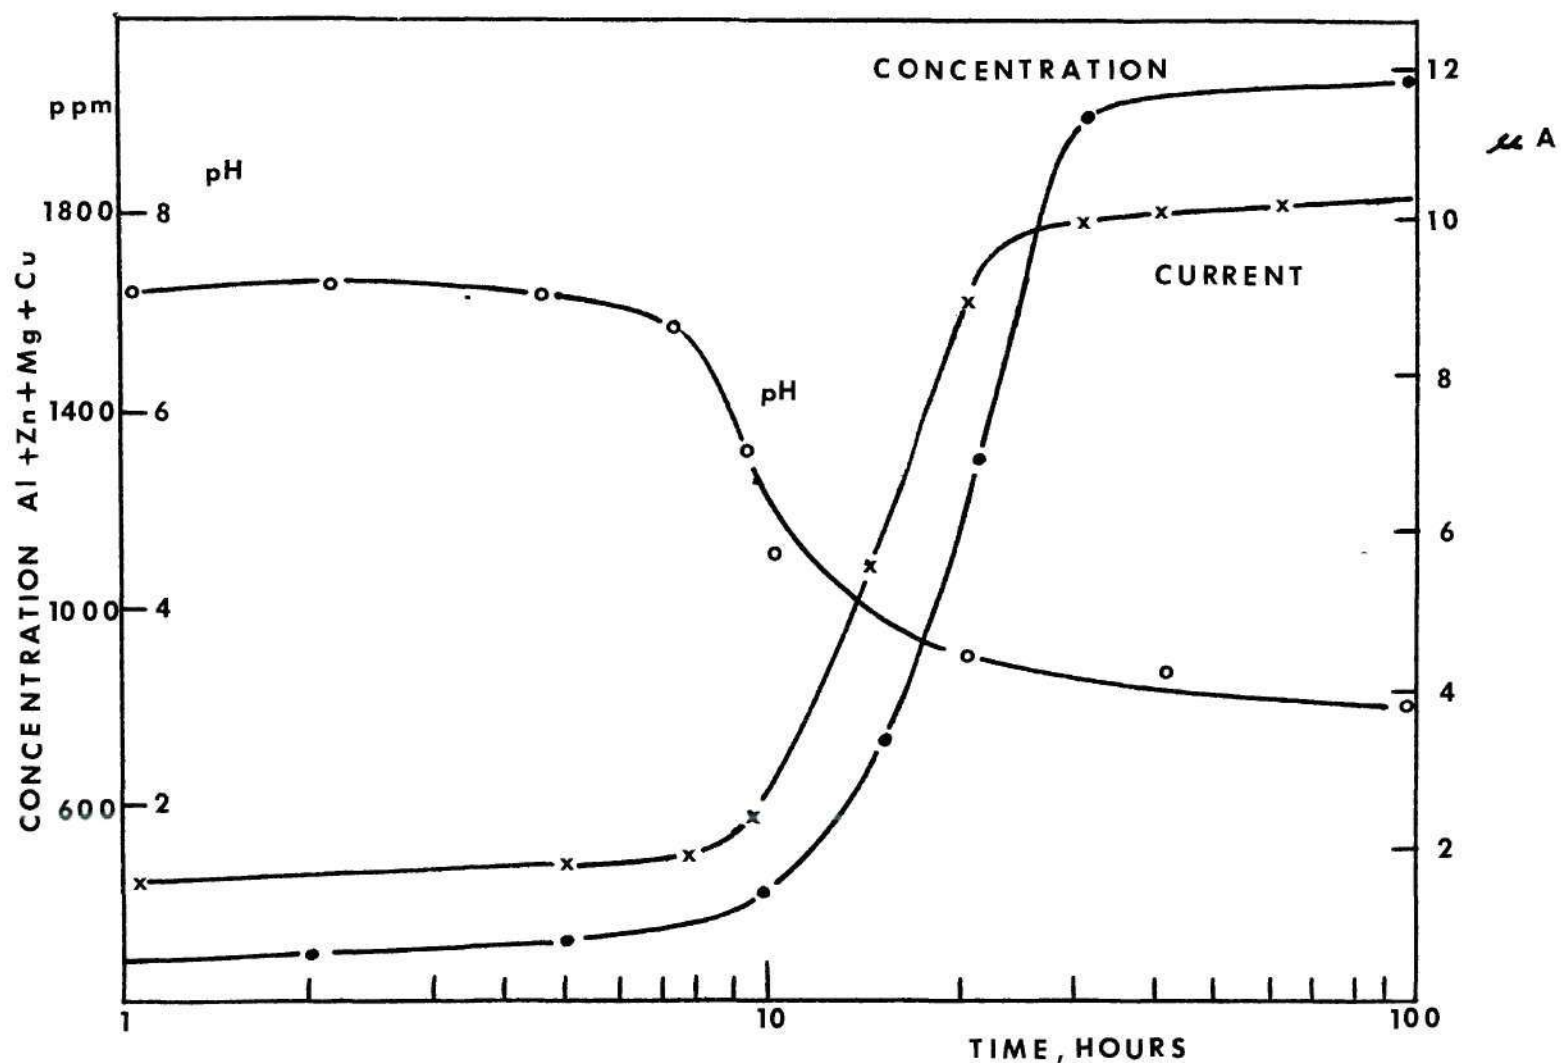
Figure 13. Results of Current and Solution Chemistry Measurements on a crevice in Alloy 7050.

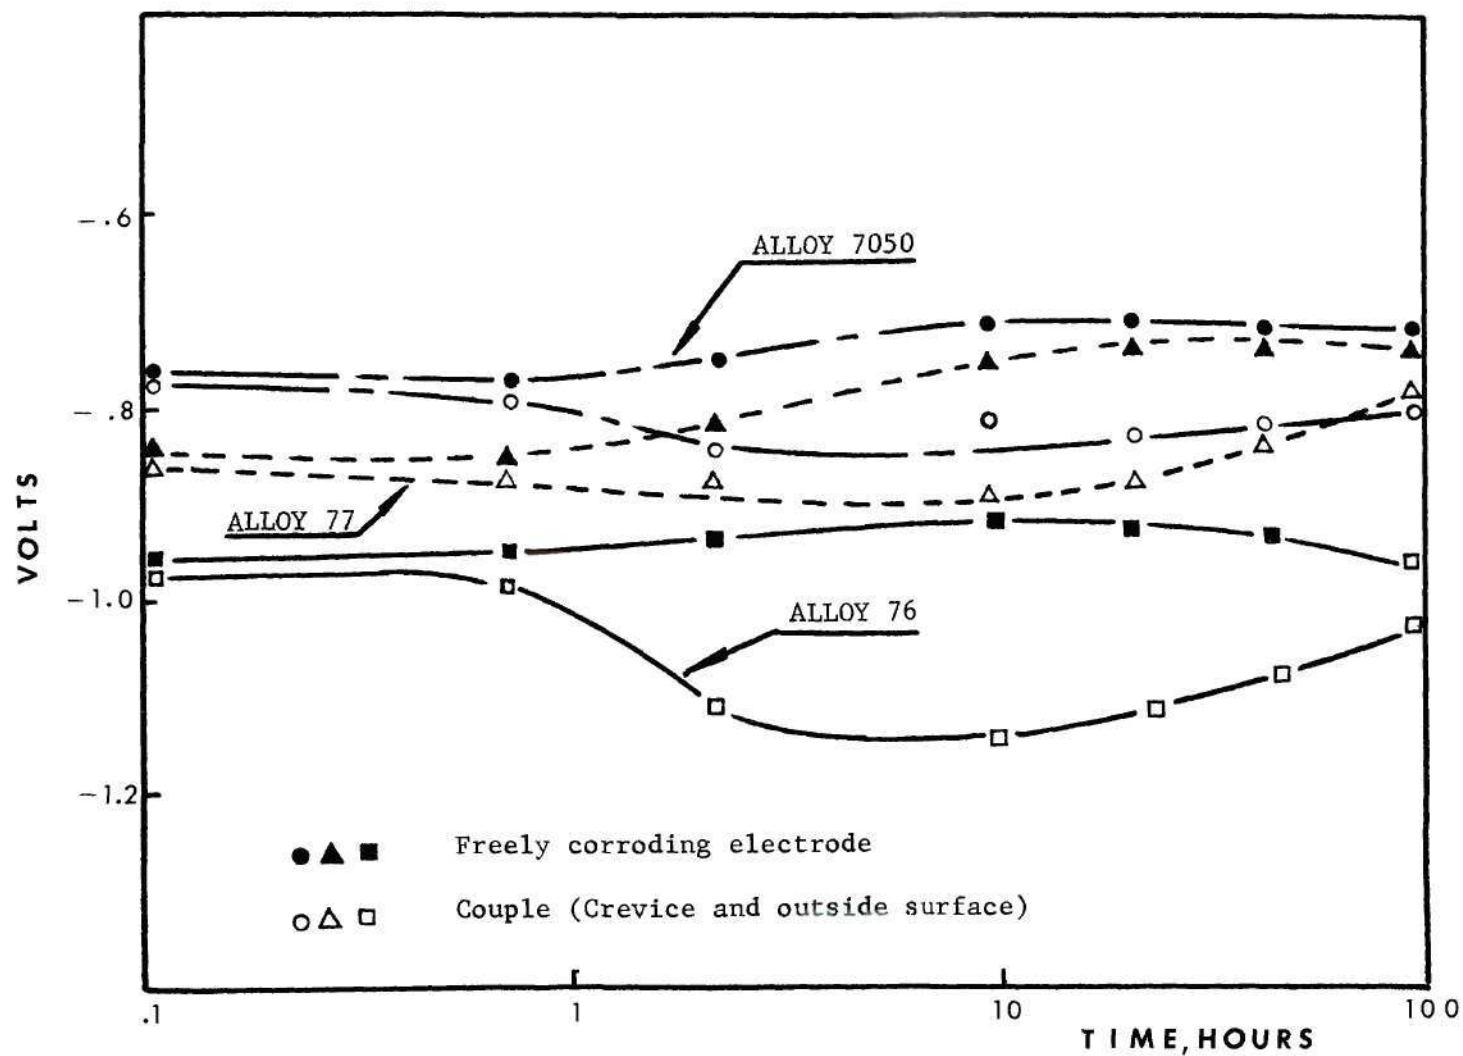
Figure 14. Corrosion Potential of Freely Corroding Samples of Alloys 76, 77, and 7050, and of Crevice Couples, in Aerated 3.5% NaCl.

Electrode potential data are shown in Figure 14 as plots of potential versus time for crevice couples (mixed potentials) and freely corroding samples. In each case, the mixed corrosion potential of the crevice couple was more negative than the potential of the freely corroding single electrode. The highest difference between the potentials (crevice couple versus single electrode) developed at the end of the transition period. With increasing copper content the potentials were more noble, and the differences between the crevice couple and the single electrode decreased. The main parameters are summarized in Table 4.

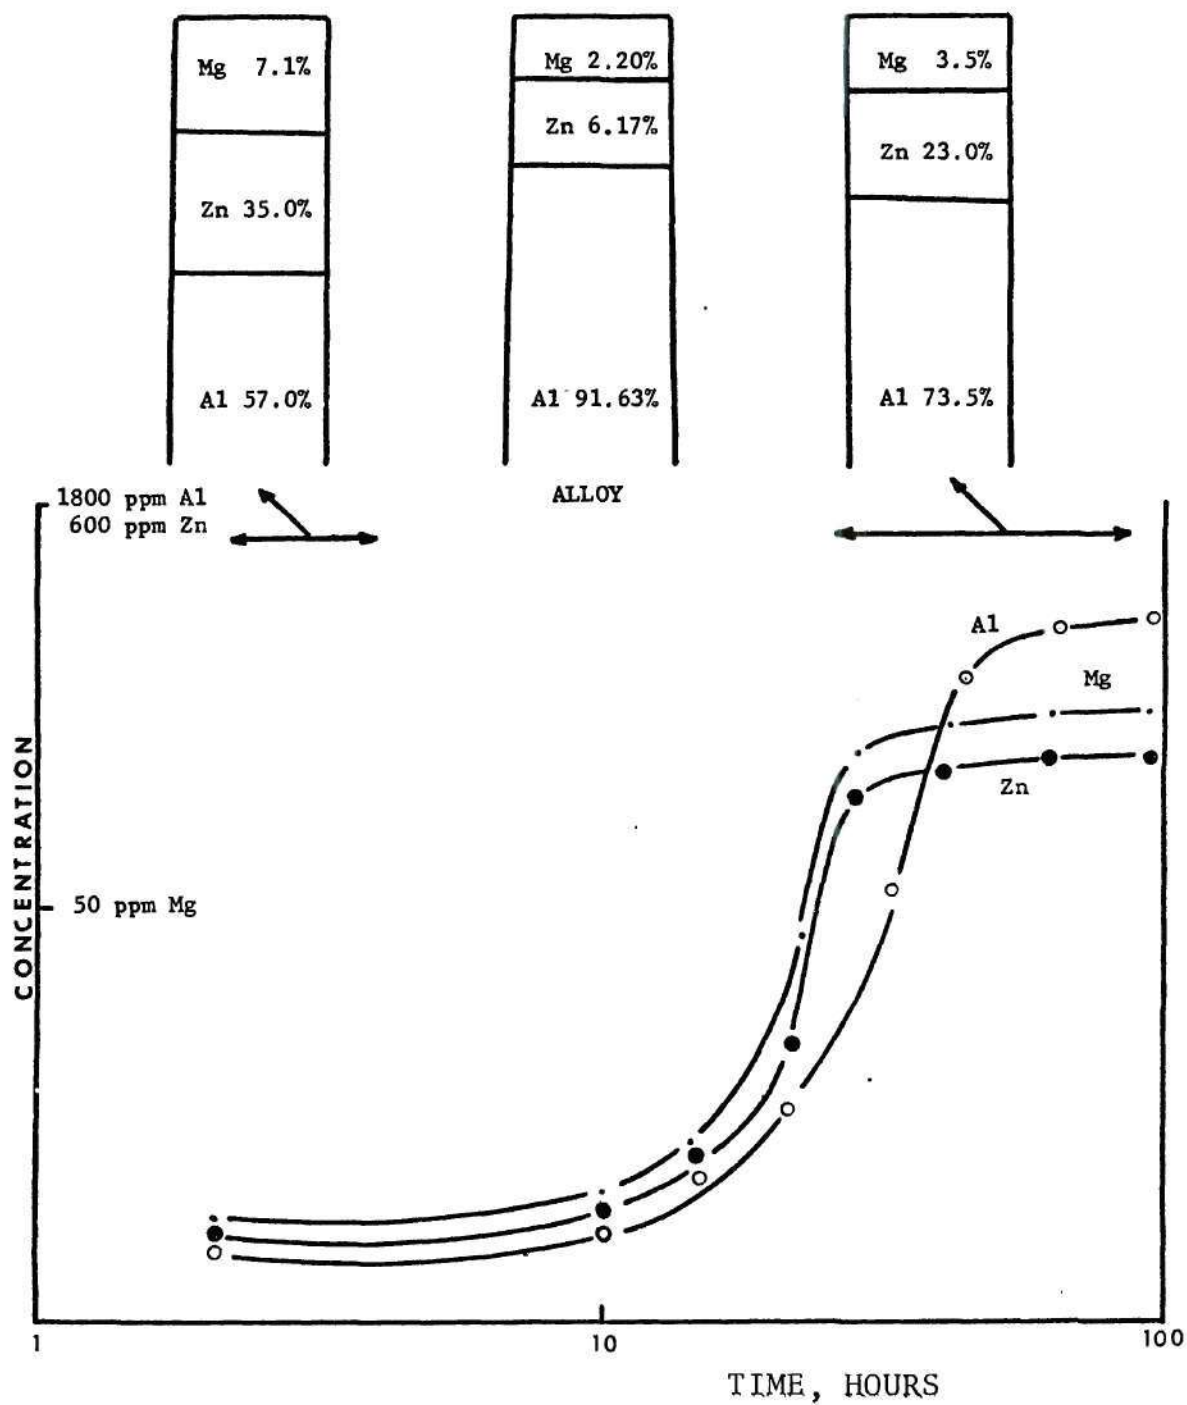
Figure 15. Concentration of Aluminum and Alloying Elements in the Crevice Solution of Alloy 76 as a Function of Time.

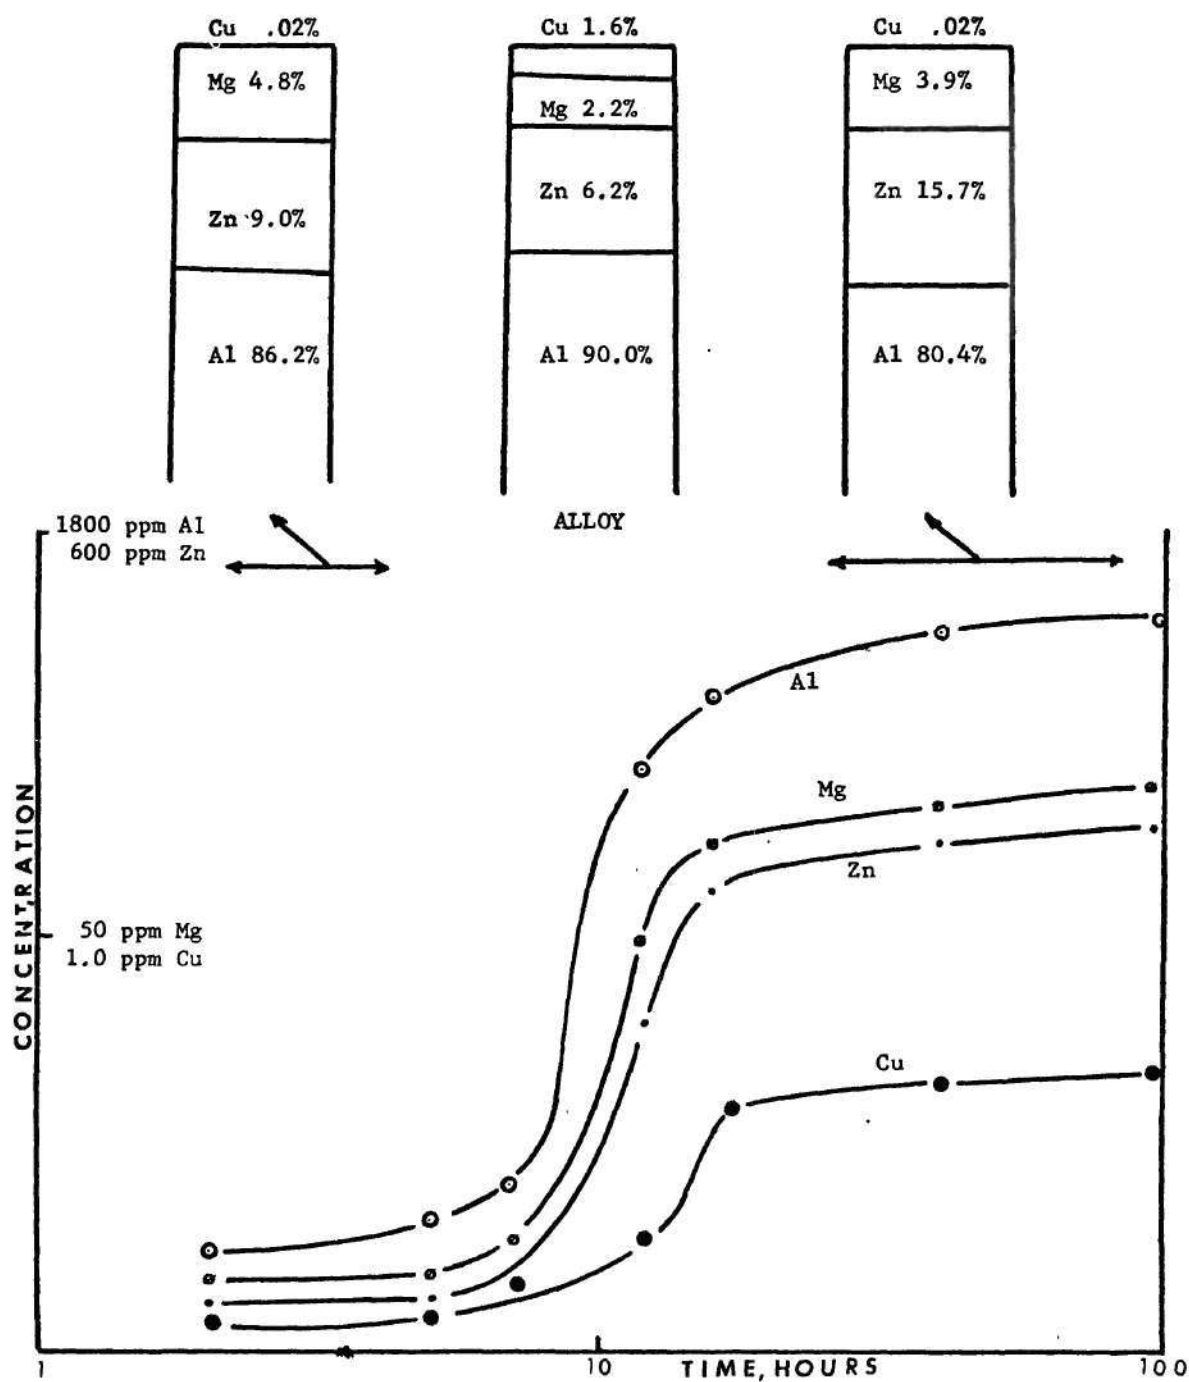
Figure 16. Concentration of Aluminum and Alloying Elements in the Crevice Solution of Alloy 77 as a Function of Time.

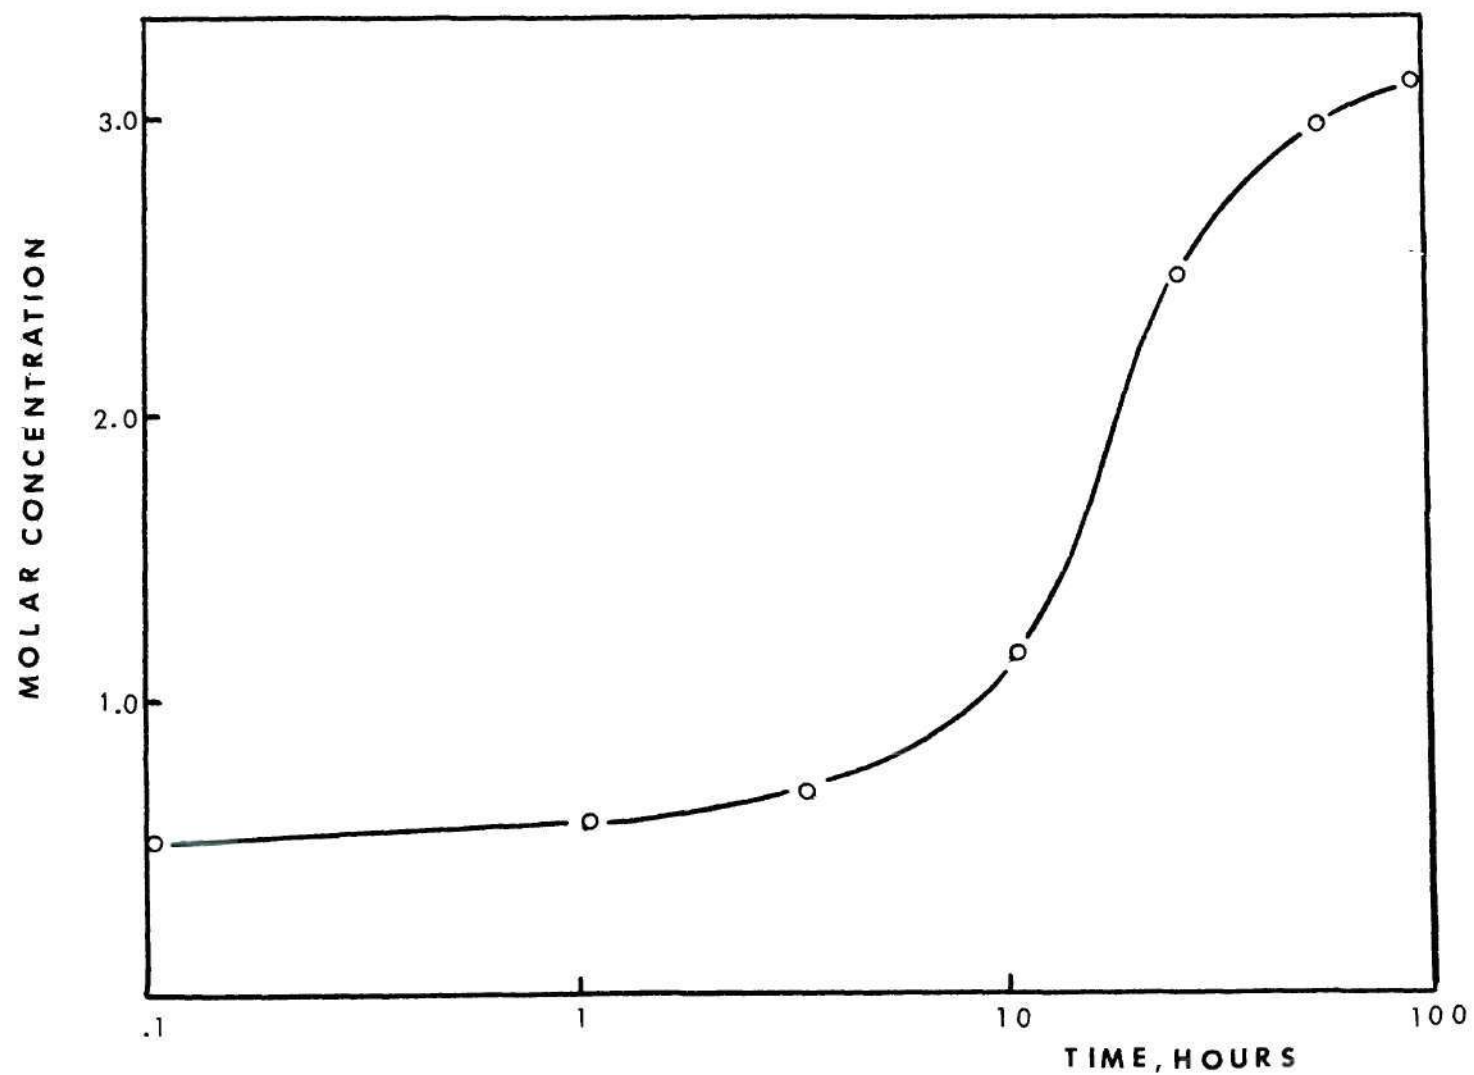
Figure 18. Chloride Ion Concentration in the Crevice Solution on Alloy 76.
