CREVICE CORROSION IN ALUMINUM ALLOYS

A THESIS

Georgia Institute of Technology

June, 1976

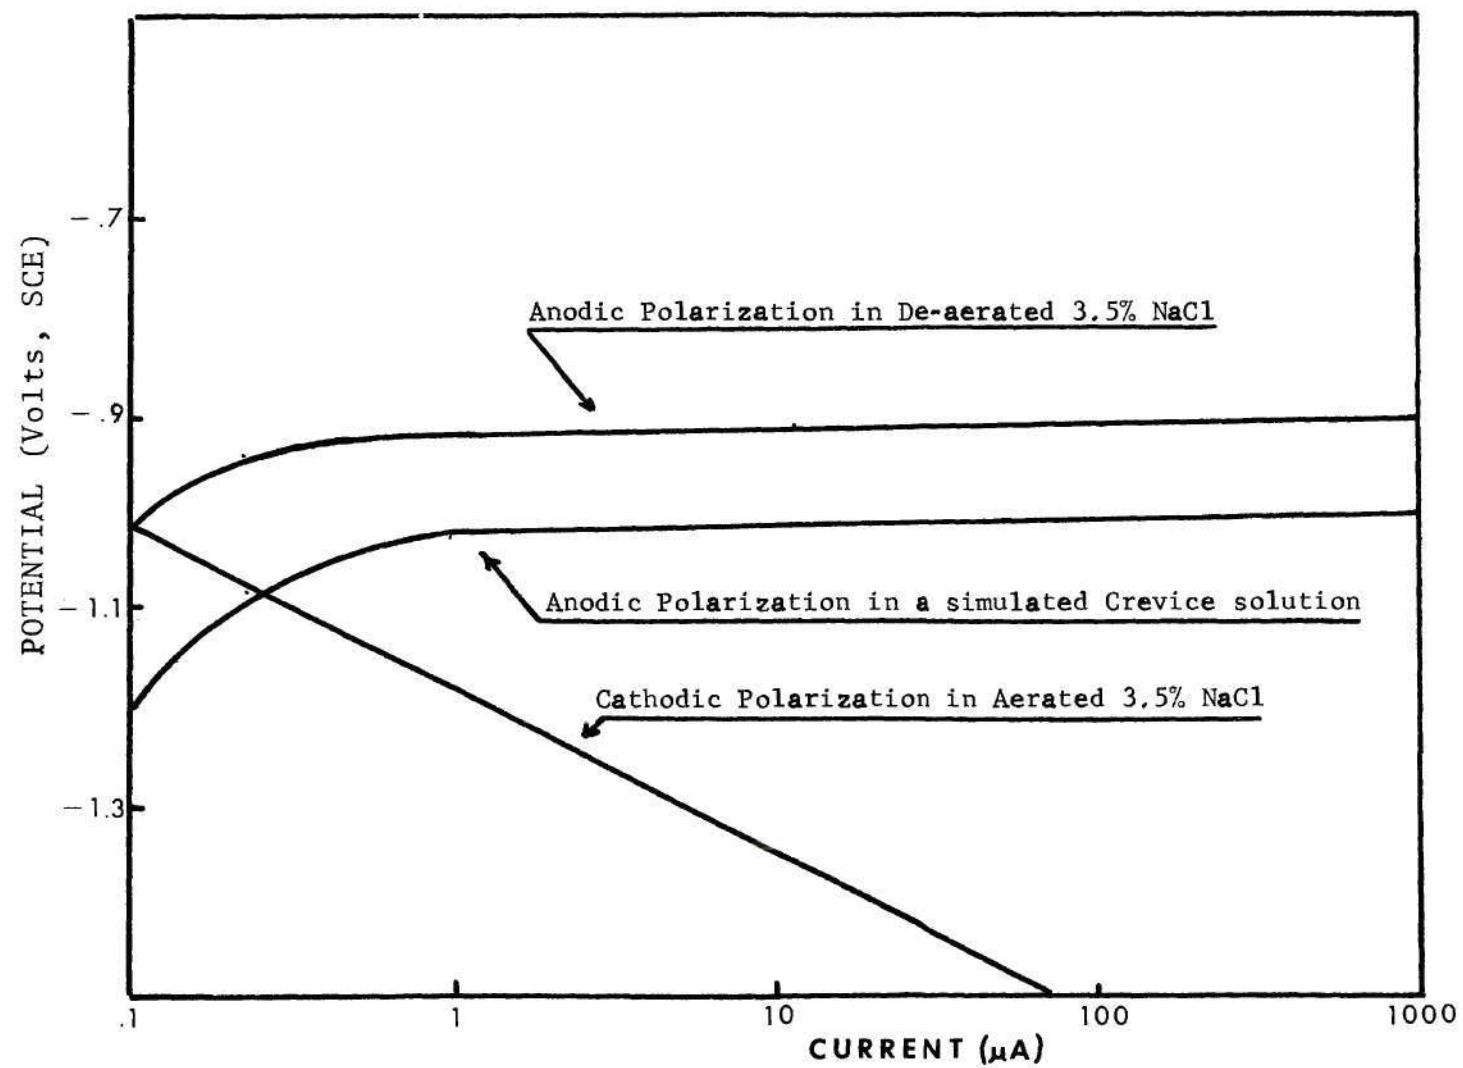
Figure 19. Polarization Curves of Alloy 76.

The results of the polarization measurements are shown in Figures 19, 20, and 21 for alloys 76, 77, and 7050, respectively. Each graph shows the anodic and cathodic polarization curves in nearly neutral 3.5% NaCl (aerated for cathodic polarization and deaerated for anodic polarization), and anodic polarization curves in solution simulating the crevice solution after 100 hours of exposure. In the neutral solution the ternary alloy showed active anodic behavior, while the polarization curves of the copper containing alloys exhibited active-passive transitions; the alloy 7050 with highest copper content showed a more extensive passive region than the alloy 77. The cathodic current densities were substantially lower on the ternary alloy than on the alloys

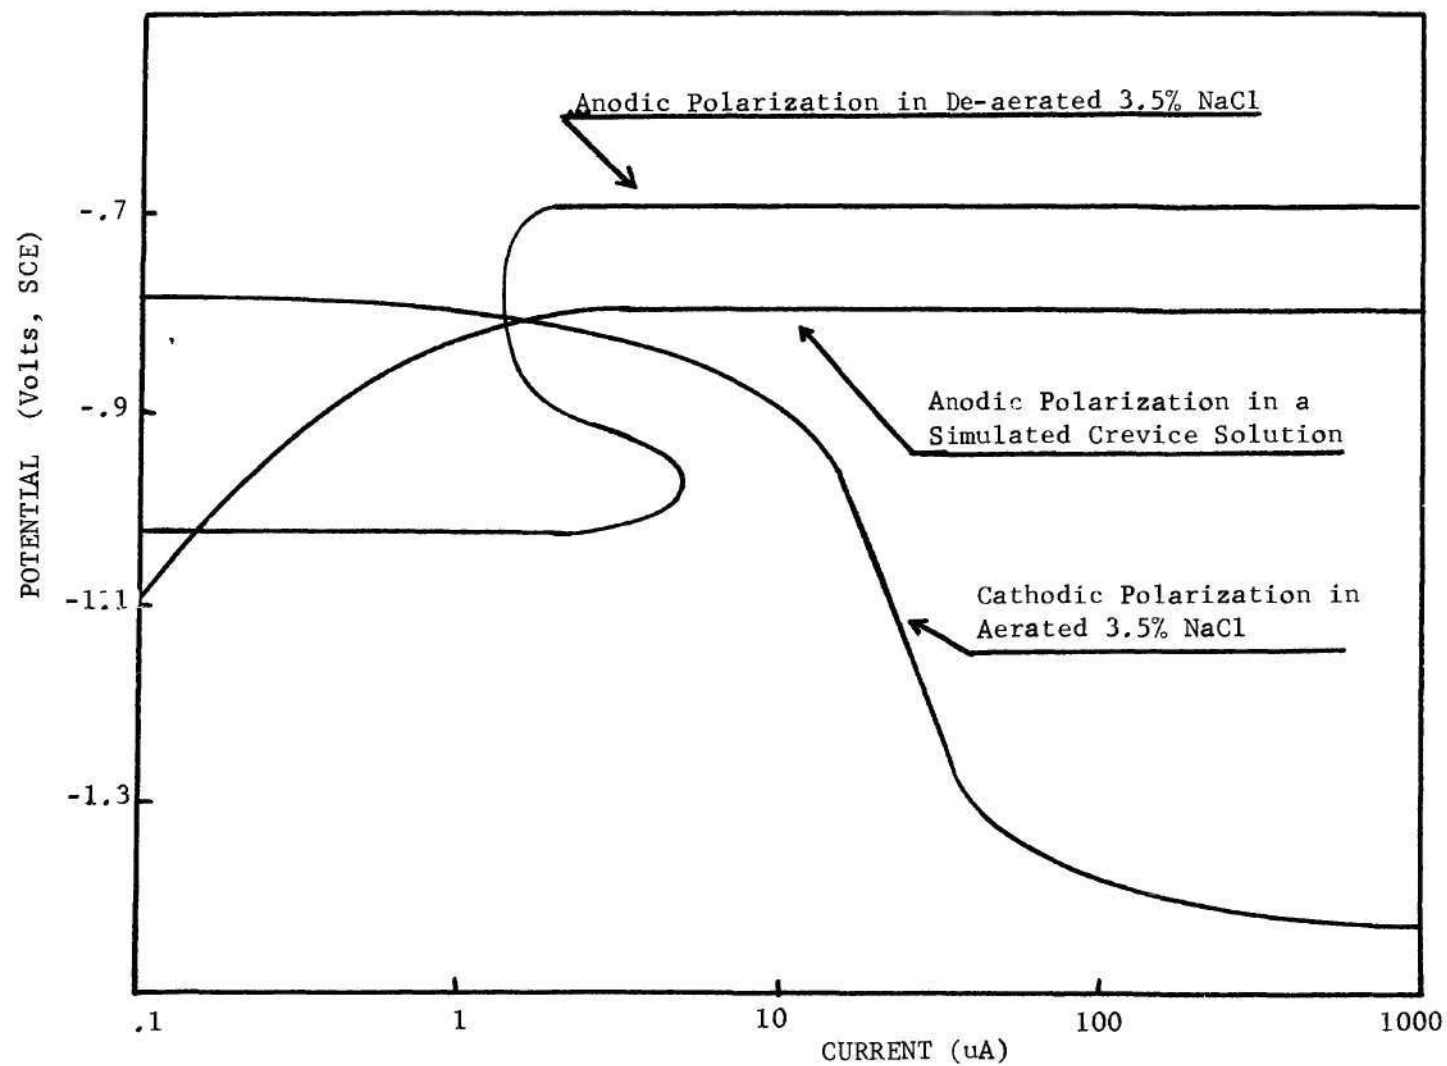
Figure 20. Polarization Curves of Alloy 77.

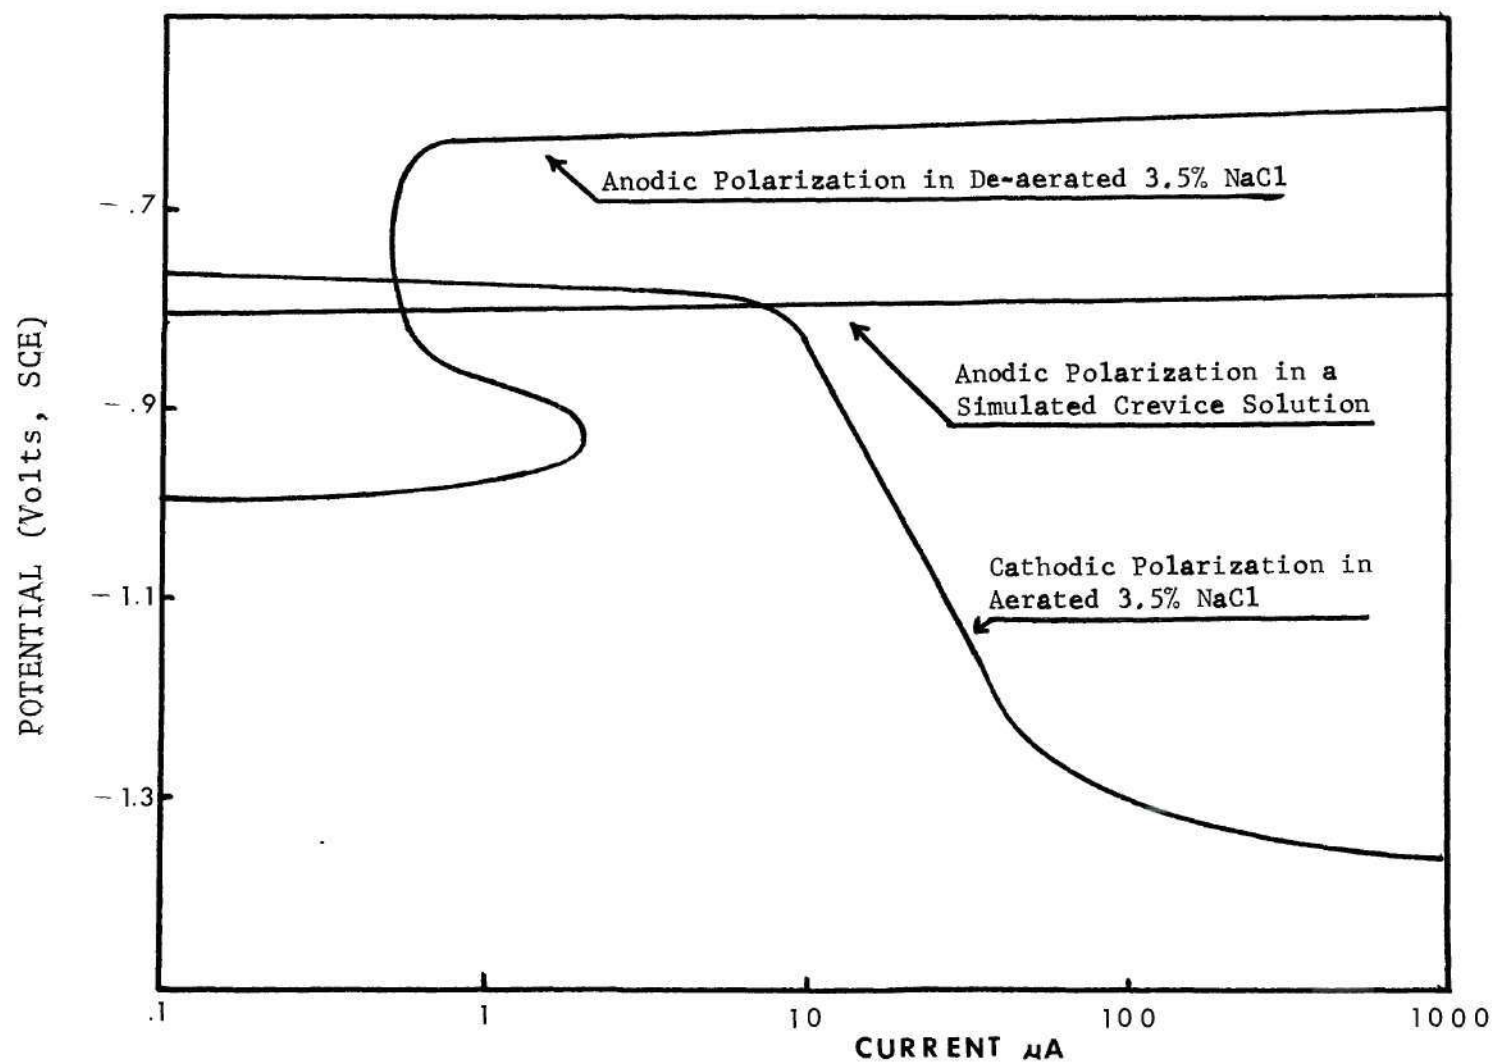
Figure 21. Polarization Curves of Alloy 7050.

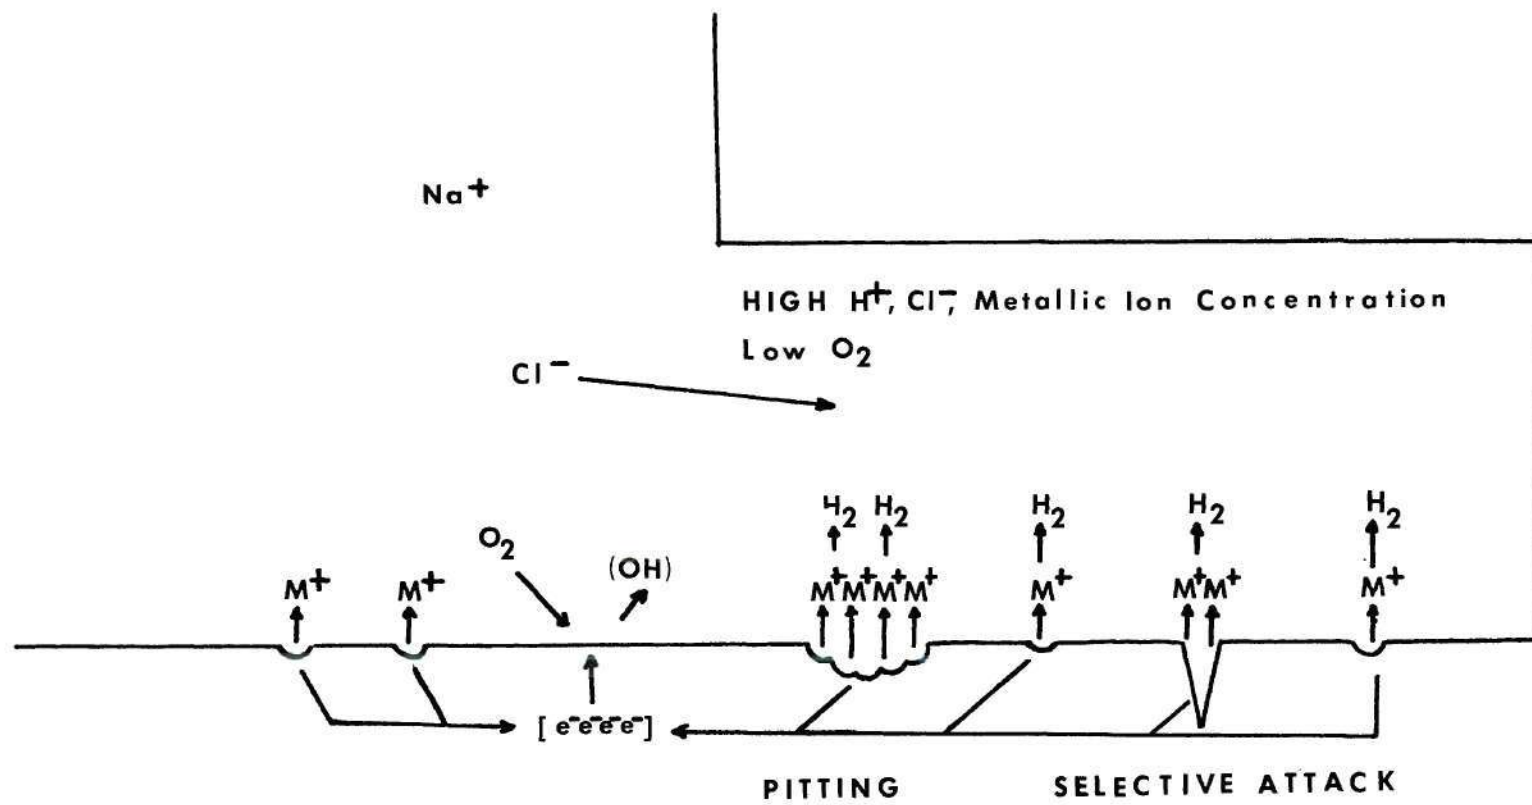
1. After initial immersion in 3.5% NaCl, micro-cells are set up on surfaces both outside and within the crevice. Galvanic current is near zero, corrosion potential is the same as the free corrosion potential, the metal ion concentration and pH are that of the bulk solution.

2. General corrosion takes place; products of corrosion are $(OH)^-$ for oxygen reduction (cathodic reaction) and metallic ions (Al^{3+}) (anodic reaction). The formation of $(OH)^-$ results in a pH increase in the crevice. The change of pH stops when the oxygen in the crevice solution is depleted.

4. Chloride ions move into the crevice.

5. High acidity and high chloride content of the solution result in the destruction of the protective film. Highly anodic regions, grain boundaries and $MgZn_2$ precipitates are attacked preferentially. On the external surfaces corrosion continues at a slightly reduced rate.

Figure 22. Crevice Corrosion Model for Al-Mg-Zn Type Alloys Based on the Fontana and Greene Model.

6. As the acidity increases, hydrogen reduction begins to take place ($H^+ + e^- \rightarrow 1/2H_2$). Higher acidity probably develops in pits and in other sites of localized attack (e.g. at the grain boundaries) resulting in hydrogen evolution from specific points.

7. Hydrogen reduction and interdiffusion stabilizes the pH, and hydrogen gas begins to displace the crevice solution. The galvanic current peaks and starts to decrease as the effective surface area is reduced by gas. The crevice corrosion process slows down; localized corrosion continues on the outside surface.

sequence of events is suggested for the crevice corrosion process in alloys studied in this work (Figure 22).
