# HISTORIC STRUCTURE REPORT

## RICH COMPUTER CENTER

**GEORGIA INSTITUTE OF TECHNOLOGY**

October 12, 2021

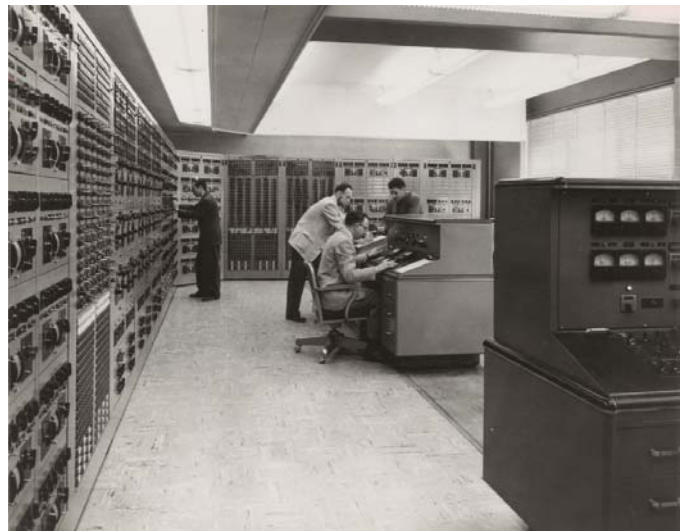
Figure 3: Westinghouse A. C. Power Network Calculator in Phillips Hall, ca. 1955 Cornell University College of Engineering photographs, #16-2-2378. Division of Rare and Manuscript Collections, Cornell University Library.

To house the massive new machine, with several components large enough to fill a 32-foot by 16-foot room [Figure 3], a new air-conditioned building was required. Ground was broken for the Calculator Building, designed by Bush-Brown, Gailey, & Heffernan in August of 1946. The new building was built at a cost of \$168,000.<sup>5</sup> The Calculator Building, and the calculator it housed, went into service in November of 1947. The Westinghouse machine was in operation through the late 1960s.

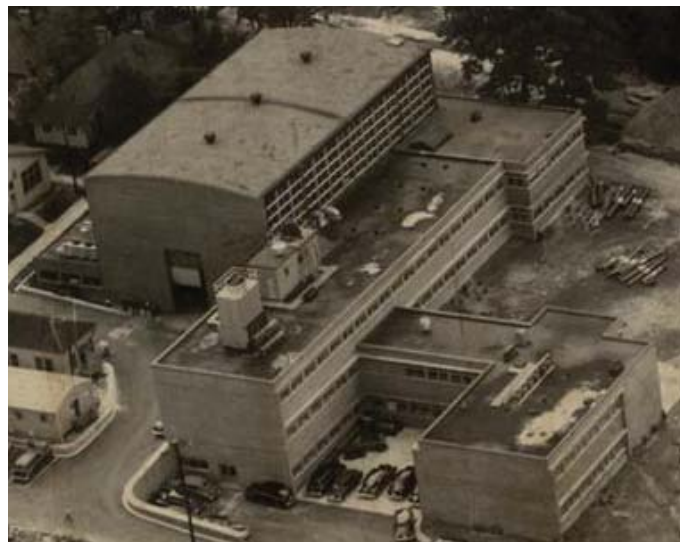
Figure 5: Aerial view of the Hinman “High-bay” building (top left), the 1951 connector (center), and the Calculator Building (lower right), circa 1951.

In 1951, an addition to the Research Building was completed. It was also designed by Bush-Brown, Gailey, Heffernan, and with R. L. Aeck, associate. Called the Hinman Connector, it connected the Hinman building to the Calculator Building [Figure 5].

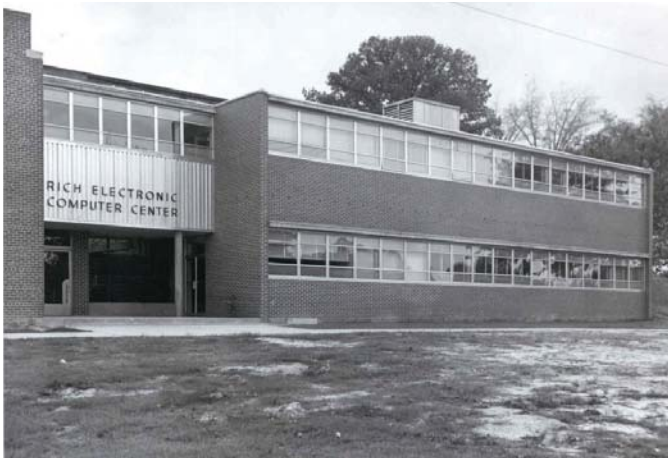
Figure 6: Rich Electronic Computer Center, circa 1955. Courtesy of Georgia Tech archives. Note the round concrete columns at the covered entry and second floor corridor.

The Rich building retains the round concrete columns that once featured prominently on the north elevation’s original two-story setback [Figure 6]. One can be seen in a mechanical room on the second floor. The others are hidden in walls.

- Rich Building West Entry [Figure 14]
- Rich Building Concrete Columns [Figure 6]
- Rich and Calculator Stairs [Figure 17]
- Rich and Calculator Exteriors [Figure 12, Figure 13]
- Rich and Calculator Landing [Figure 15]
- Rich and Calculator Historic Floor Plans

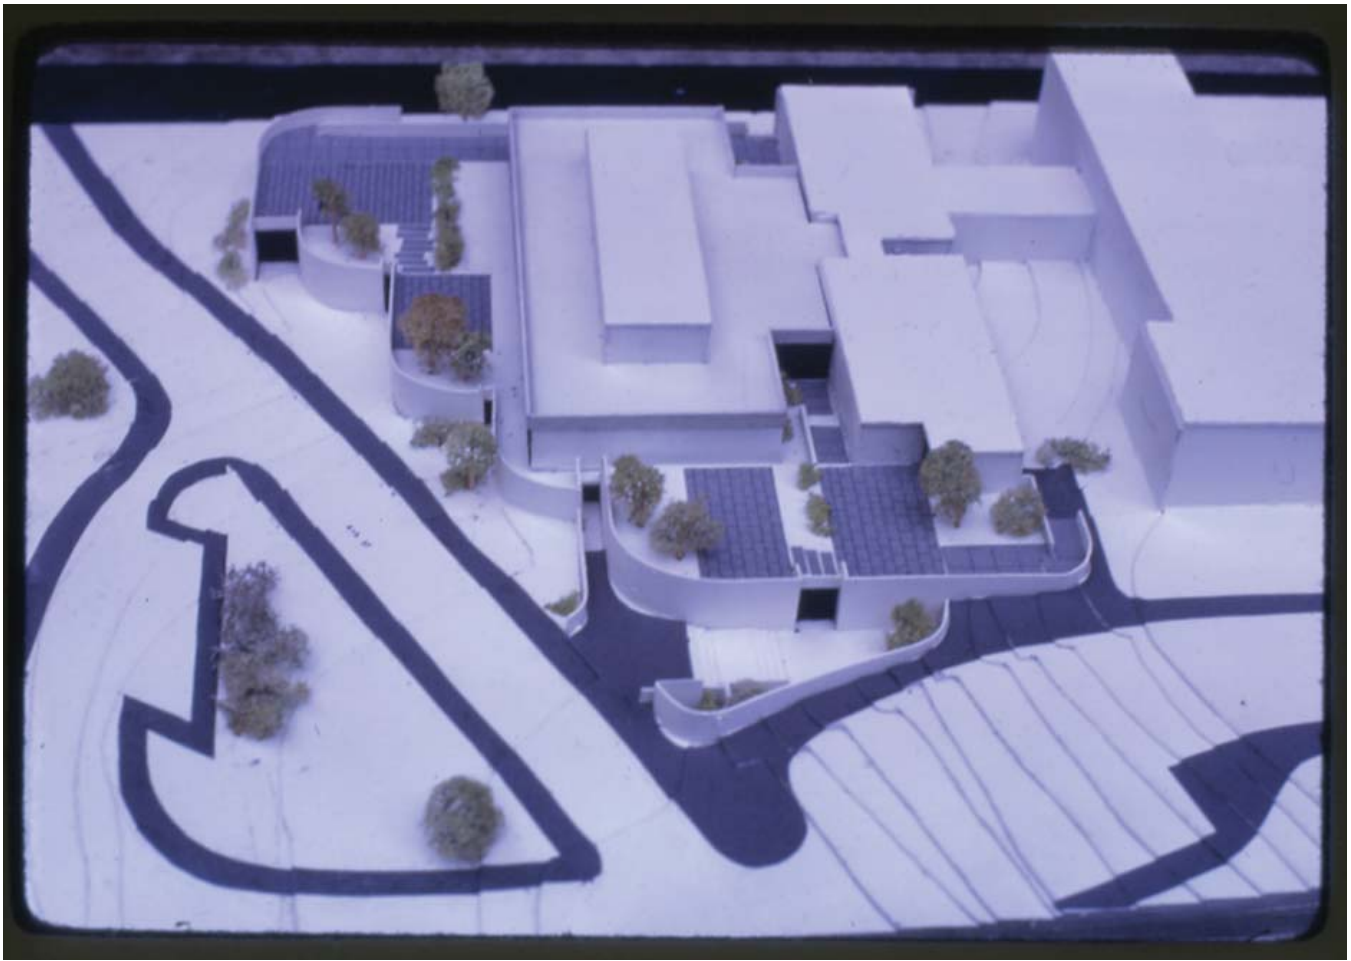
Figure 9: Model of the new Rich Computer Center, c. 1969. Georgia Tech archives.

Between 1963 and 1965, the National Science Foundation (NSF) awarded \$1.5 million to Georgia Tech to establish an Information Science Research Center as part of a new national program to develop university “research centers of excellence.”<sup>9</sup> The Information Science program, and later Information and Computer Science, was the precursor to the College of Computing. Continued NSF funding and the success of Georgia Tech’s research initiatives led to the construction of a new Rich Computer Center in 1971, designed by Cooper Carry and Associates beginning in 1967 [Figure 9].

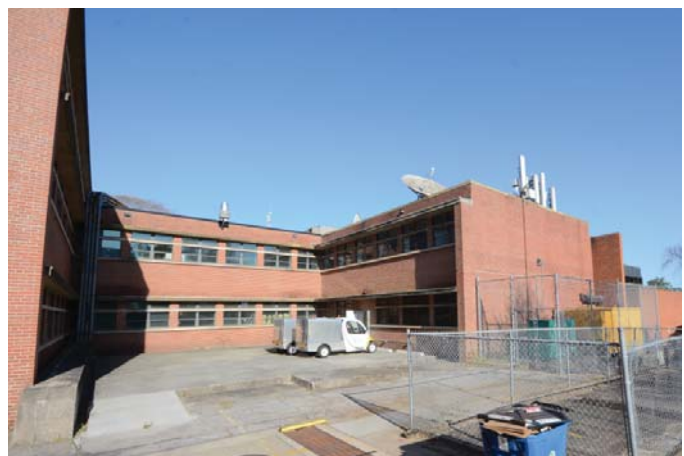
Figure 11: View of Hinman Research building addition wing (center) and Calculator Building (right), looking northwest.

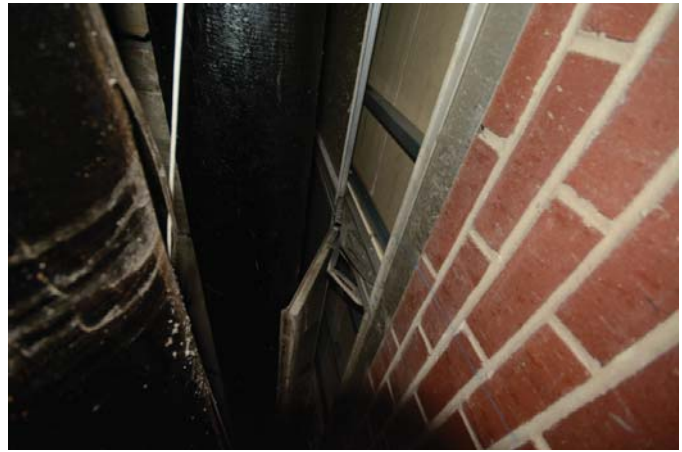
Figure 12: View of Old Rich's windows from a mechanical chase between the building and New Rich.

Original aluminum windows on the north and south elevations of the Rich building are set in continuous bands and are composed of three-part units; a lower awning sash and fixed middle and upper sash. All of these windows are boarded up and hidden behind the 1971 and 1985 construction. An additional fixed window assembly is located on the original west elevation of Rich and is extant and still visible. It is composed of four orthogonal glazed aluminum frames in a Mondrian panel [Figure 14]. Below this window assembly is a concrete canopy and glass and aluminum entry (described below).

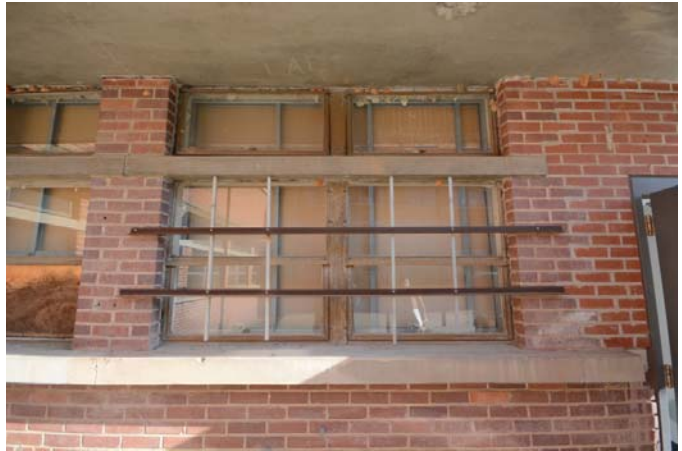
Figure 13: Calculator Building ground floor windows, south elevation, boarded up from the interior.

Exposed, original steel windows on the Calculator building are rusting and do not appear to be regularly serviced.

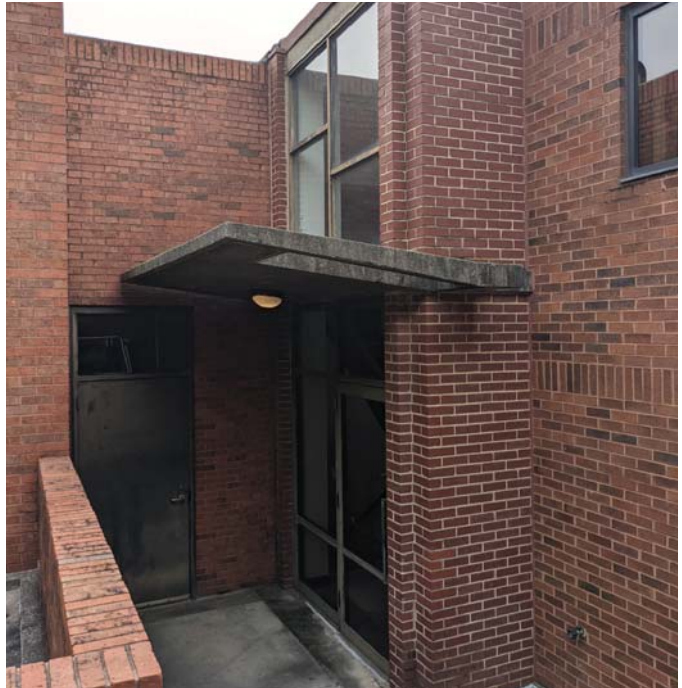
Only one original door assembly remains and it is located on the original west elevation of the Rich building. The aluminum and glass door, full-size sidelight, and two fixed transom windows are original to the building [Figure 14]. Above the door is an original concrete canopy and aluminum window assembly (described above).

Figure 14: Original entry at west end of Old Rich, retains window and door assembly and concrete canopy.

The original and extant door and window assembly on the west elevation is in stable condition, but does require some maintenance to remove oxidation from

metal components. Glass panes should be replaced as needed.

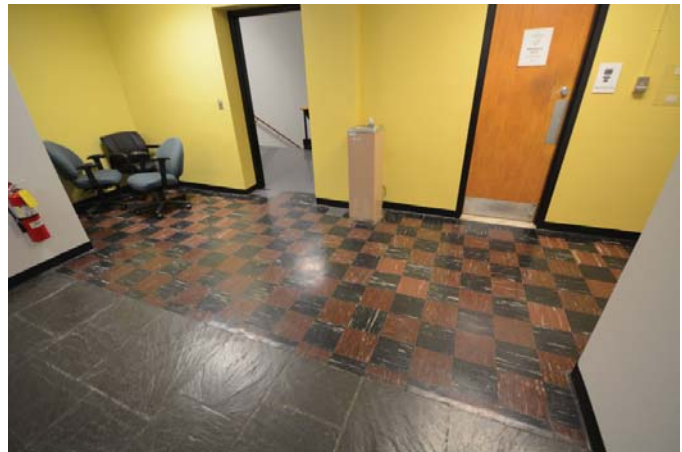
All floors are carpeted with the exception of the landing at the second floor, between Rich and the Calculator Building. This floor retains its original resilient tile in a red and black checkerboard pattern [Figure 15]. It is possible that similar tile, seen in historic images, will be found below carpeting in some areas.

Figure 15: A portion of the original flooring at the second floor landing between Old Rich (left) and the Calculator Building (right).

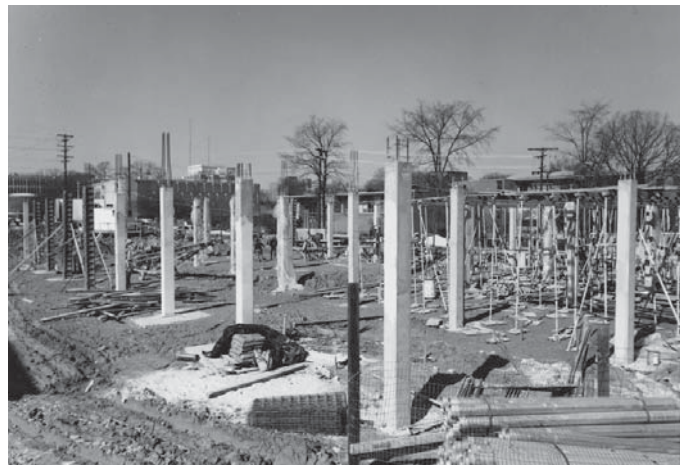
Figure 19: New Rich under construction, c. 1971. Georgia Tech Library, Archives and Special Collections.

Roofing at the terrace level is composed of composite pavers with inset panels of brick unit pavers [Figure 19]. Roofing at the penthouse level is a composite bituminous sheet material.

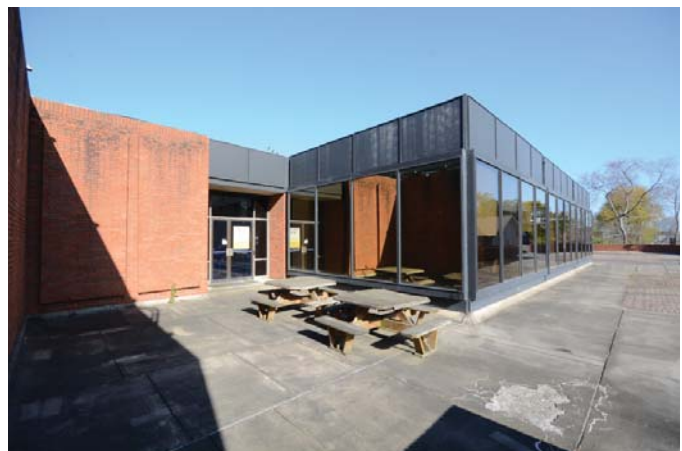
Figure 20: Glass, steel, and brick penthouse level of New Rich.

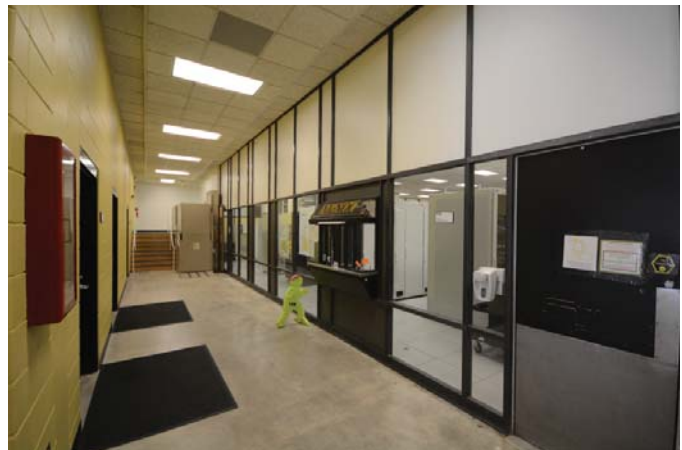
Figure 22: Corridor in New Rich with concrete masonry unit walls on left and glass and steel wall on right.

Most interior walls are composed of painted concrete masonry units in stacked coursing. Overlooking the two large server rooms are glazed and paneled wall assemblies with painted metal grids and opaque transoms [Figure 21].

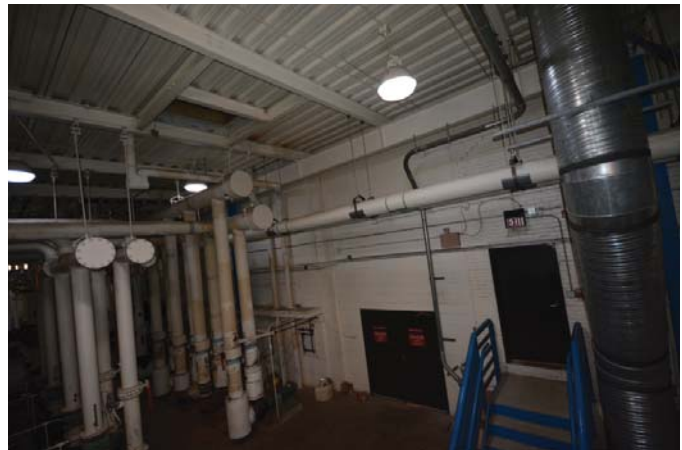
Figure 24: Interior of the Rich Chiller Plant showing exposed, painted structure.

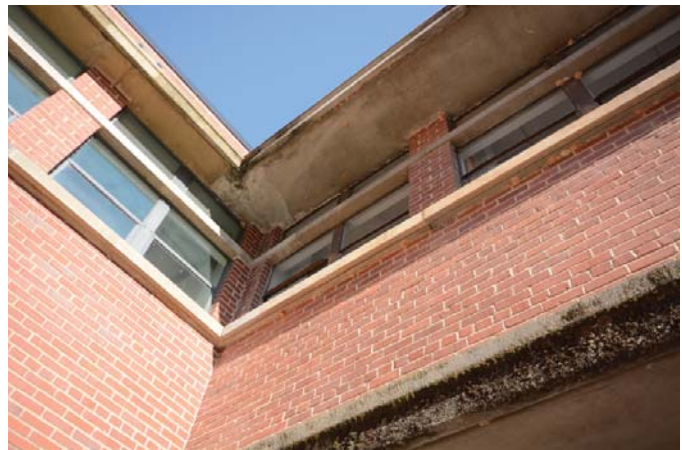
The exterior of the Calculator Building's south elevation (one of the only locations where an exterior wall is exposed) exhibits soiling and staining associated with environmental weathering and unabated water flow [Figure 25]. There is also an abundance of Mud-Dauber Wasp nests on the underside of the concrete canopies and banding. Rain water flow may be mitigated at the parapet by repairing and maintaining flashing and drainage systems.

Figure 25: Stains and insect nests are visible on the exterior surfaces of the Calculator Building.

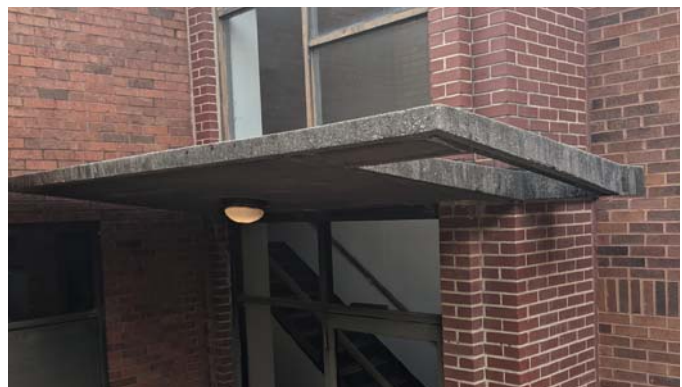
The concrete canopy at the west entrance to Old Rich also is weathered and stained. There is a non-original light fixture in an original receptacle; both are rusted.

Figure 26: Concrete canopy at west entrance to Old Rich.

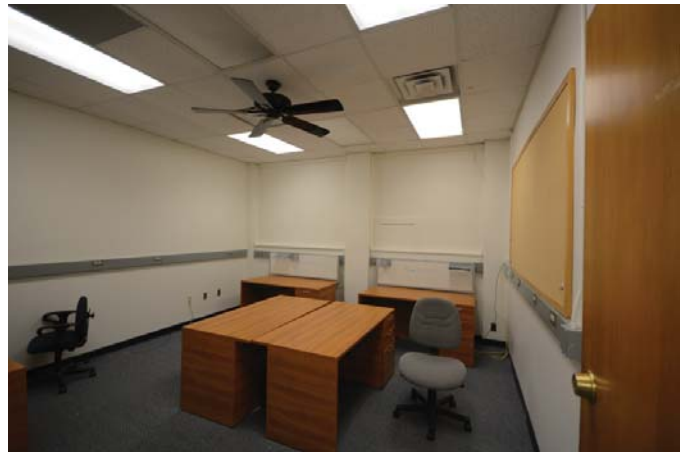
Figure 27: Interior office in the Calculator Building showing typical finishes and conditions. Note the boarded up exterior windows.

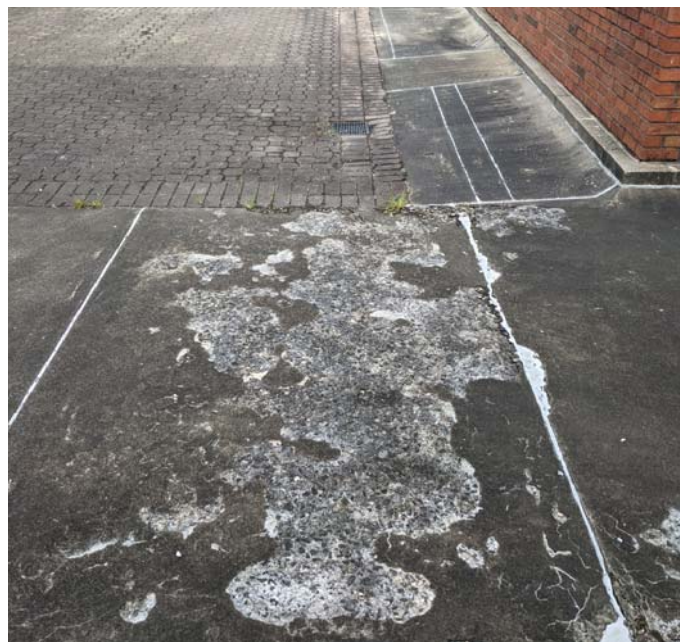
The concrete and brick paver roofing exhibits significant signs of weathering and past remedial activities [Figure 28]. However, no interior signs of water infiltration were observed.

Joints between concrete pavers appear to have been modified by saw-cutting additional joints and in a

Figure 28: 1971 Rich building roof showing spalling concrete and sealant in joints.

majority of joints, a white sealant material has been applied. Vegetation has been allowed to take hold in many areas around the roof and evidence of poor drainage and ponding is abundant.

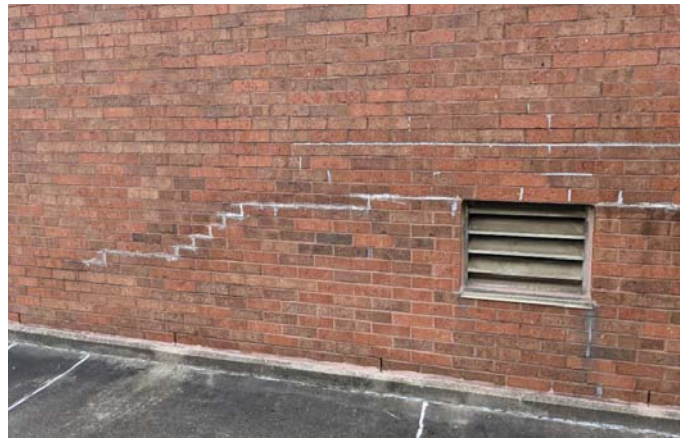
Walls are stable and typically are in need of cleaning. Some evidence of inadequate roof drainage appears as dark staining below parapets and scuppers. In some areas, sealant has been installed into joints, which may inappropriately retain moisture inside the wall in those areas.

Figure 29: 1971 Rich building wall with sealant in mortar joints.

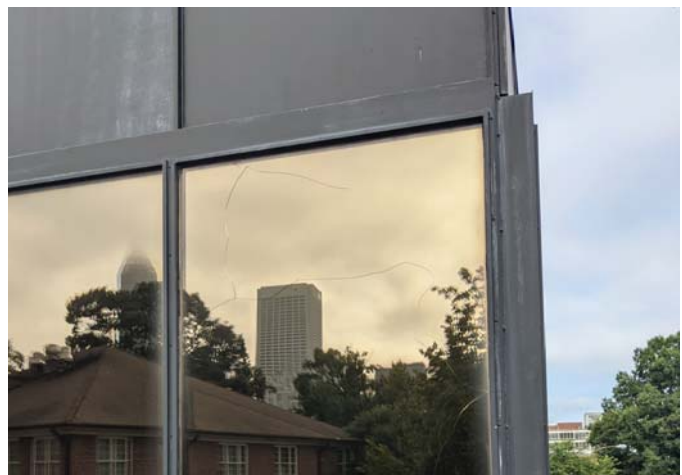
Many windows, especially at the penthouse level, were observed to have internal condensation, indicating failed gaskets - typical of windows of this age. Several panes were also observed to be cracked.

Figure 30: Penthouse windows showing fogging (condensation) and cracks.

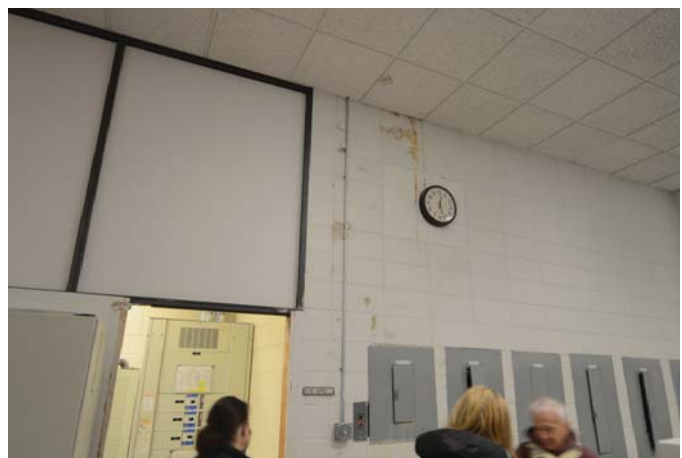
Two locations on the interior were observed to have water staining related to leaking (or condensing) mechanical systems. At one location, a note on the wall above the ceiling reads "Always Leaks". At another location, in one of the main server rooms, the leak is above electrical panels [ ]. Some efflorescing of the concrete masonry units composing the wall was observed.

Figure 31: Water stains are visible on the wall (center) in one of the server rooms.

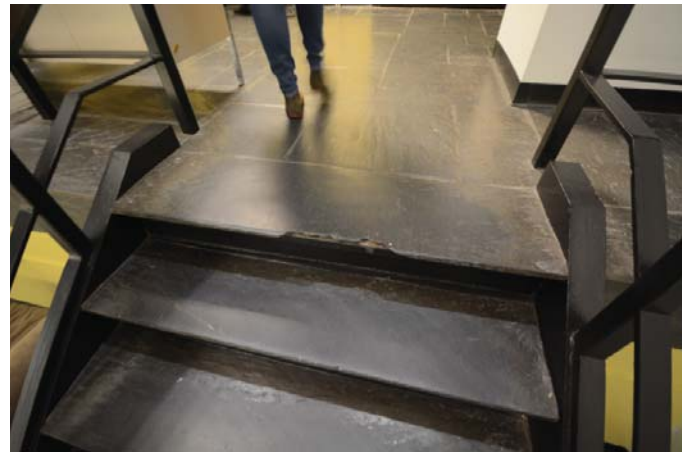
There is minor wear and tear to the slate stair treads where portions of the projecting nosing has chipped and broken [Figure 32].

Figure 32: Chipped nosing on the slate treads in New Rich.

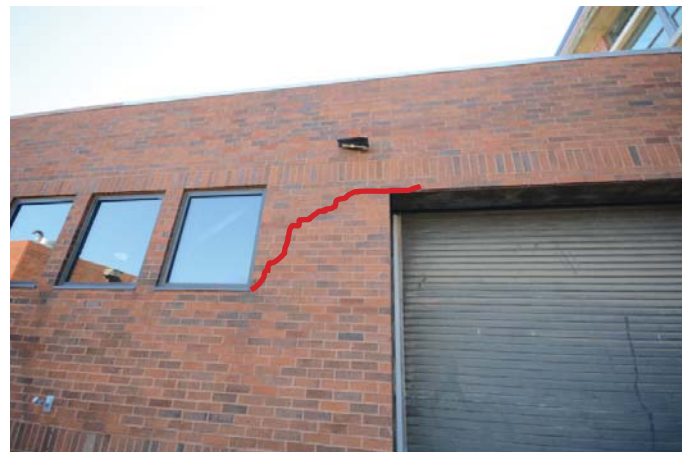
There is a crack in the brick veneer of the west wall of the Rich Chiller Plant. The crack extends from the bottom corner of a window opening to the top corner of the overhead door opening [Figure 33]. The likely cause of the crack is from normal settlement.

Figure 33: A large crack in the veneer (center) extends from the window sill to the corner of the overhead door opening.

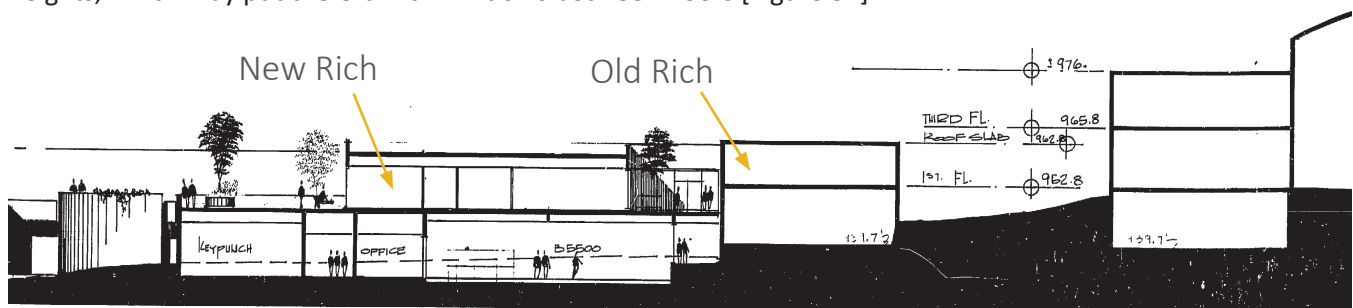
Figure 34: Architects illustration of a proposed cross-section of the New Rich Computer Center that includes cross-sections of Old Rich and Hinman (right). Note that the floor levels between Old Rich and New Rich do not align.

Exposed, original steel windows on the Calculator building are in need of restoration. The windows on the Hinman building appear to have been rehabilitated and provide a good baseline for the work on the Calculator. It is likely infeasible to re-expose the windows on Old Rich, due to programming in New Rich and the differences in floor heights, which may put the Old Rich windows between floors [Figure 34].
