Project Title: "Feasibility of Local Manufacture of the AID Hand Pump in SRI LANKA"

Project No: A-2611

# *USAID/SRI LANKA HAND PUMP PROGRAM*

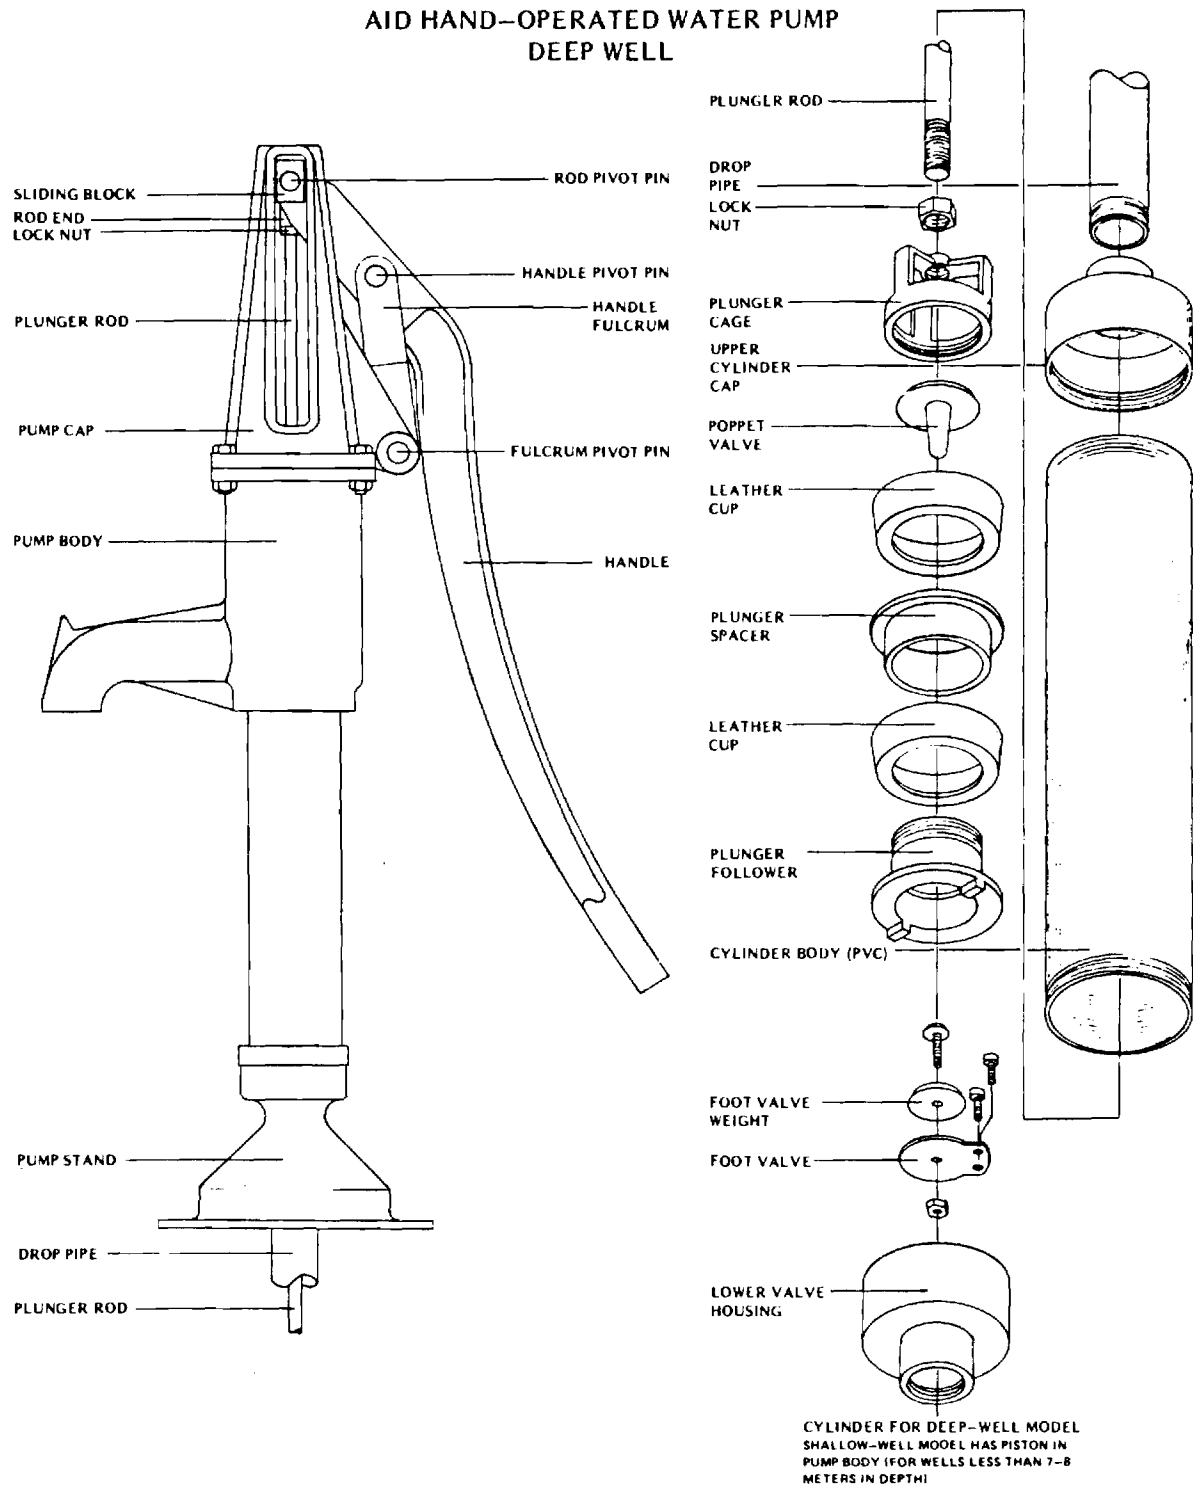
Figure 2.

# AID HAND-OPERATED WATER PUMP DEEP WELL

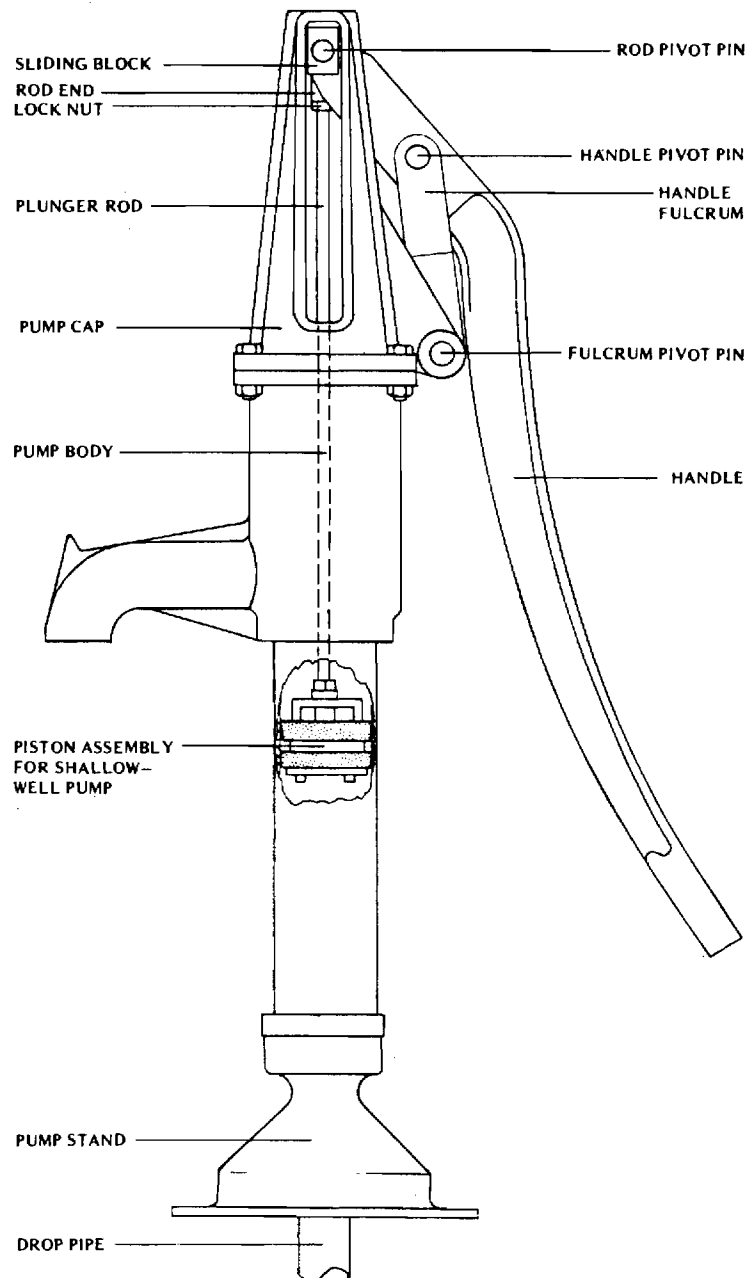
Figure 3.

# AID HAND-OPERATED WATER PUMP SHALLOW WELL

(For Wells less than 7-8 meters in depth)

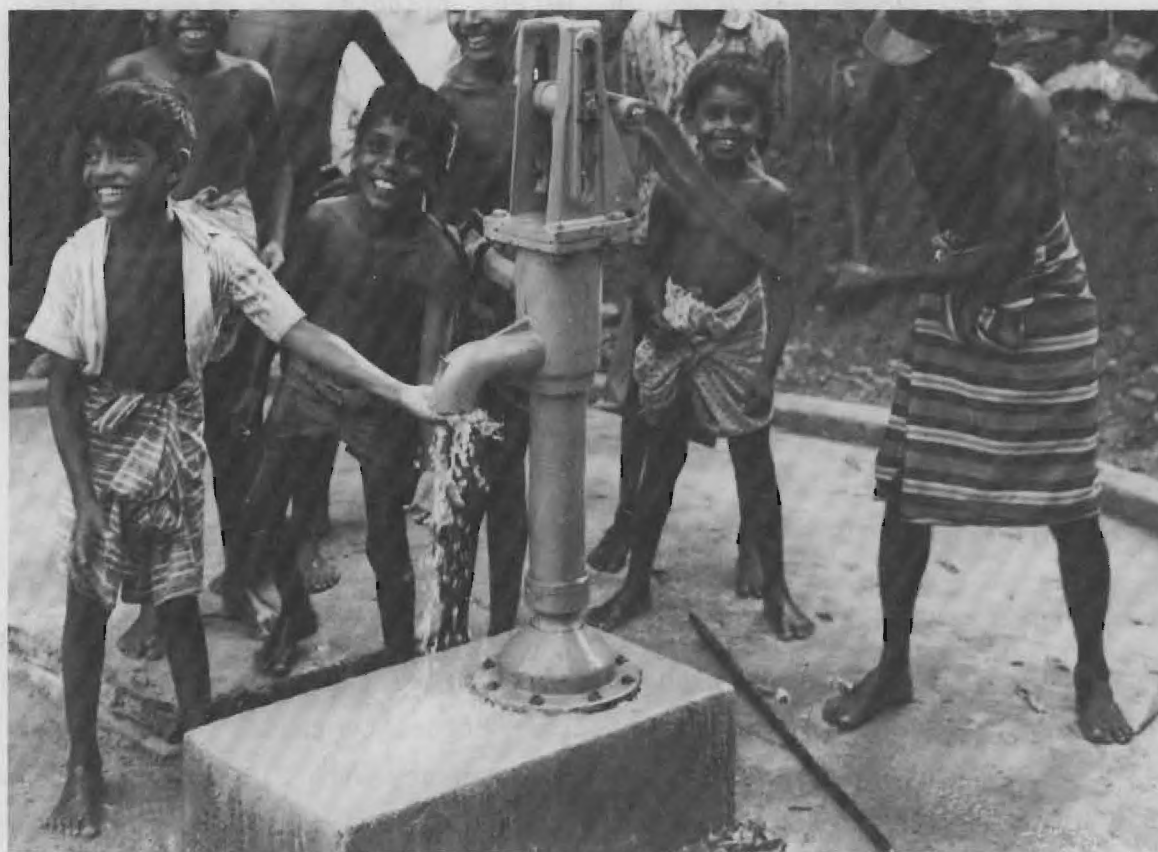
Figure 4. AID Hand Pump Installed in Kalutara, Sri Lanka--1981

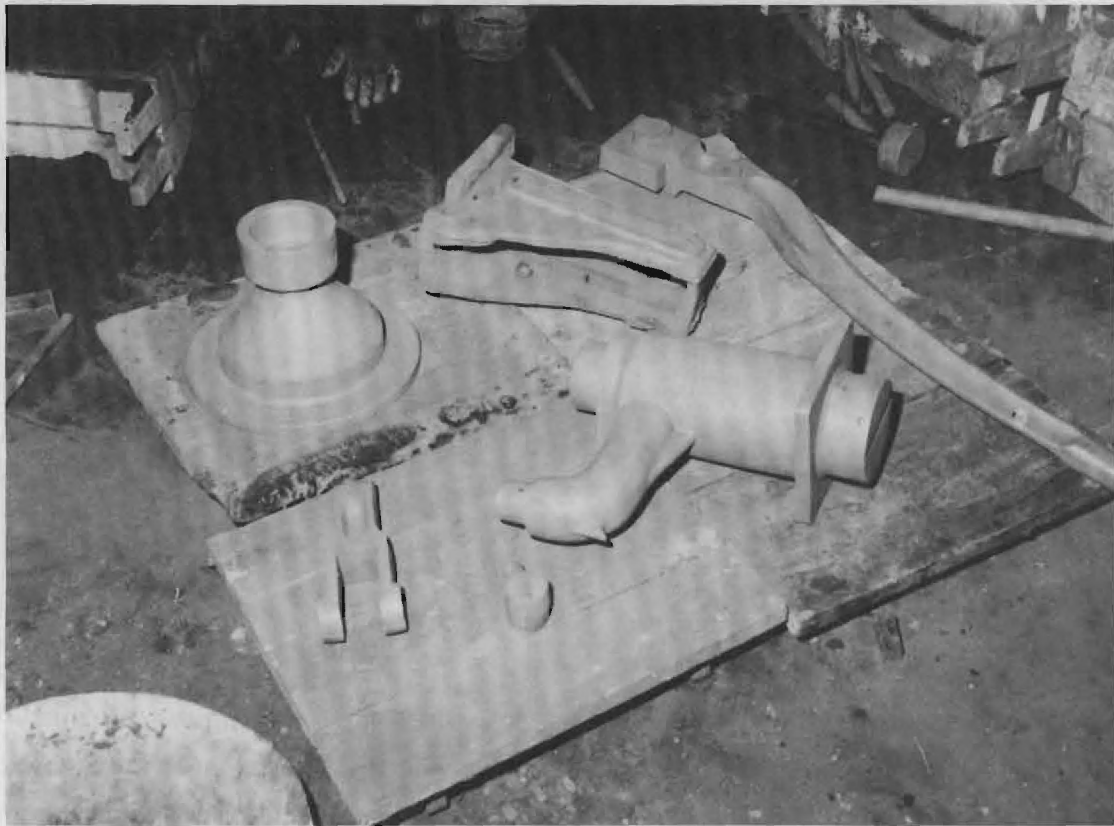
Figure 6. Pump Patterns

The first step in the manufacturing process is pattern making. Scaled drawings are used to make wooden patterns from which aluminum patterns (above photo) are prepared for durability. The cap and handle patterns are more difficult to fabricate because of their complex shapes. A second pattern, which is called the core, is made to fit the cavity of the pump. Since the core is surrounded by hot metal during forming, it must be made of a special sand with a high silica content.

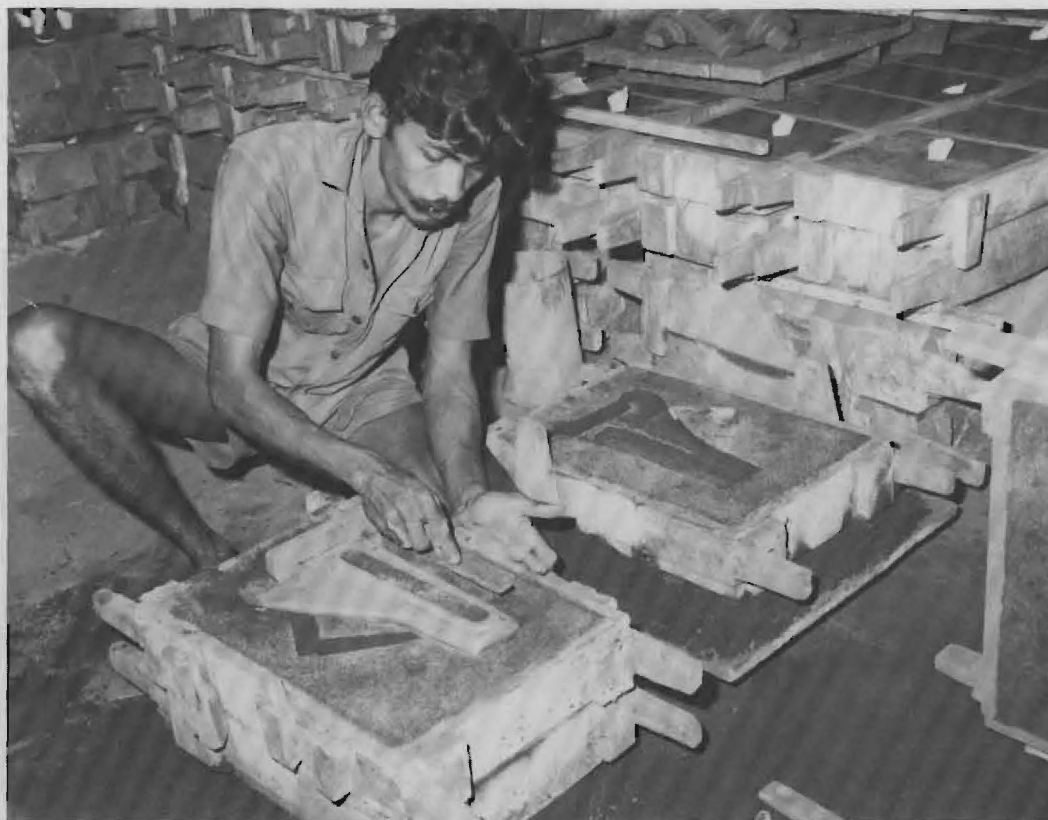
Figure 7. Mold Preparation

The next, and a most important step, is preparing the molds. If this is not done correctly, a defective casting may be produced. Thus, a top quality sand, especially adapted for foundries, must be used. The molds are prepared by hand in a wooden box laid on a plank. The molding sand is then placed around the pattern and tamped until firm.

Each mold is prepared in two halves with double pins (except the cap mold which is in three pieces), and the halves are carefully aligned to form the complete cavity. A pour hole is made by putting a round tapered stick through the cavity and inserting a paper pour cup. If a core is being used, it is put in the mold before the halves are joined.

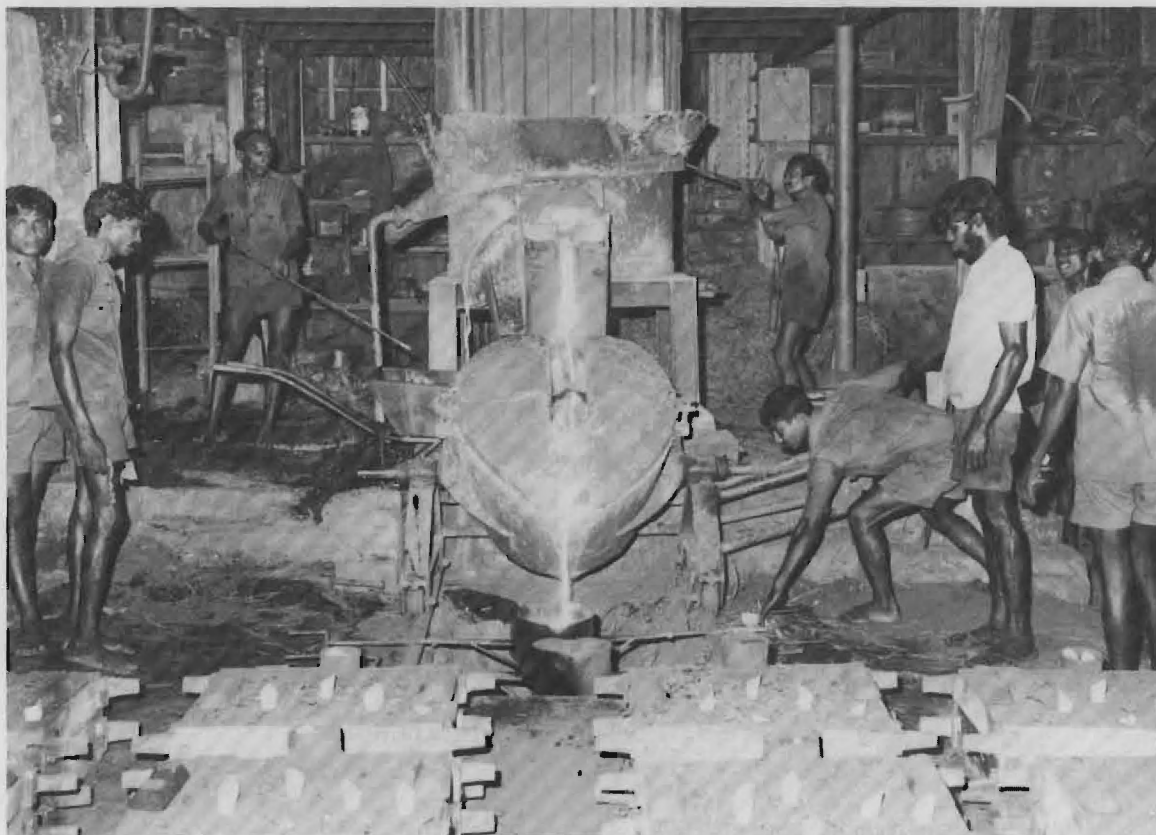
Figure 8. Pouring Metal from Cupola to Ladle

Casting is the next step in the manufacturing process. Metal is melted in the cupola, a straight shaft furnace, and poured into a ladle.

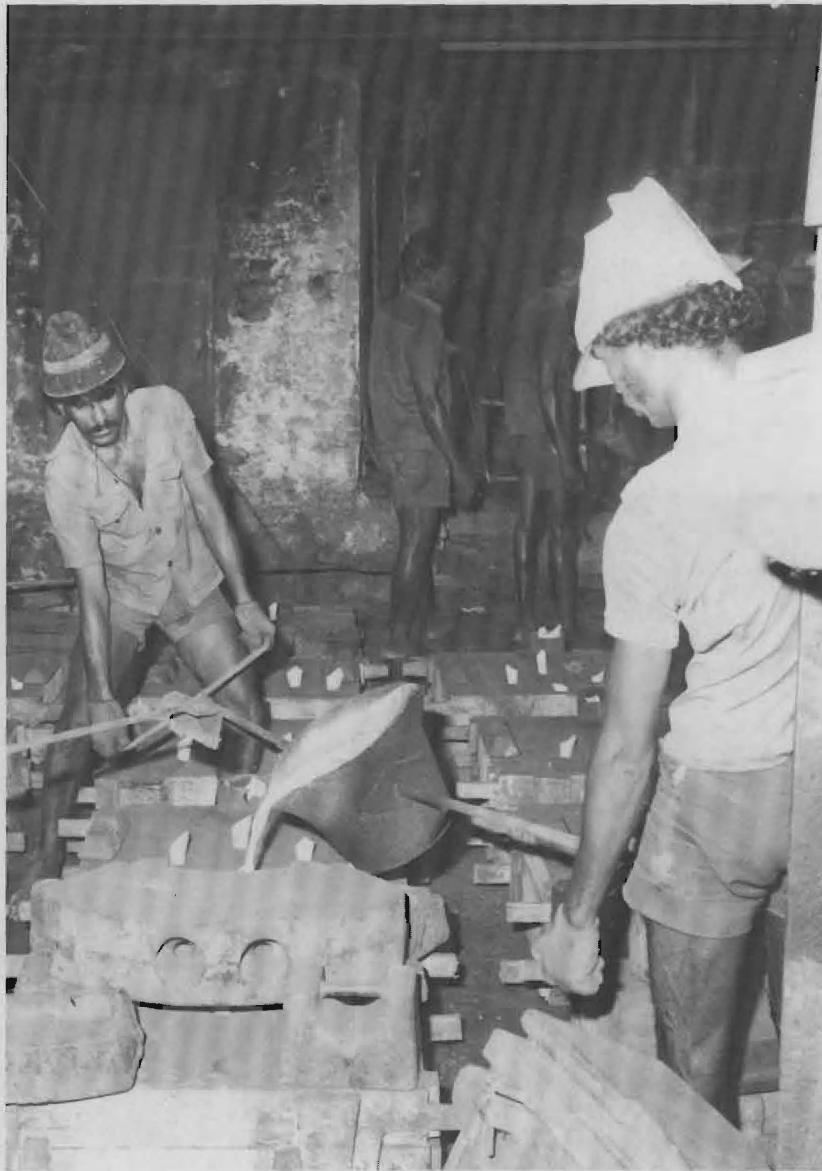
Figure 9. Pouring Metal Into Mold

The molten iron is poured down the gate of the mold at a steady stream, the foundrymen being careful not to break the stream at any time until the level of the metal reaches the top of the mold. The metal is allowed to cool and solidify before being taken from the mold.

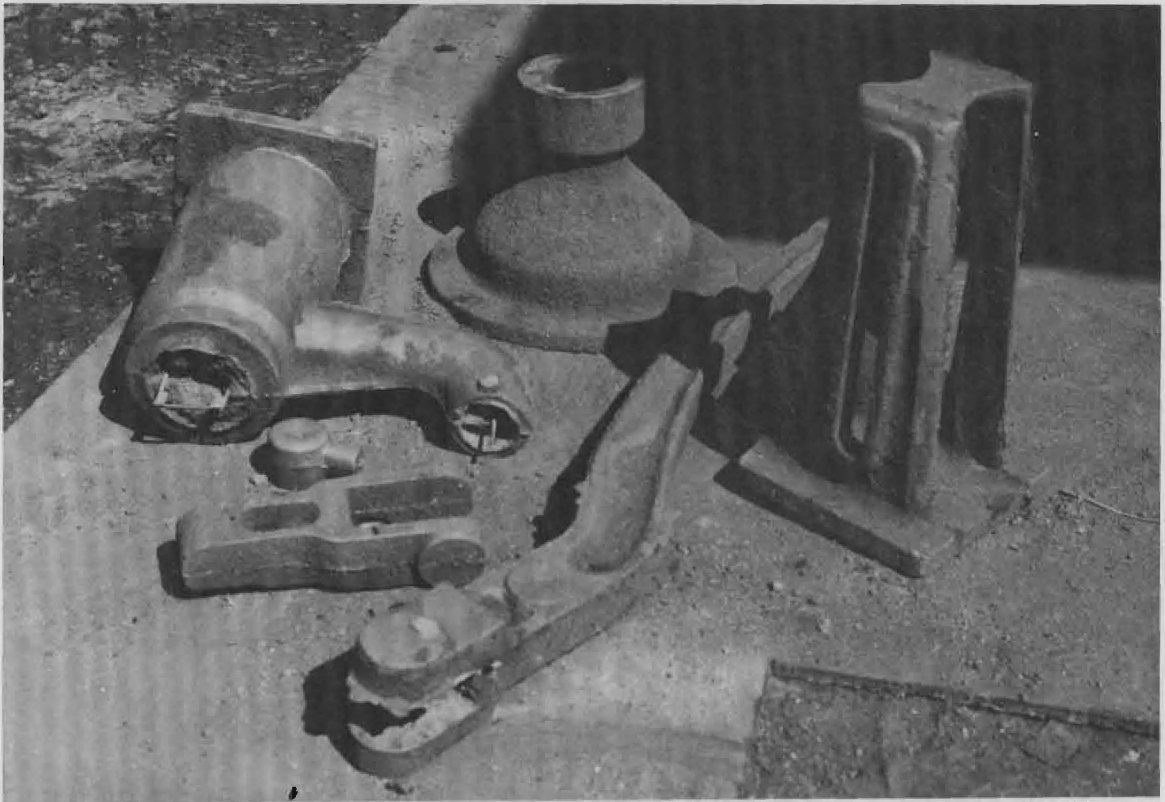
Figure 10. Cast Parts From Mold

After the metal has cooled and solidified, the mold is broken apart to remove the castings. The cores and molding sand are then shaken from the castings.

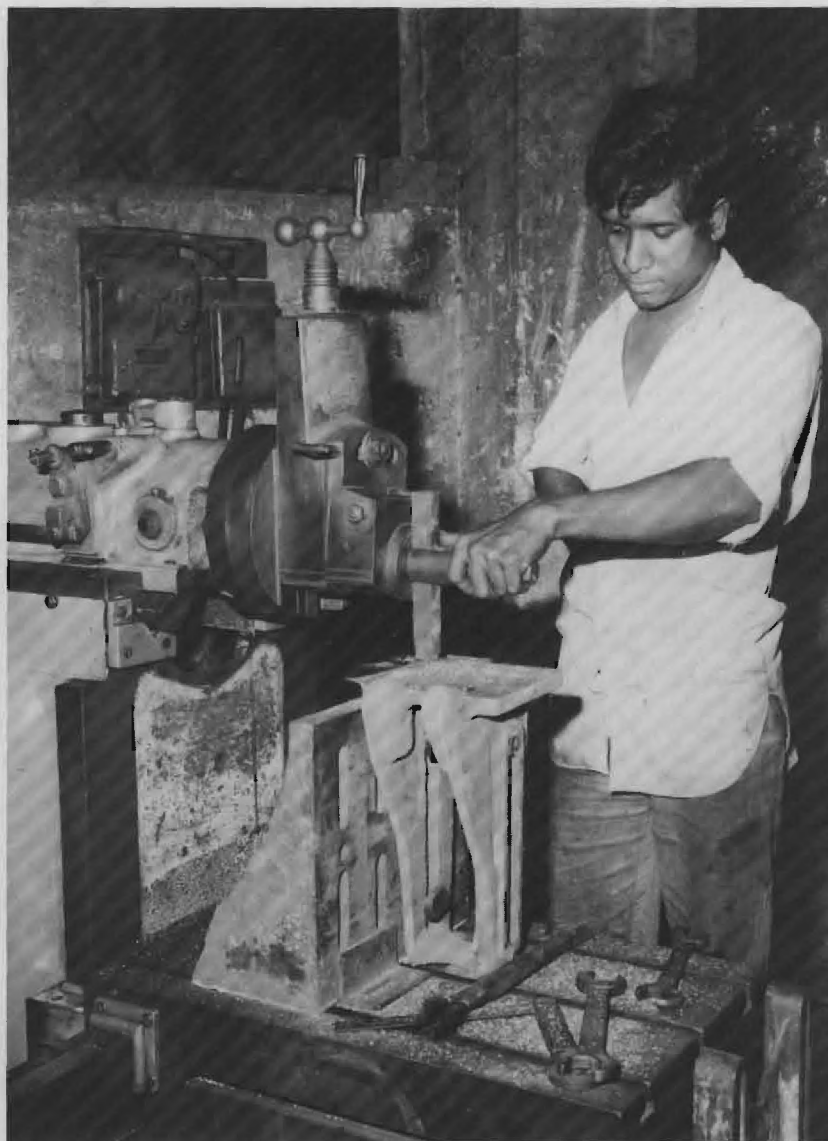
Figure 11. Machining the Pump Cap

The casting is prepared for machining by removing excess pieces of metal and sand, then metal protrusions are ground off and flat surfaces planed. The parts are then bored, drilled and threaded using lathes and drill presses. Jigs are used to ensure interchangeability of parts such as the pump cap, body and base. The pump is then assembled, painted with a primer and overcoat, and tested over a 55-gallon drum of water.

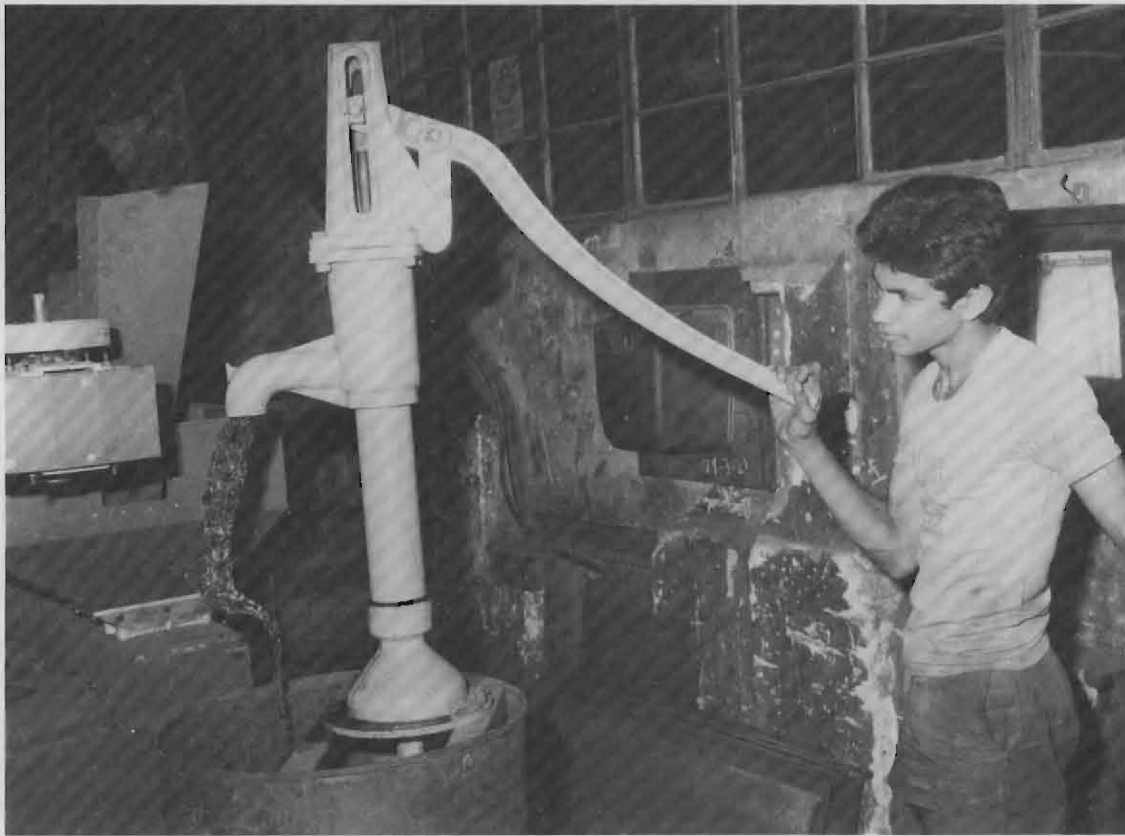
Figure 12. Testing of Pump in Foundry

Before any pumps are released from the manufacturer, they must be tested over a 55-gallon drum of water for certification that all parts easily move together and that the piston assembly and foot valve are properly functioning.

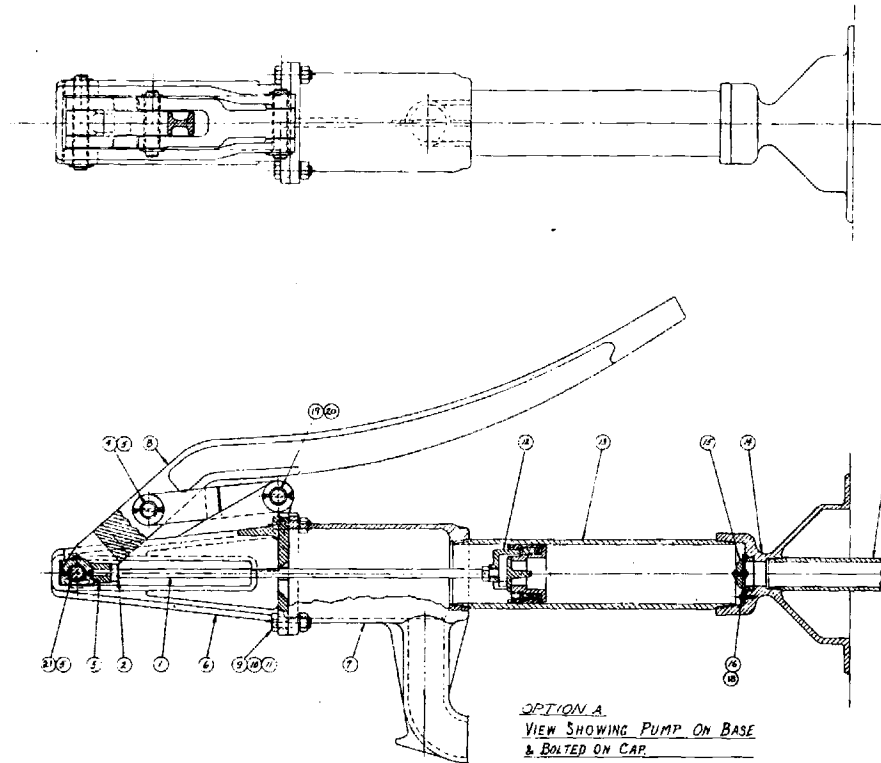
OPTION A  
VIEW SHOWING PUMP ON BASE  
& BOLTED ON CAP.

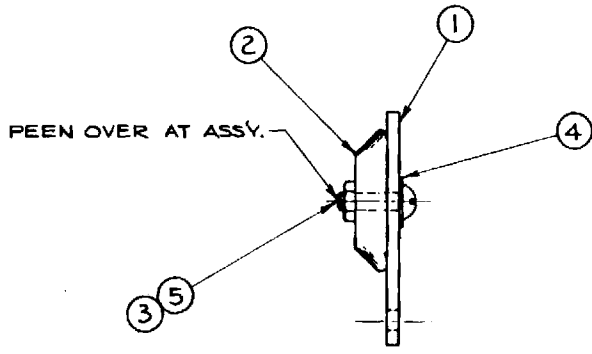
PEEN OVER AT ASSY.

FIND NO.	QTY.	PART NO. OR IDENTIFYING NO.	DWG. SIZE	DESCRIPTION	SPECIFICATION	NOTE NO.
5	1	-	-	#10 NC-2B HEX NUT	BRASS	
4	1	-	-	#10 PLAIN FLAT WASHER	BRASS	
3	1	-	-	#10-24 NC-2A X 3/4 LONG RD. HD SCR.	BRASS	
2	1	2022	A	CHECK VALVE WEIGHT	CAST IRON	
1	1	2021	B	VALVE FLAPPER	RUBBER

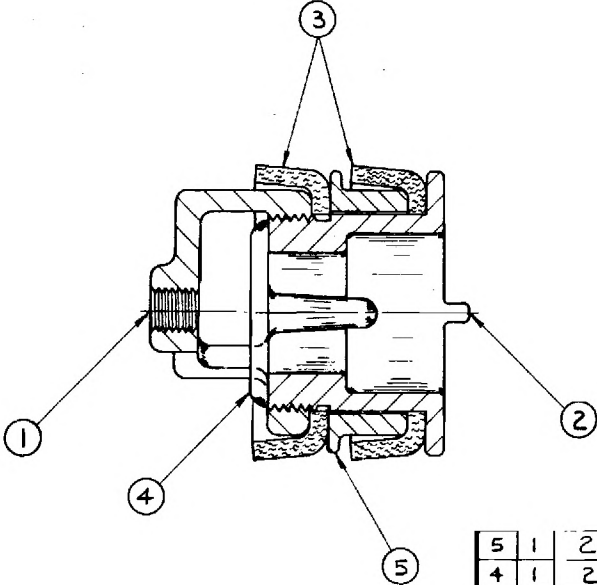
5	1	2032	A	PLUNGER SPACER		
4	1	2018	A	PLUNGER POPPET		
3	2	2019	A	THREE INCH CUP		
2	1	2031	B	PLUNGER FOLLOWER		
1	1	2017	B	PLUNGER CAGE

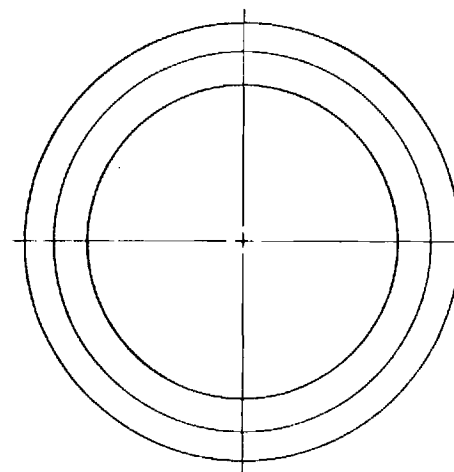
\* THIS SIZE IS FOR A 3" ID CYLINDER AND WILL VARY WITH THE ID OF THE PVC PIPE OR LINER.

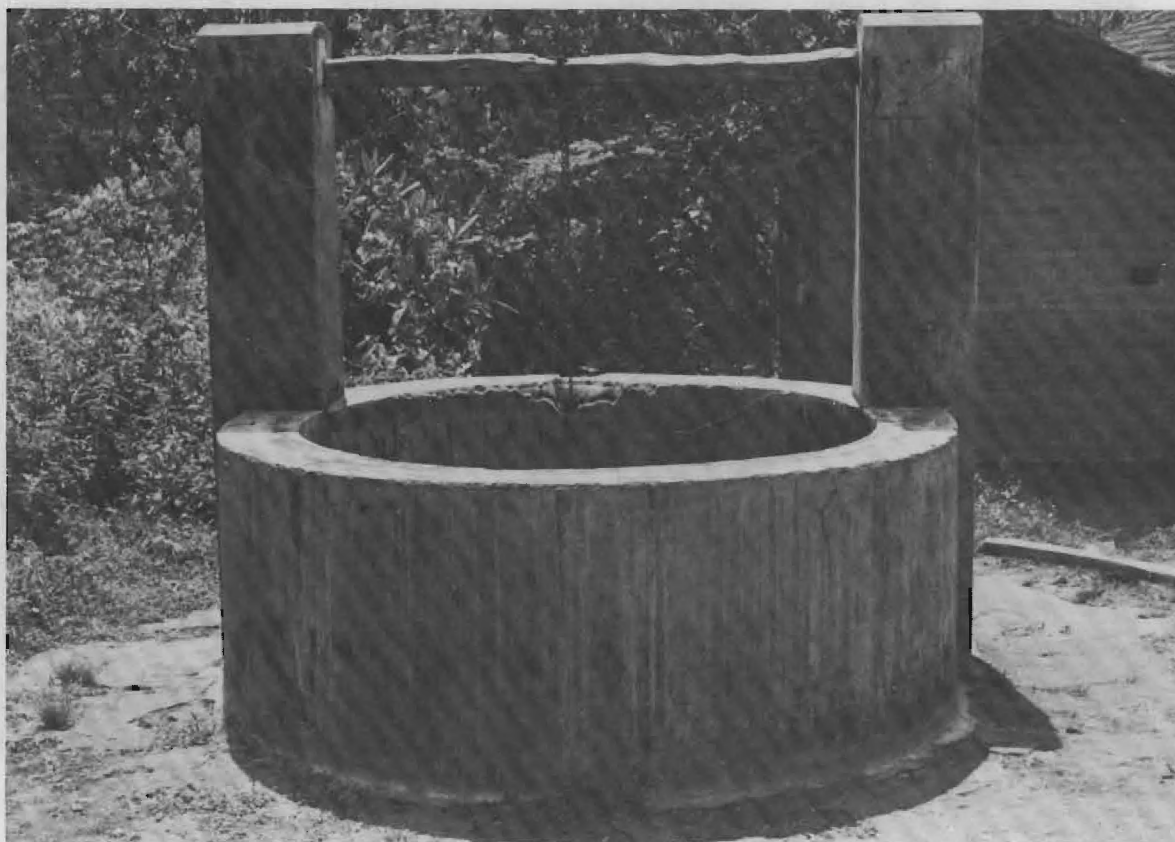
Figure 13. Typical Unimproved Well in Sri Lanka

Open dug wells are not very sanitary due to the probability of dirt and debris falling into the well. The wells are also vulnerable to contamination by the inflow of sullage water or from dirty buckets used to draw the water. Thus, a full cover, proper lining, and a hand pump is a desirable arrangement to help reduce the risk of such contaminants.

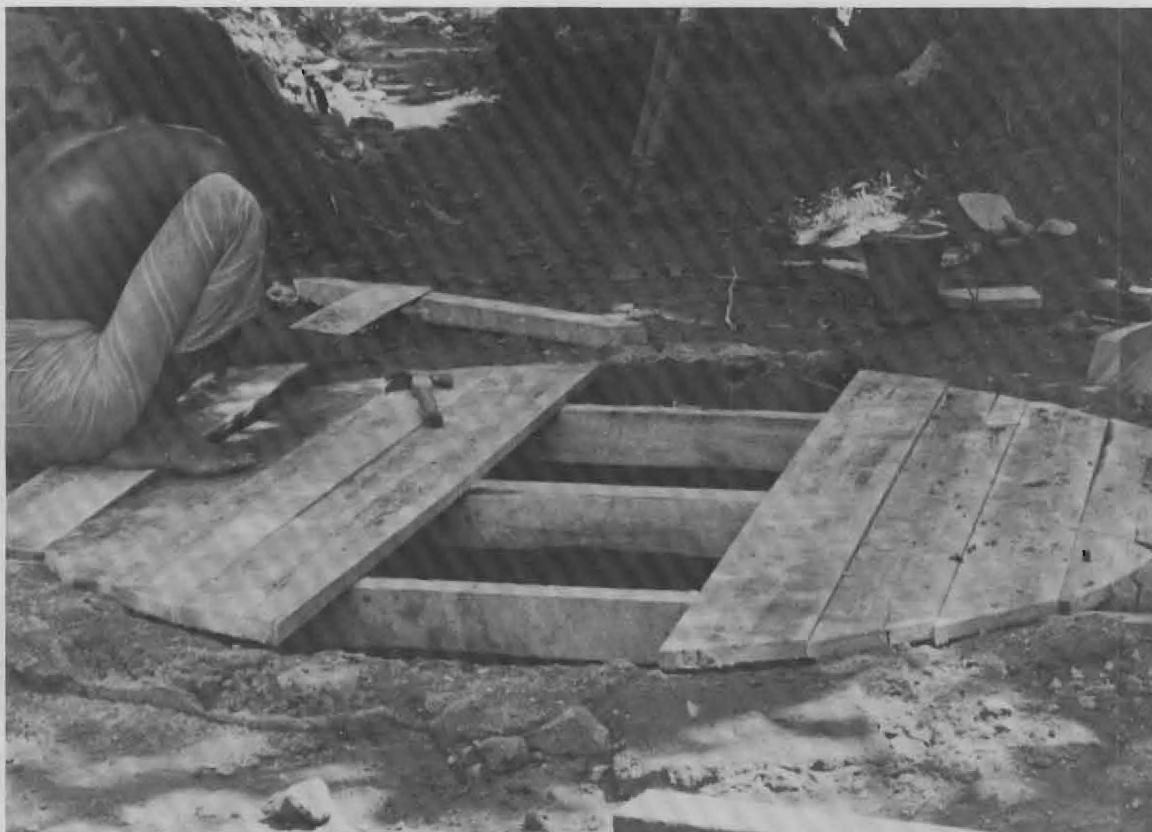
Figure 14. Construction of Formwork

The first step in Sri Lankan well construction was to remove any loose brick and plaster from the inside of the well. Following this, the well was cleaned with the aid of a motorized pump, deepened if necessary, and relined with new plaster as deeply as possible. The headwalls were, in general, removed in order that the concrete base would be supported by the ground instead of the well lining. The slab formwork was then designed and constructed for ease of removal following construction.

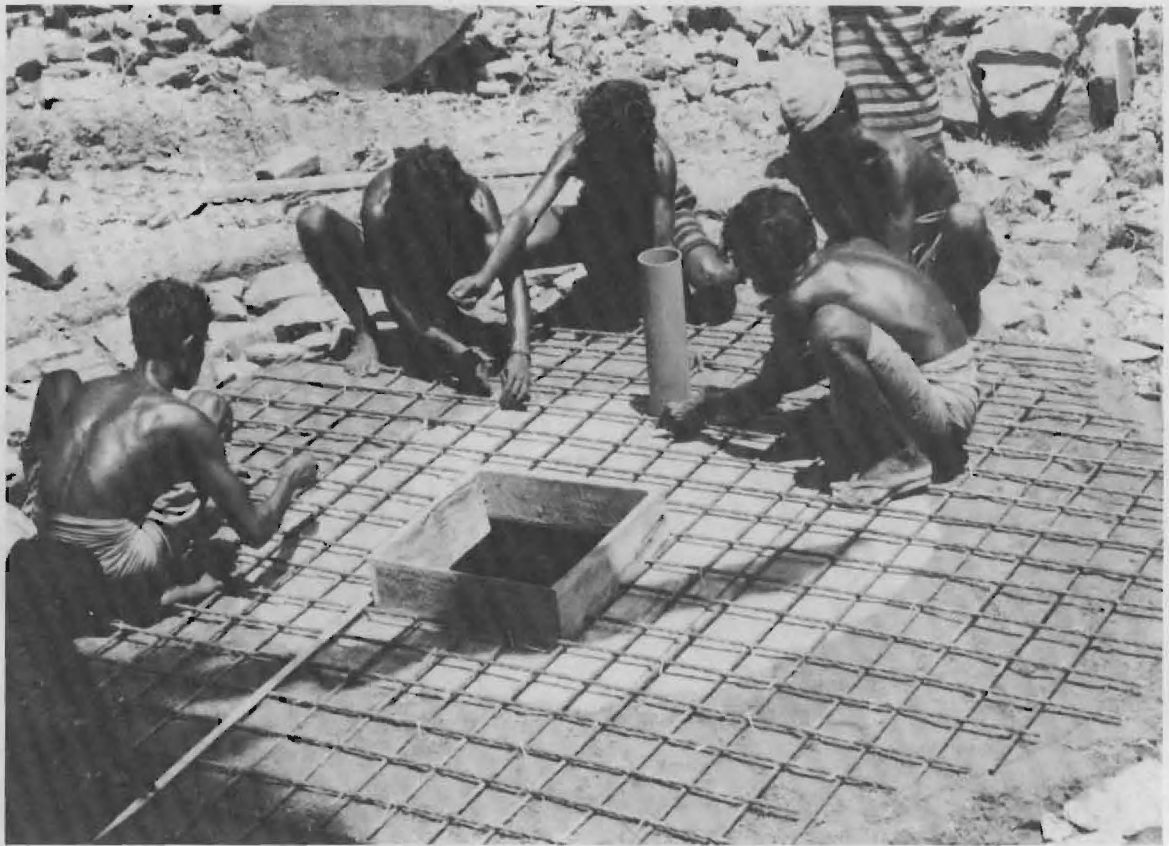
Figure 15. Steel Reinforcing

The area around the well was prepared for the cover slab with an apron extending at least five feet from the outer edge of the well. A form for the manhole was constructed and  $3/8$ -inch steel reinforcing was placed on six-inch centers. The reinforcing steel extended three feet beyond the edge of the well.

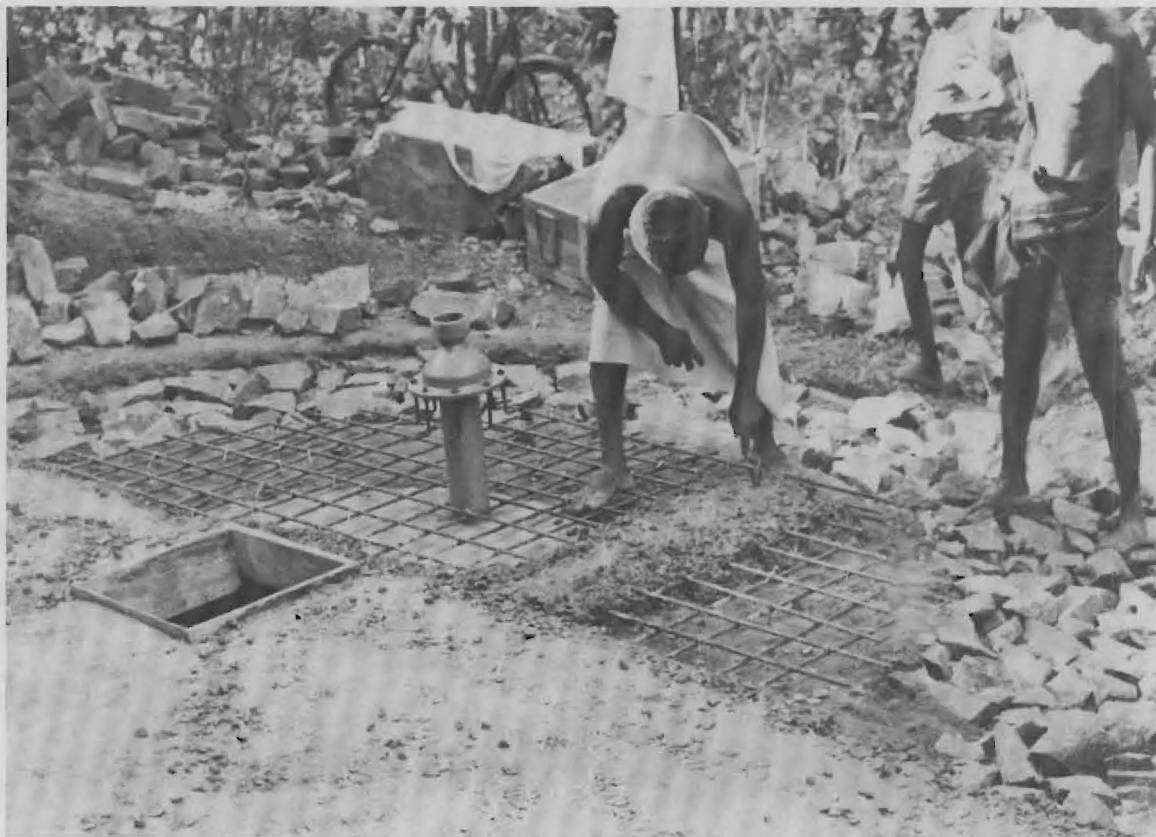
Figure 16. Concrete Placement

A 1:2:4 mix of concrete was poured over the well and apron area, and given a 1 in 30 slope for drainage. A short section of PVC pipe was placed in the concrete to allow for the pump drop pipe and to prevent sullage water from re-entering the well from under the pump base.

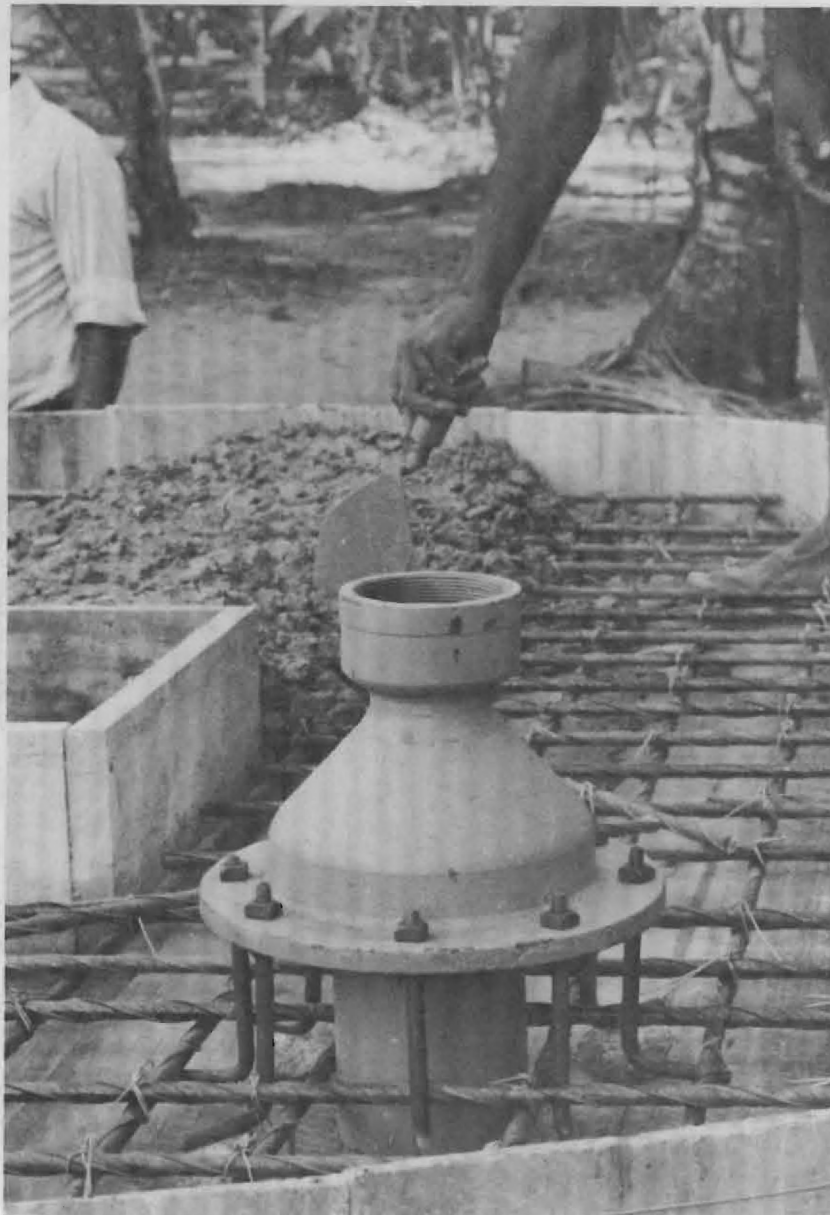
Figure 17. Close-up of Pump Base

In order to obtain proper alignment of the anchor bolts, the pump base was used as a template when forming the well slab. The base was located at a height that would be comfortable to the users when the entire pump was later installed. The anchor bolts were then tied into the steel reinforcing for increased strength.

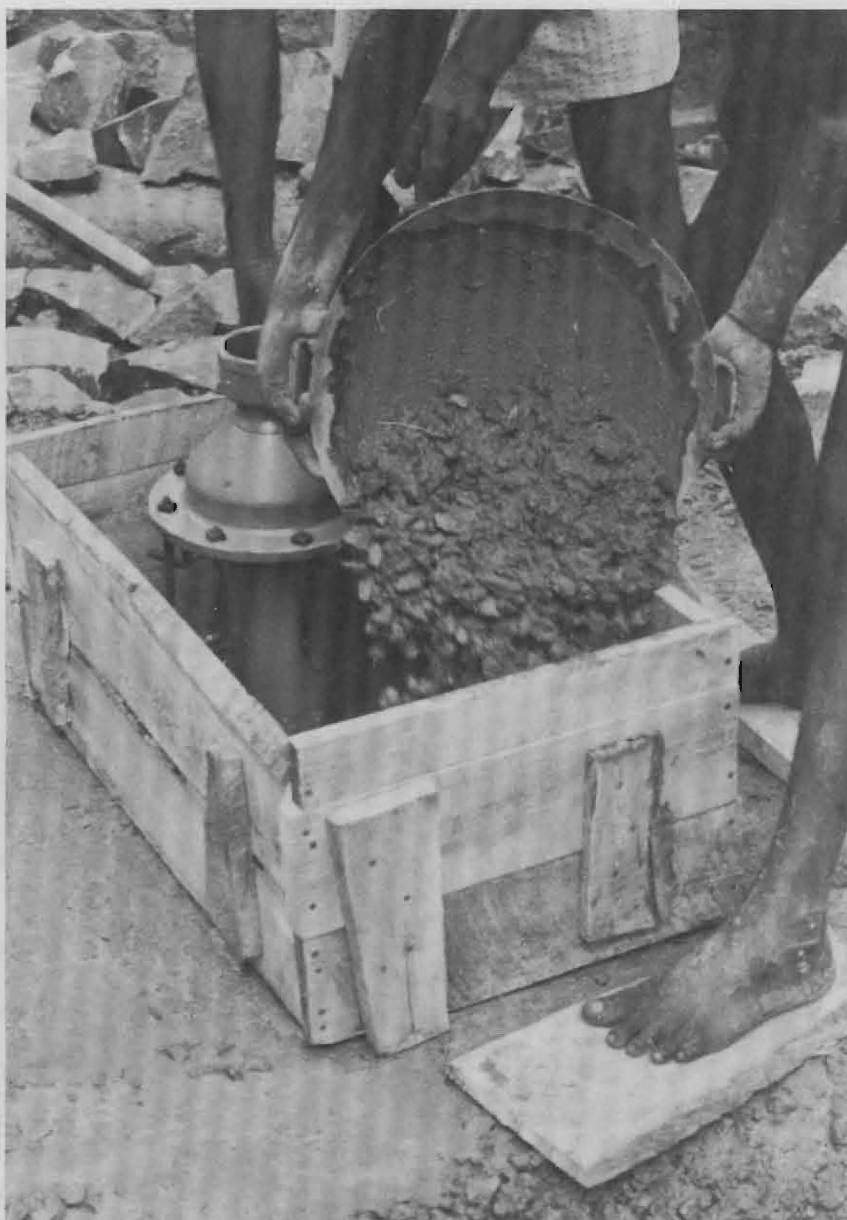
Figure 18. Pump Pedestal

A wooden form was placed around the pump base to form the pump pedestal. The pedestal was poured at the same time as the cover slab to ensure a good bond between the two.

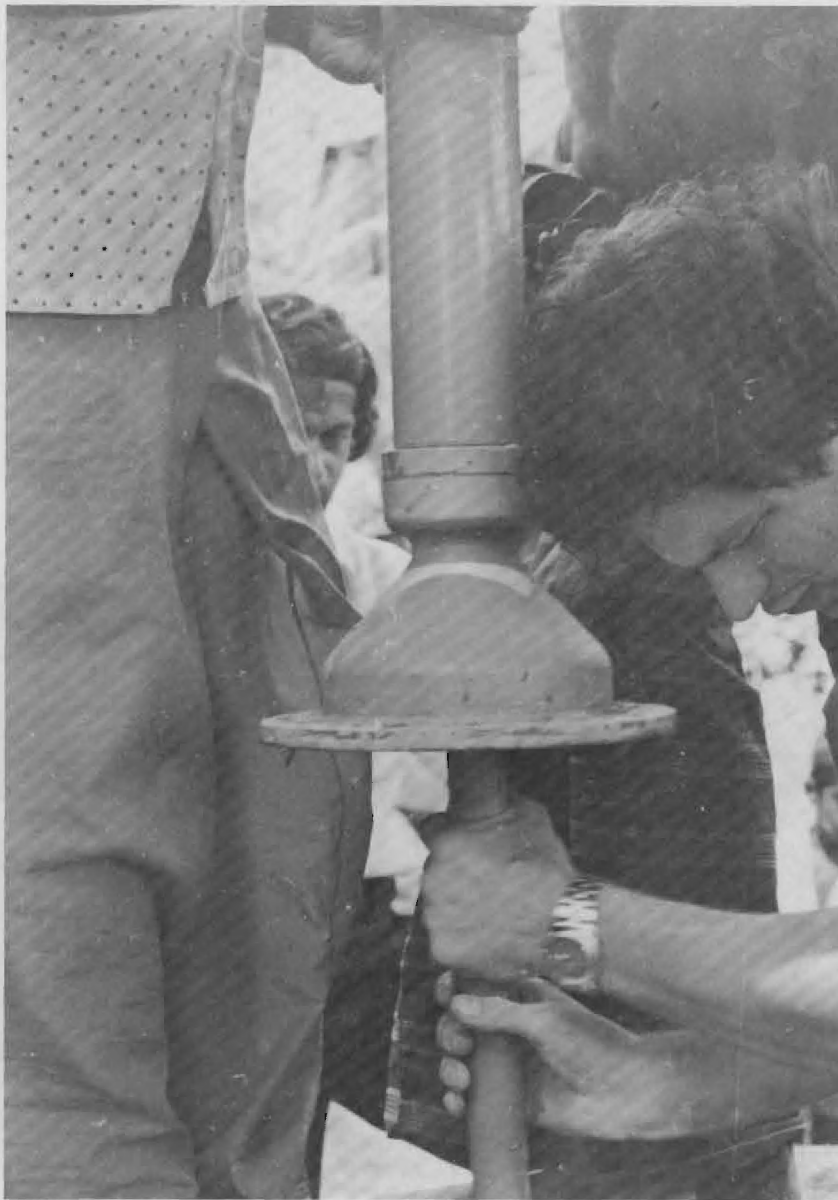
Figure 19. Attaching the Drop Pipe to a Shallow-Well Pump

The AID shallow-well pump was installed by inserting a 1¼-inch drop pipe into the well platform opening, attaching the threaded drop pipe to the base of the pump, and then securing the pump to the well platform. The length of the required drop pipe was determined by measuring the depth of the well with a weight and string from the well platform, allowing approximately two feet for mud at the bottom of the well if it were new, or one foot if it was an older well where the mud had settled.

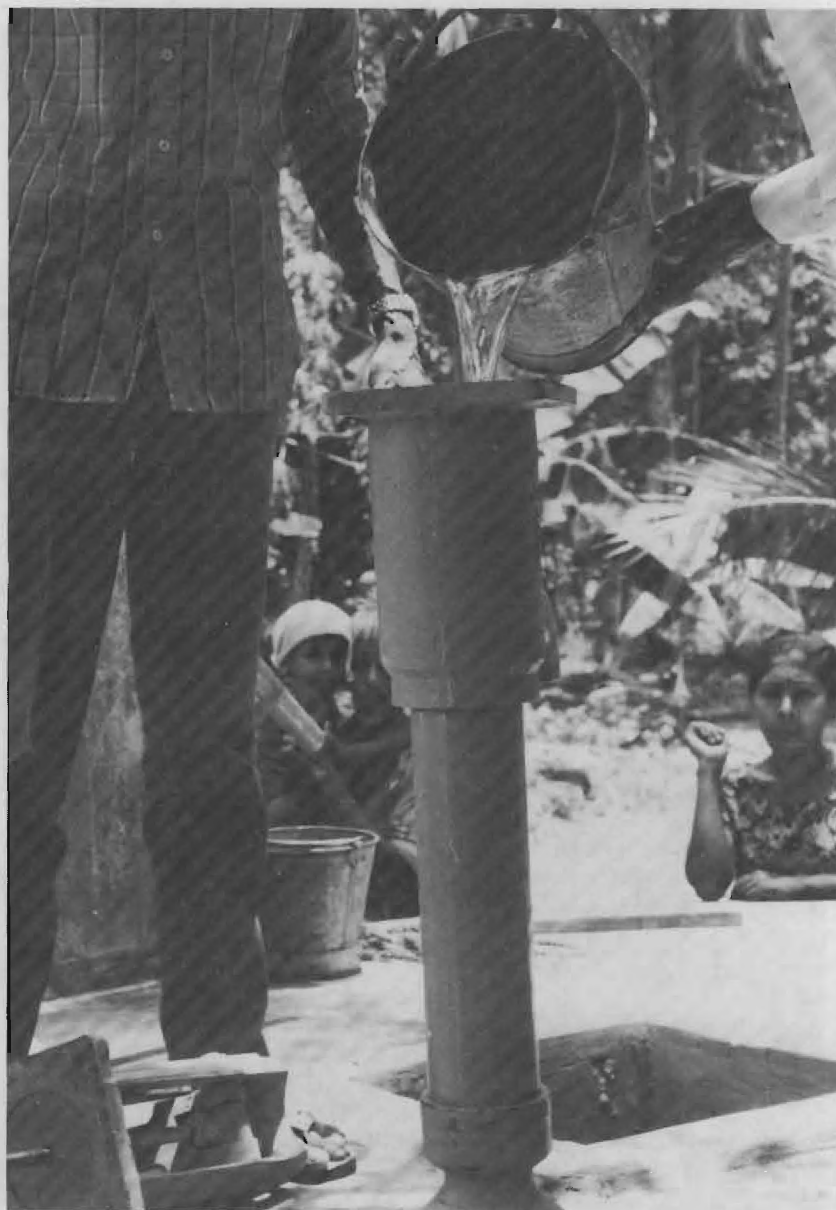
Figure 21. Initial Priming of the Pump

Properly made leather cups were soaked in an edible oil for at least 12 hours to preserve the leather and to keep them from drying and shrinking (leather shrinks as it dries). However, over an extended period of storage, shrinkage could occur as the oil evaporated, in which case the shallow-well pump would have to be primed initially to get sufficient suction to bring water up the drop pipe. The pumps are self priming when in operation.

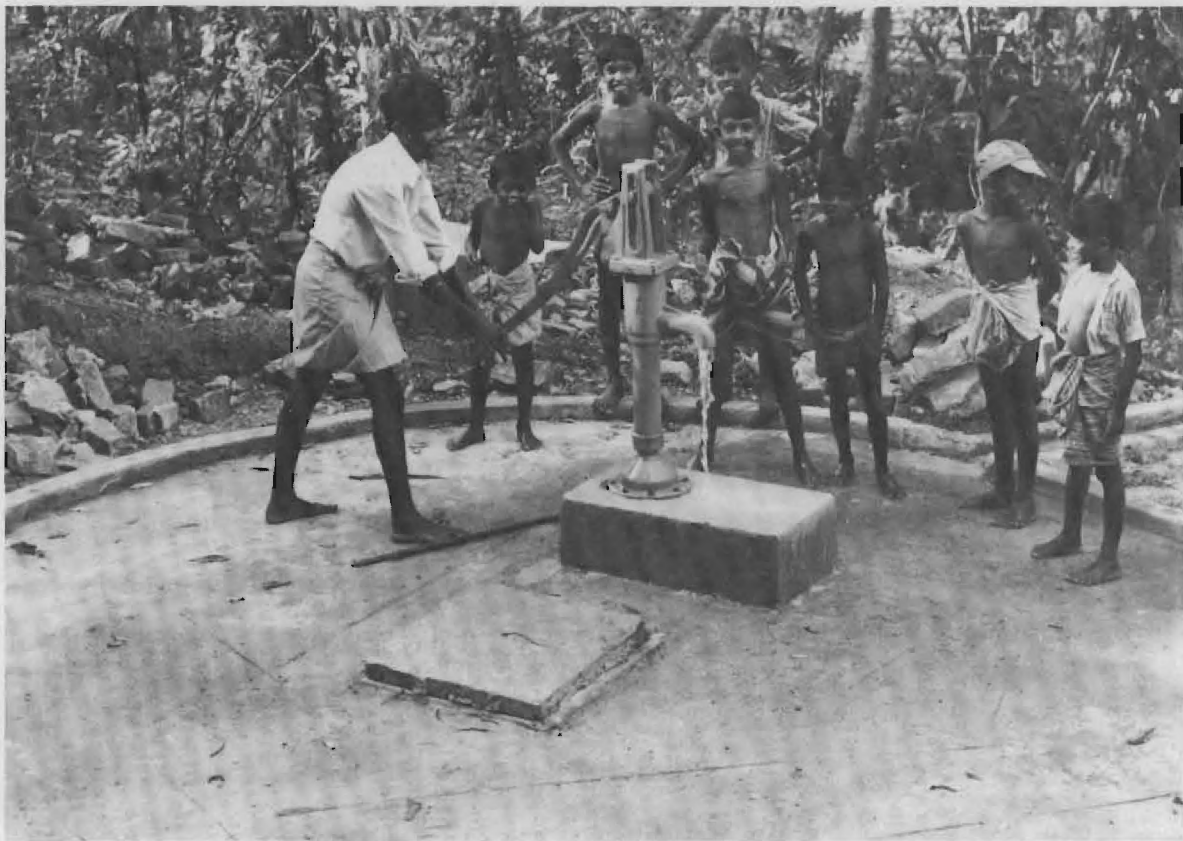
Figure 23. Site Drainage

In order to provide proper drainage, a raised curb was formed on the edge of the apron and a drainage channel provided. Following curing of the concrete for two weeks, the pumps were installed and the well disinfected. A manhole provided access to the well for pump maintenance and well repair, but was sealed off to prevent inflow of contaminated water.
