Project Title: "Feasibility of Local Manufacture of the AID Hand Pump in SRI LANKA"

Project No: A-2611

# *USAID/SRI LANKA HAND PUMP PROGRAM*

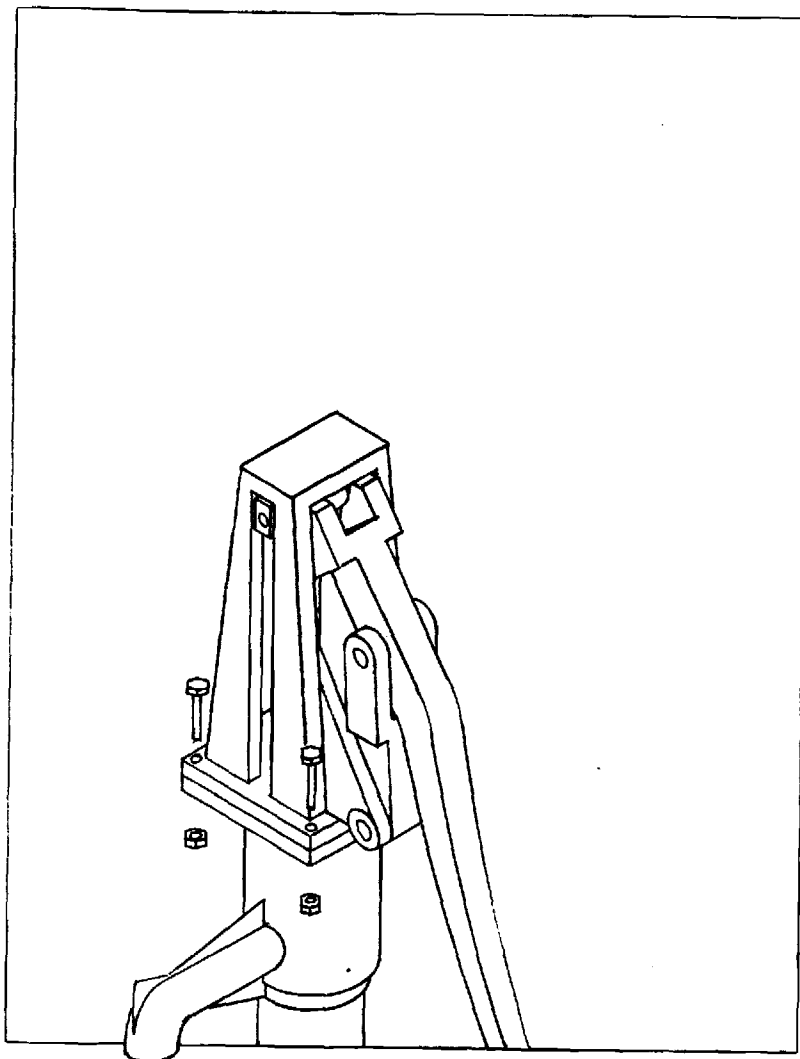
Remove the four bolts holding down the pump cap.

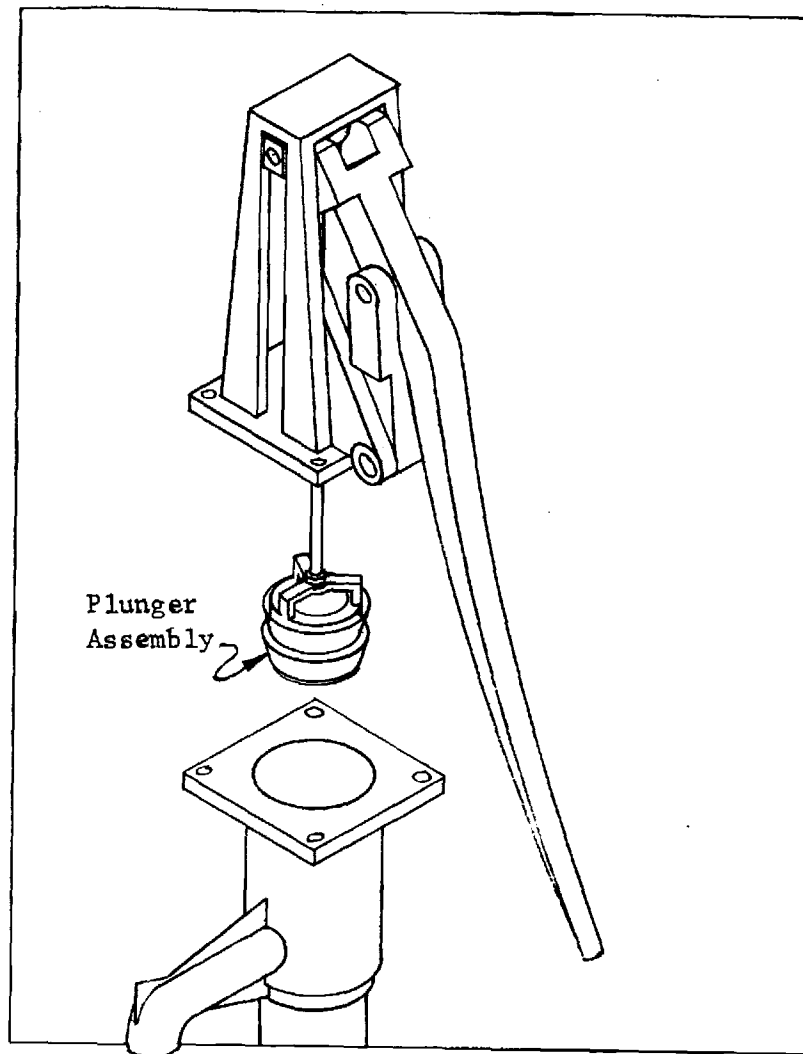
Lift the cap off the pump body.

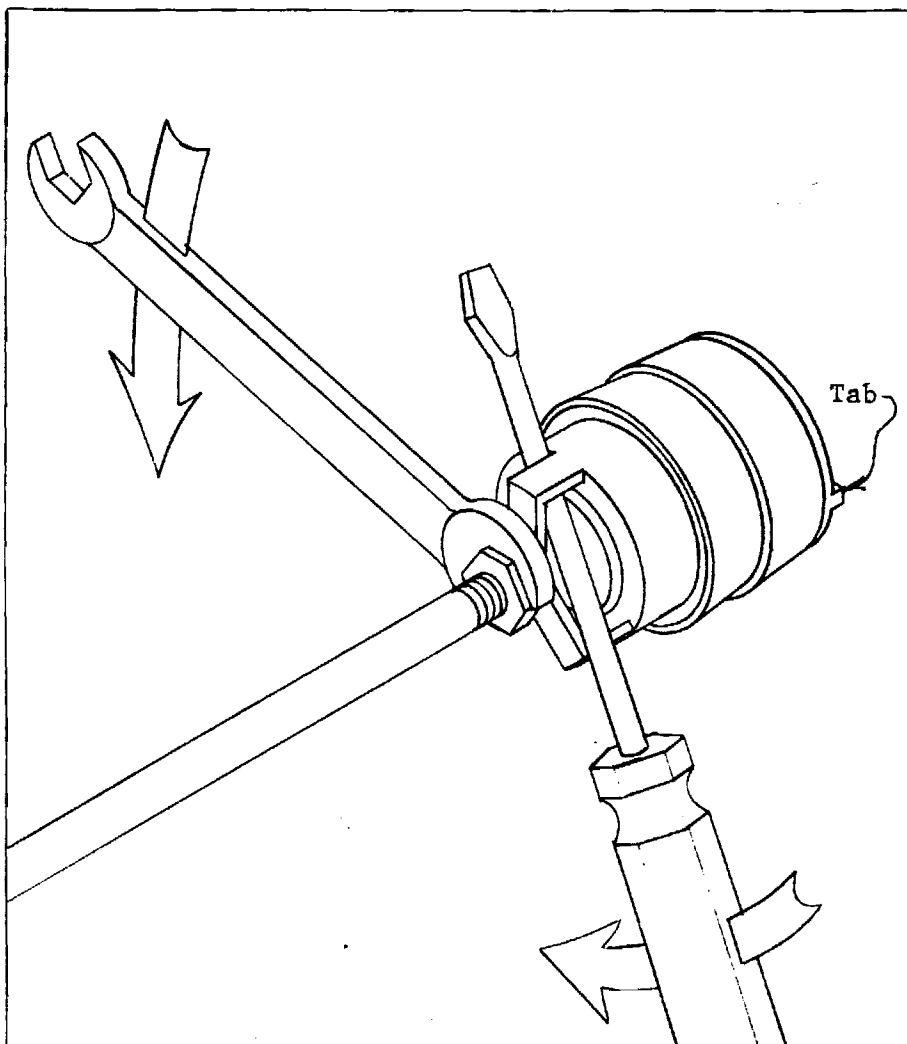
Unscrew the plunger assembly  
from the plunger rod.

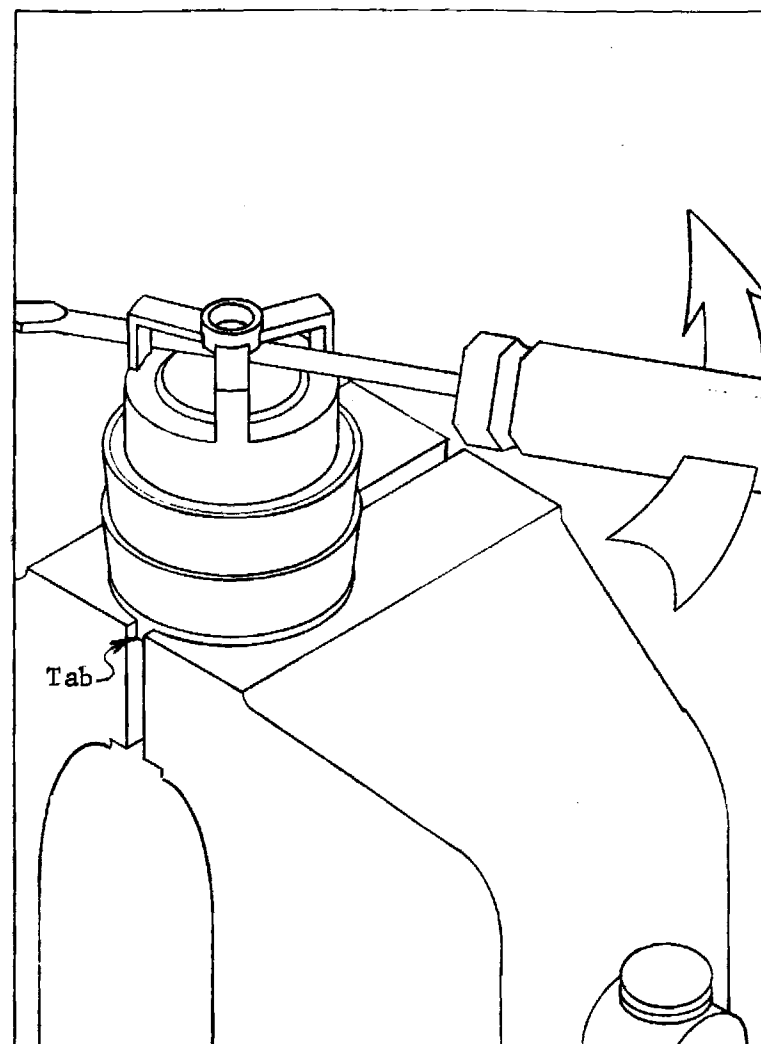
Unscrew the plunger assembly. A  
wrench can easily be used in place  
of the vice to grip the tabs.

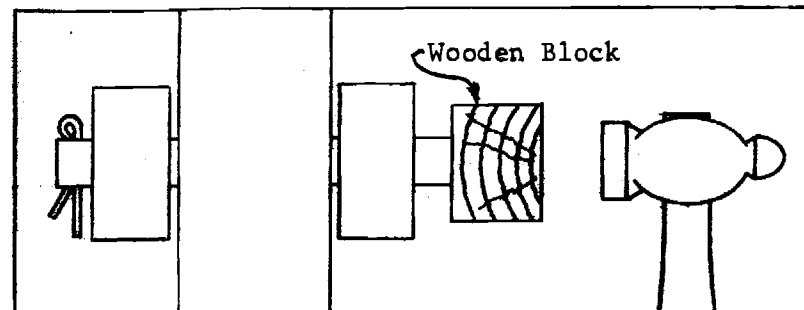
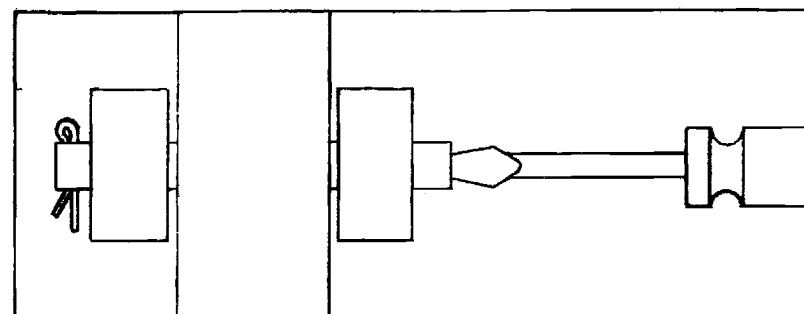
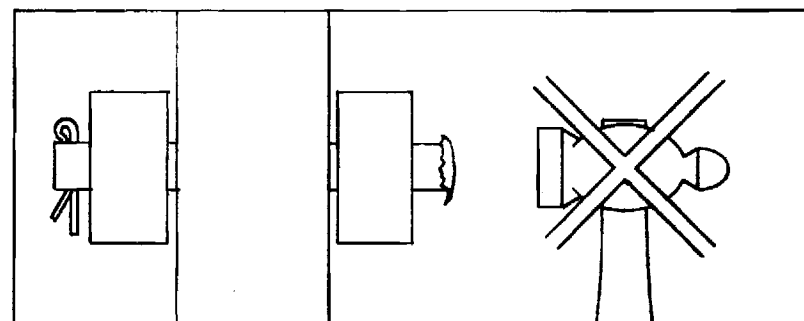
Remove the retaining pins.

Drive out the connecting pins. Use a hammer and a block of wood or a slender object like a screw-driver. Do not use a hammer directly on the pin as it will make the pin impossible to remove.

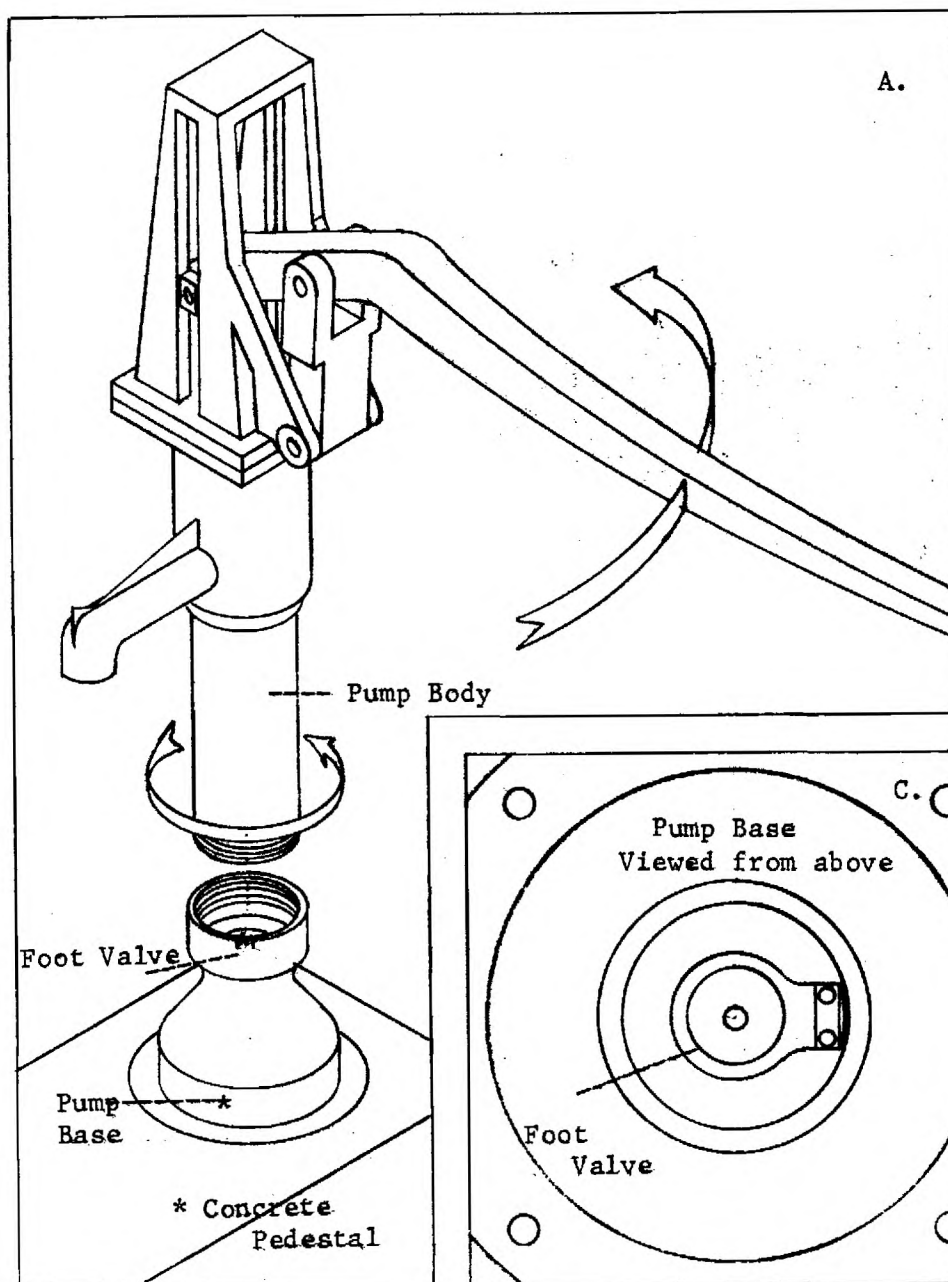
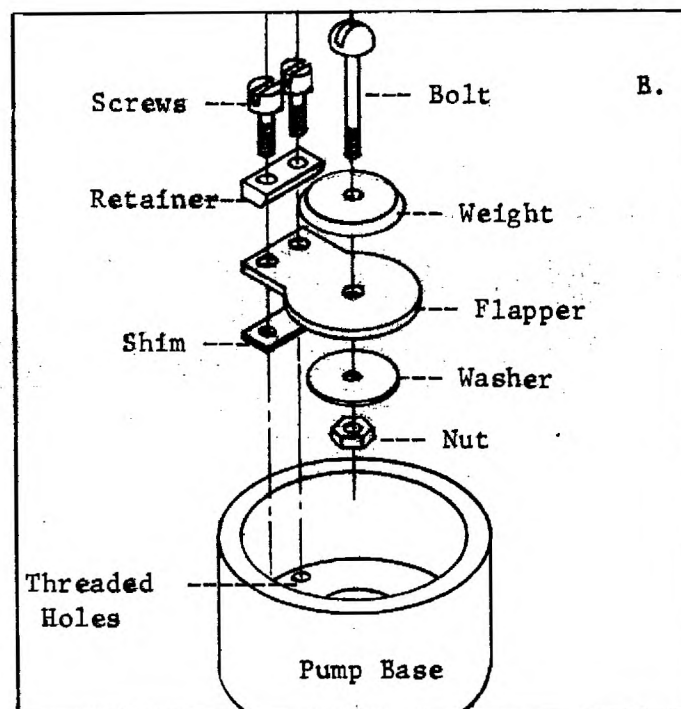
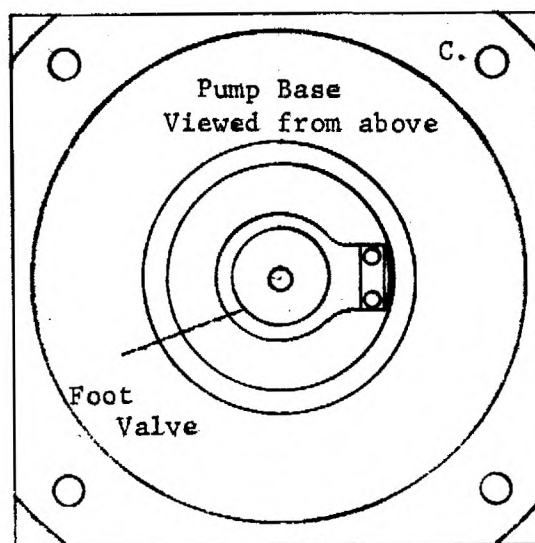
- A. Unscrew the pump body from the pump base. If a large pipe wrench is unavailable, the handle may be used as a lever.
- B. Replace the old footvalve flapper. Wipe any oil or dirt off of the valve seat. Reassemble as shown.
- C. The reassembled valve should be centered as shown when viewed from above.

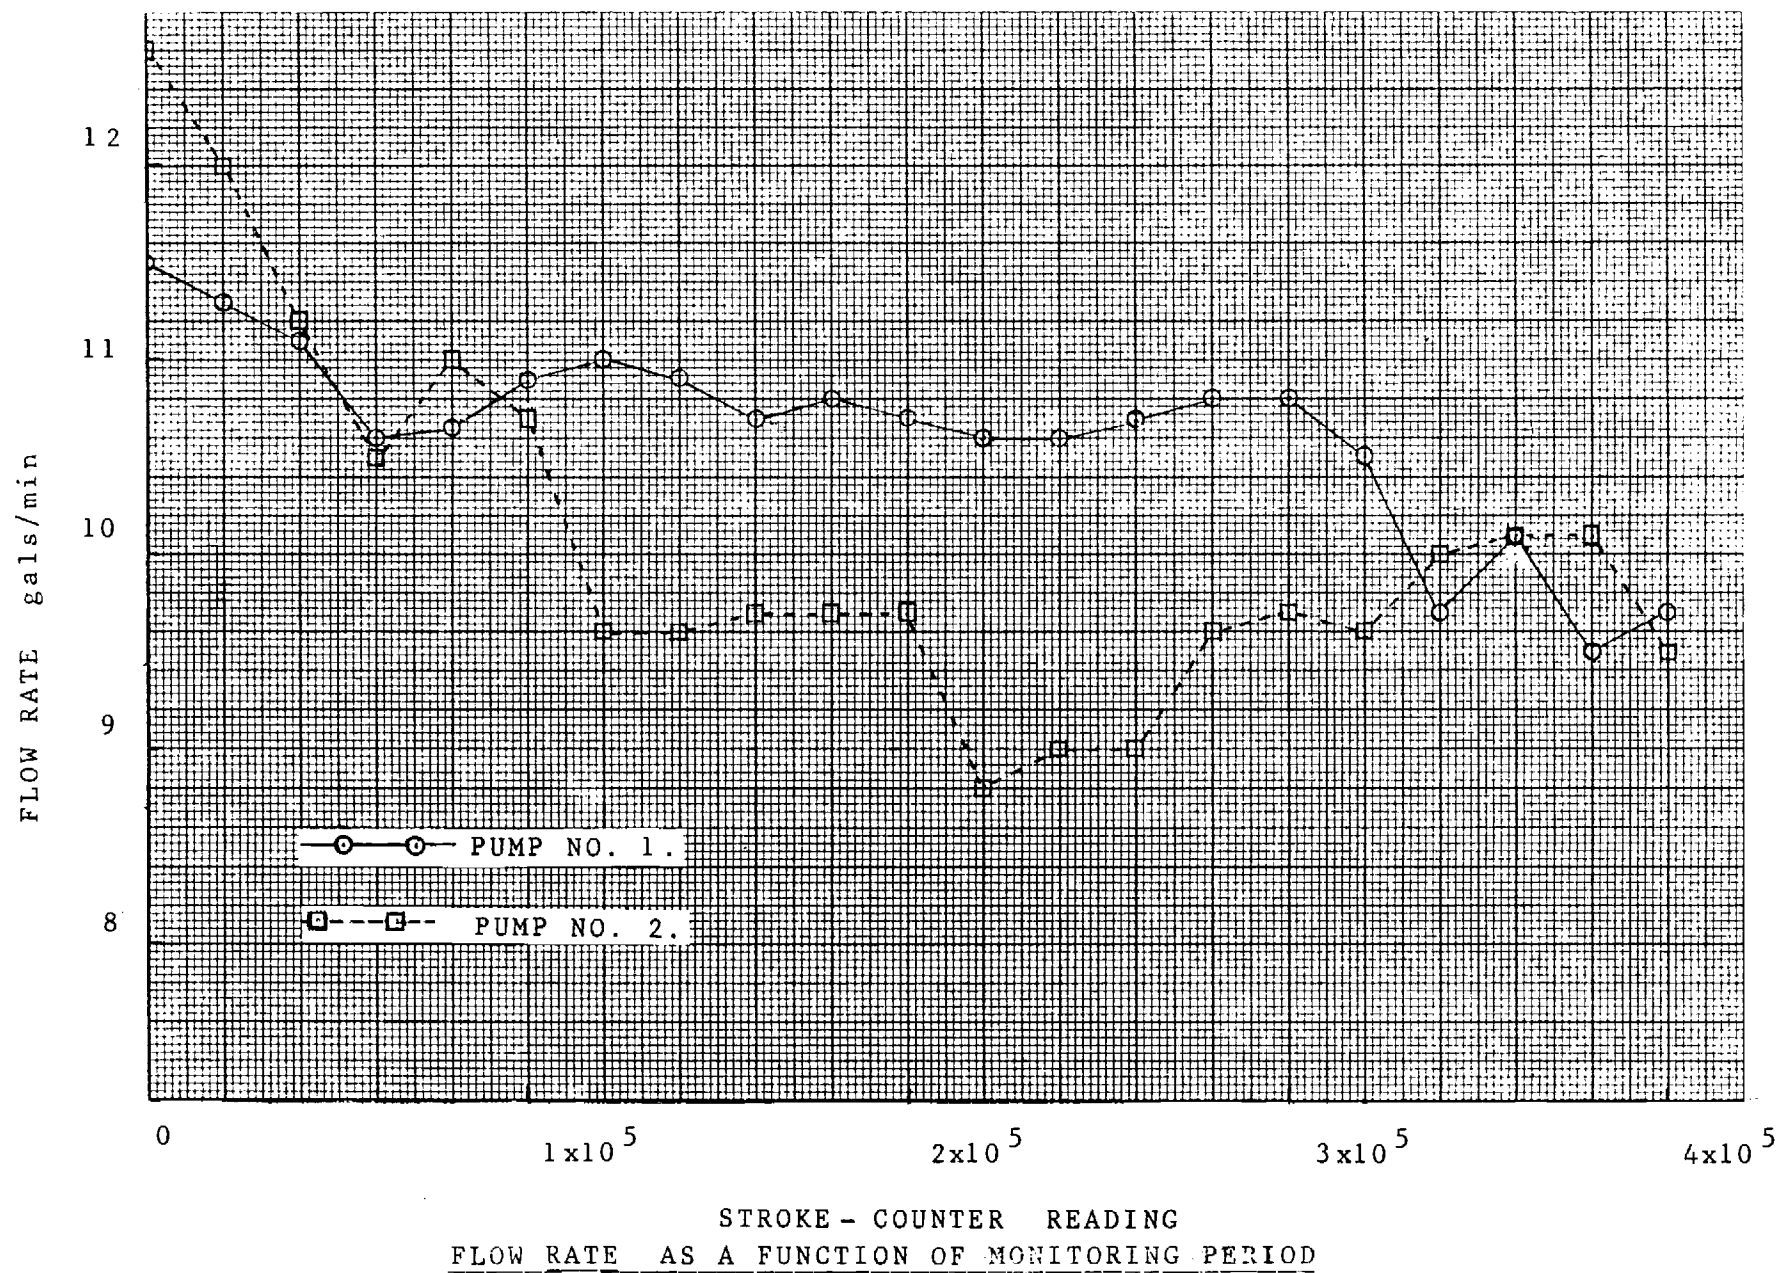
FIGURE 1

The flow-rate as a function of the monitoring period is seen in figure 1. Table 1 gives details with reference to operation times and flow rates of the pumps. The failures and the adopted remedial measures are given in Table 2.

Operating period (No. of Strokes)	Time (hrs)		Pump Flow Rate U.S. gallon/min. (measured at the end of the testing period)	
	Operation	For attention to repairs and failures	Pump No.1.	Pump No.2
(0 - $1 \times 10^6$ )	400	48	10.9	10.6
( $1 \times 10^6$ - $2 \times 10^6$ )	375	9	10.9	9.7
( $2 \times 10^6$ - $3 \times 10^6$ )	368	16	10.9	10.0
( $3 \times 10^6$ - $4 \times 10^6$ )	354	13	9.0	9.0
